August 23, 2023

ARBORIST REPORT  
5858 Dunn Street, Niagara Falls, Ontario

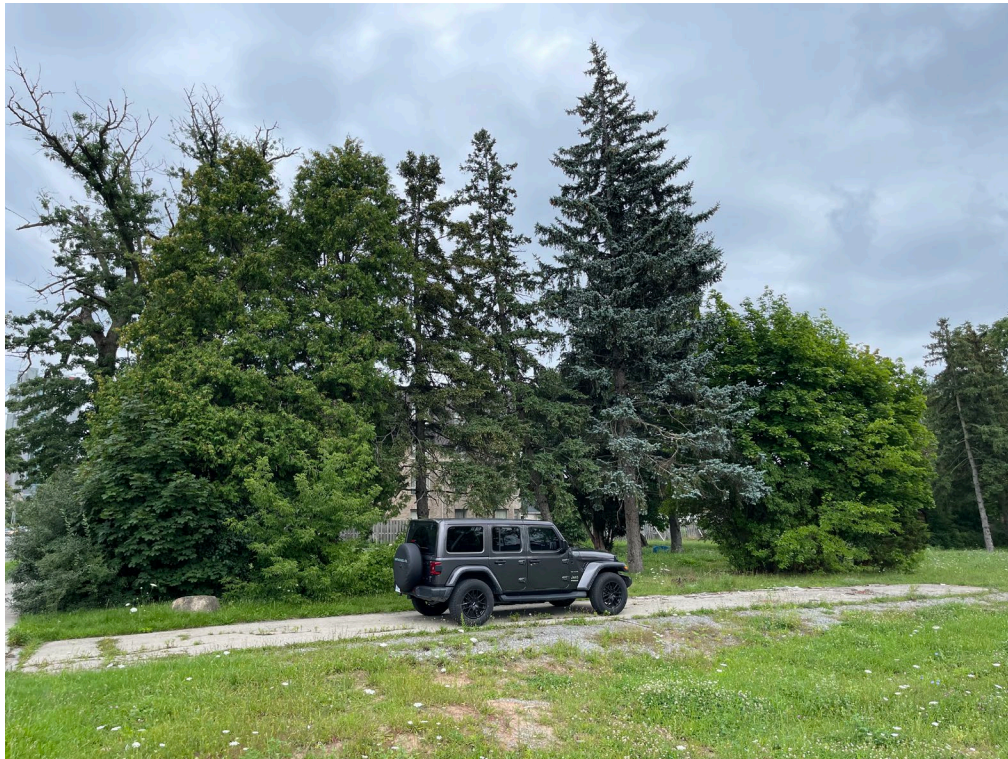
Trees 353 – 360

Tree #	Common Name	Botanical Name	DBH (CM)	Condition	Comments	Recommendation
353	White Cedar	<i>Thuja occidentalis</i>	35	F	Minor to moderate deadwood in canopy, 2 stem at 0.8 metres	Remove due to construction
354	White Cedar	<i>Thuja occidentalis</i>	27	F	Co-dominant at 1.5 metres, minor deadwood in canopy	Remove due to construction
355	White Spruce	<i>Picea glauca</i>	32	F	Elevated canopy, minor to moderate deadwood in canopy	Remove due to construction
356	Norway Spruce	<i>Picea abies</i>	30	F	Mild lean, elevated canopy, minor to moderate deadwood in canopy	Remove due to construction
357	Colorado Blue Spruce	<i>Picea pungens</i> var. <i>glauca</i>	43	F	Elevated canopy, minor deadwood in canopy	Remove due to construction
358	Norway Maple	<i>Acer platanoides</i>	20	F		Remove due to construction
359	Norway Maple	<i>Acer platanoides</i>	18	F	2 stem at base	Remove due to construction
360	Norway Maple	<i>Acer platanoides</i>	17	F		Remove due to construction

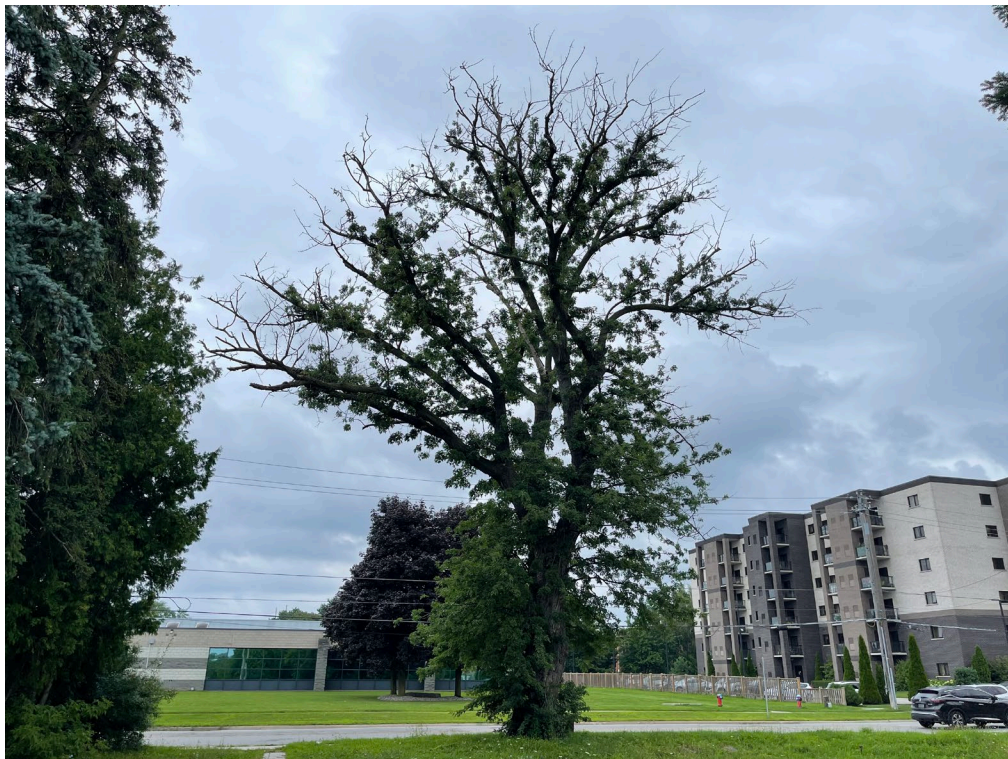
Tree 361

361	Silver Maple	<i>Acer saccharinum</i>	119	P	Moderate deadwood in canopy	Remove due to construction
362	Yew Sp.	<i>Taxus</i> Sp.	23	F	Multi-stem at 0.2 metres	Remove due to construction
363	Norway Spruce	<i>Picea abies</i>	51	F	Elevated canopy, minor deadwood in canopy	Remove due to construction
364	Norway Spruce	<i>Picea abies</i>	35	P	Elevated canopy, moderate to significant deadwood in canopy	Remove due to construction
365	American Elm	<i>Ulmus americana</i>	38	F	Significant lean, cavity in base of trunk	Remove due to construction
366	Black Walnut	<i>Juglans nigra</i>	22	F		Retain
367	Norway Spruce	<i>Picea abies</i>	37	F	Elevated canopy, minor deadwood in canopy	Remove due to construction

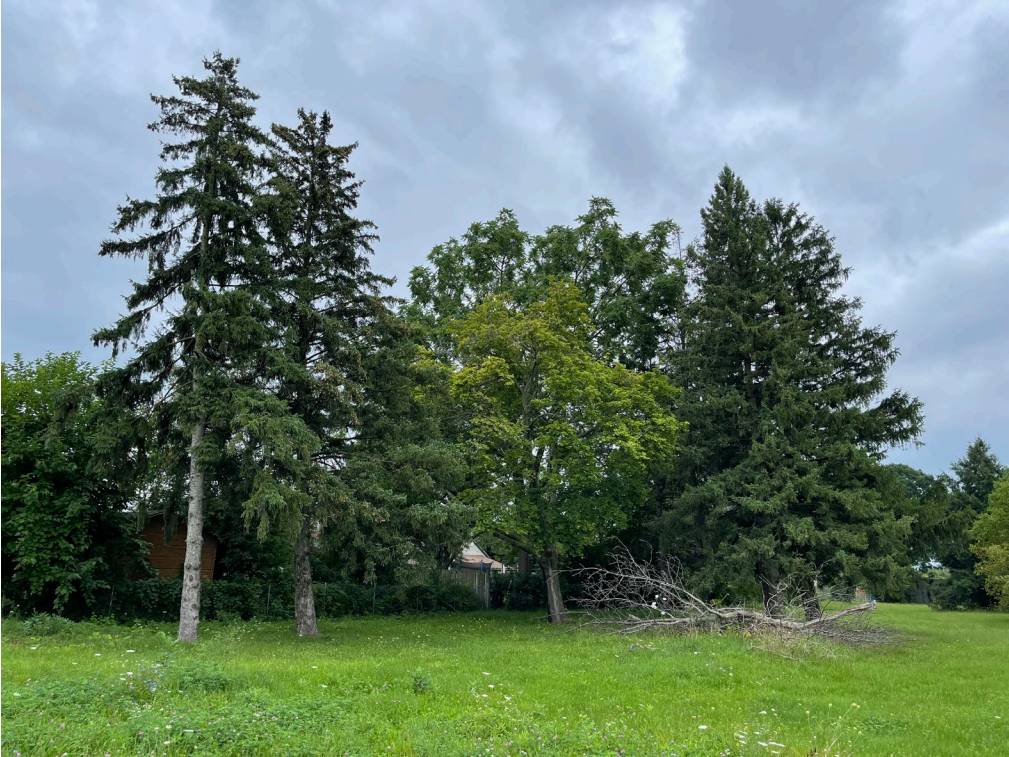
Trees 367 – 375

368	Norway Spruce	<i>Picea abies</i>	43	F	Moderate deadwood in canopy	Remove due to construction
369	Norway Maple	<i>Acer platanoides</i>	57	F	Minor deadwood in canopy	Remove due to construction
370	Norway Spruce	<i>Picea abies</i>	45	F	Minor deadwood in canopy	Remove due to construction
371	Norway Spruce	<i>Picea abies</i>	58	F	Minor deadwood in canopy	Remove due to construction
372	Norway Spruce	<i>Picea abies</i>	47	F	Moderate deadwood in canopy	Remove due to construction
373	Norway Spruce	<i>Picea abies</i>	37	P/D	Significant deadwood in canopy, tree is 95% dead	Remove due to condition
374	Norway Spruce	<i>Picea abies</i>	33	F/P	Moderate to significant deadwood in canopy	Remove due to construction
375	Black Walnut	<i>Juglans nigra</i>	~65	F	Minor deadwood in canopy	Retain
376	Manitoba Maple	<i>Acer negundo</i>	~61	F/P	Significant deadwood in canopy, growing through fence, main limb encroaches over property line about 9.0 metres	Retain

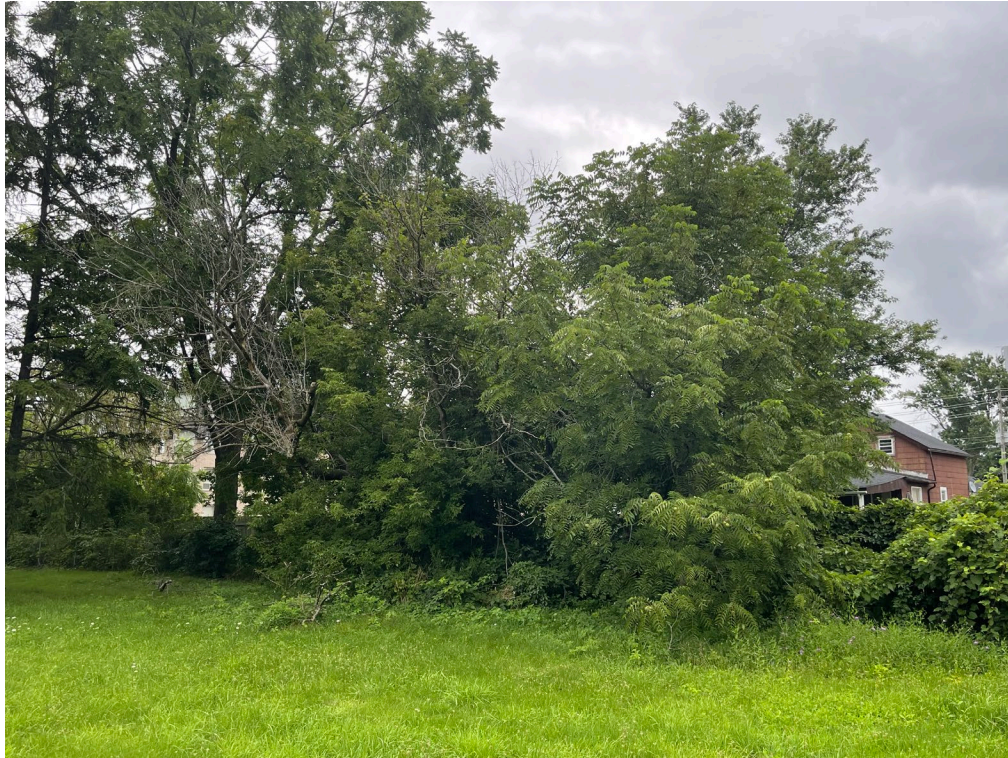
Trees 376 – 378

377	Black Walnut	<i>Juglans nigra</i>	26	F		Retain
378	Dead deciduous		~28	D	Tree is 100% dead, vines growing throughout	Remove due to condition
379	Ash Sp.	<i>Fraxinus Sp.</i>	23	F	Minor deadwood in canopy	Remove due to construction
380	American Chestnut	<i>Castanea dentata</i>	21	F	Minor deadwood in canopy	Remove due to construction
381	American Chestnut	<i>Castanea dentata</i>	19	F		Remove due to construction
382	American Chestnut	<i>Castanea dentata</i>	26	F	Minor deadwood in canopy	Remove due to construction
383	Flowering Crabapple Tree	<i>Malus Sp.</i>	28	F	Minor deadwood in canopy	Remove due to construction
384	American Chestnut	<i>Castanea dentata</i>	30	F		Remove due to construction
385	Canadian Hemlock	<i>Tsuga canadensis</i>	63	F		Remove due to construction
386	White Cedar	<i>Thuja occidentalis</i>	29	F/P	2 stem at base, moderate deadwood in canopy	Remove due to construction
387	White Cedar	<i>Thuja occidentalis</i>	38	F/P	Multi-stem at base, moderate deadwood in canopy	Remove due to construction

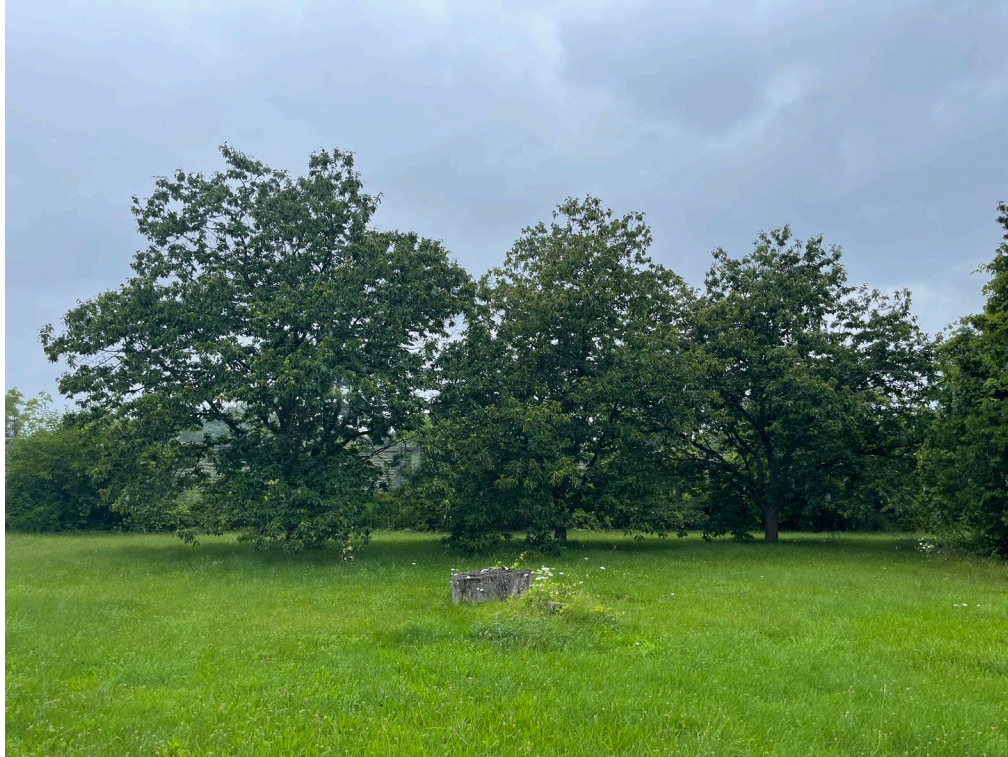
Trees 388 – 390

388	American Chestnut	<i>Castanea dentata</i>	44	F	Minor deadwood in canopy	Remove due to construction
389	American Chestnut	<i>Castanea dentata</i>	27	F	Co-dominant at 0.7 metres	Remove due to construction

390	American Chestnut	<i>Castanea dentata</i>	48	F	Minor deadwood in canopy	Remove due to construction
391	Black Walnut	<i>Juglans nigra</i>	71	F	Minor deadwood in canopy	Remove due to construction
392	Black Walnut	<i>Juglans nigra</i>	60	F	Minor deadwood in canopy	Remove due to construction
393	Burr Oak	<i>Quercus macrocarpa</i>	~110	F		Retain
394	Black Walnut	<i>Juglans nigra</i>	22	F		Retain
395	Flowering Crabapple Tree	<i>Malus Sp.</i>	19	F		Remove due to construction
O1	Silver Maple	<i>Acer saccharinum</i>	~95	F		Retain
O2	Flowering Crabapple Tree	<i>Malus Sp.</i>	~34	F		Retain
O3	Common Hackberry	<i>Celtis occidentalis</i>	~21	F		Retain
