ISSUED FOR SPA ONLY
 NOT FOR CONSTRUCTION

PROJECT: 7301 LUNDYS LANE NIAGARA FALLS

FILE NAME: TREE INVENTORY, PROTECTION, AND REMOVALS

DWG NO.: T1-1

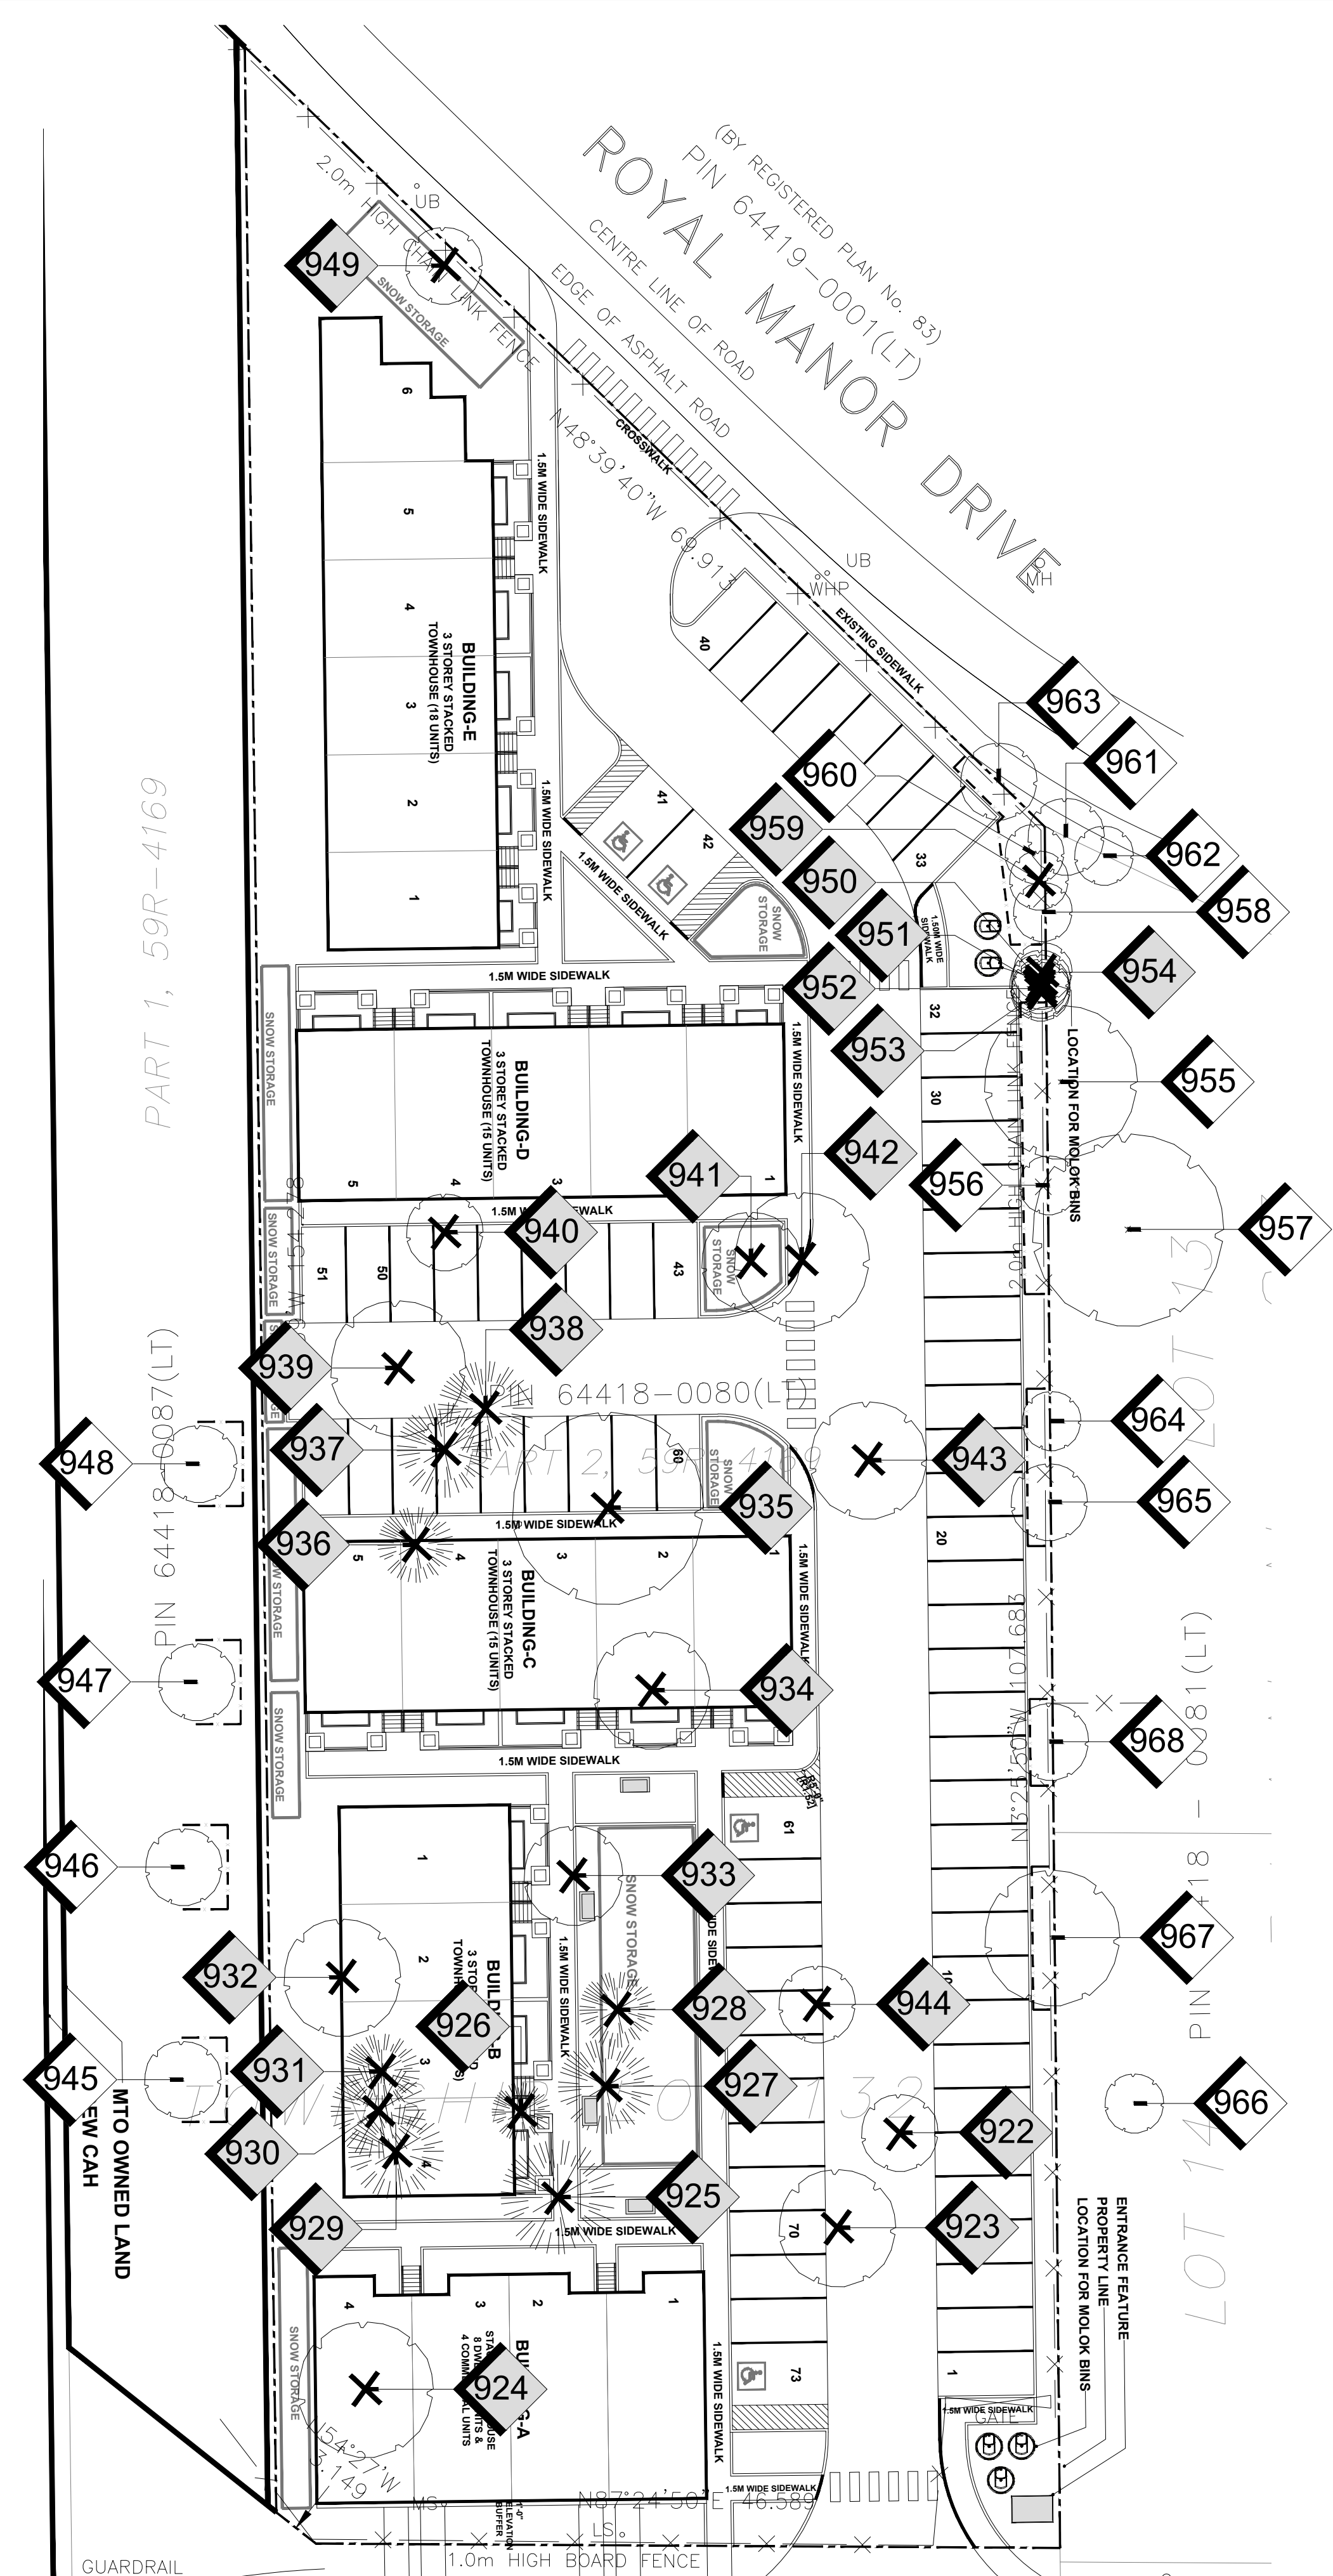
1
T1-1
TREE INVENTORY, REMOVALS, AND PROTECTION PLAN
SCALE: 1:300

Tree #	Common Name	Botanical Name	DBH (CM)	Condition	Comments	Recommendation
922	Honey Locust	Gleditsia triacanthos	38	F	Moderate deadwood in canopy	Remove due to construction
923	Honey Locust	Gleditsia triacanthos	58	F	Moderate deadwood in canopy	Remove due to construction
924	Silver Maple	Acer saccharinum	66	F	3 stem at 0.9 metres, minor deadwood in canopy	Remove due to construction
925	Austrian Pine	Pinus nigra	59	F/P	Moderate to significant deadwood in canopy	Remove due to construction
926	White Spruce	Picea glauca	26	F/P	Elevated canopy, moderate to significant deadwood in canopy	Remove due to construction
927	Colorado Blue Spruce	Picea pungens var. glauca	43	F	Moderate deadwood in canopy	Remove due to construction
928	Colorado Blue Spruce	Picea pungens var. glauca	40	F/P	Moderate to significant deadwood in canopy	Remove due to construction
929	Austrian Pine	Pinus nigra	48	F/P	Significant deadwood in canopy	Remove due to construction

930	Austrian Pine	Pinus nigra	48	P	Significant deadwood in canopy	Remove due to construction
931	Austrian Pine	Pinus nigra	31	P	Significant deadwood in canopy	Remove due to construction
932	Honey Locust	Gleditsia triacanthos	52	F	Minor to moderate deadwood in canopy	Remove due to construction
933	Norway Maple	Acer platanoides	49	P/D	Tree is 85% dead, significant deadwood in canopy, cavity in trunk, internal rot evident	Remove due to condition
934	Honey Locust	Gleditsia triacanthos	58	F	Minor deadwood in canopy	Remove due to construction
935	Siberian Elm	Ulmus pumila	97	F/P	Co-dominant at 1.2 metres, multiple limbs previously failed, cavity in trunk, minor deadwood in canopy	Remove due to construction
936	Colorado Blue Spruce	Picea pungens var. glauca	34	P	Moderate to significant deadwood in canopy	Remove due to construction
937	Austrian Pine	Pinus nigra	43	P	Significant deadwood in canopy	Remove due to construction

938	Austrian Pine	Pinus nigra	46	F/P	Moderate to significant deadwood in canopy	Remove due to construction
939	Little Leaf Linden	Tilia cordata	66	F		Remove due to construction
940	Norway Maple	Acer platanoides	35	F		Remove due to construction
941	Honey Locust	Gleditsia triacanthos	50	F	Moderate deadwood in canopy	Remove due to construction
942	Honey Locust	Gleditsia triacanthos	67	F	Moderate to significant deadwood in canopy	Remove due to construction
943	Little Leaf Linden	Tilia cordata	57	F		Remove due to construction
944	Honey Locust	Gleditsia triacanthos	36	F	Minor deadwood in canopy	Remove due to construction
945	Norway Maple	Acer platanoides	35	F		Retain
946	Norway Maple	Acer platanoides	31	F	Minor deadwood in canopy	Retain
947	Norway Maple	Acer platanoides	34	F	Minor deadwood in canopy	Retain
948	Norway Maple	Acer platanoides	39	F		Retain
949	Manitoba Maple	Acer negundo	31	F	4 stem at 0.3 metres, growing through fence, minor deadwood in canopy	Remove due to construction

950	Norway Maple	Acer platanoides	23	F/P	Mildew disease evident, moderate deadwood in canopy, growing through fence	Remove due to construction
951	Norway Maple	Acer platanoides	20	P	Mildew disease evident, growing through fence, significant deadwood in canopy	Remove due to construction
952	Norway Maple	Acer platanoides	24	F/P	Growing through fence, moderate deadwood in canopy	Remove due to construction
953	Norway Maple	Acer platanoides	20	F	Growing through fence	Remove due to construction
954	Norway Maple	Acer platanoides	22	F	2 stem at base, moderate deadwood in upper canopy	Remove due to construction
955	Honey Locust	Gleditsia triacanthos	71	F/P	Moderate to significant deadwood in canopy	Retain
956	Norway Maple	Acer platanoides	15	F		Retain
957	Black Walnut	Juglans nigra	92	F	Minor deadwood in canopy, co-dominant limbs fused at 2.0 metres	Retain
958	Norway Maple	Acer platanoides	20	F	Minor deadwood in canopy	Retain

959	Norway Maple	Acer platanoides	15	P/D	Growing through fence, tree is 50% dead	Remove due to construction
960	Norway Maple	Acer platanoides	15	F/P	Growing through fence, moderate lean, moderate deadwood in canopy	Retain
961	Norway Maple	Acer platanoides	37	P	Moderate to significant deadwood in canopy, mildew disease evident, 2 stem at base	Retain
962	Black Walnut	Juglans nigra	13	F		Retain
963	Black Walnut	Juglans nigra	37	F	Minor deadwood in canopy	Retain
964	Black Walnut	Juglans nigra	15	F/P	Elevated canopy, vines growing throughout	Retain
965	Manitoba Maple	Acer negundo	36	F	Vines growing throughout	Retain
966	White Mulberry	Morus alba	17	F		Retain
967	Siberian Elm	Ulmus pumila	62	F	Minor deadwood in canopy, vines growing throughout	Retain
968	Black Walnut	Juglans nigra	39	F	Minor deadwood in canopy	Retain
