August 23, 2023

ARBORIST REPORT
7301 Lundy's Lane, Niagara Falls, Ontario

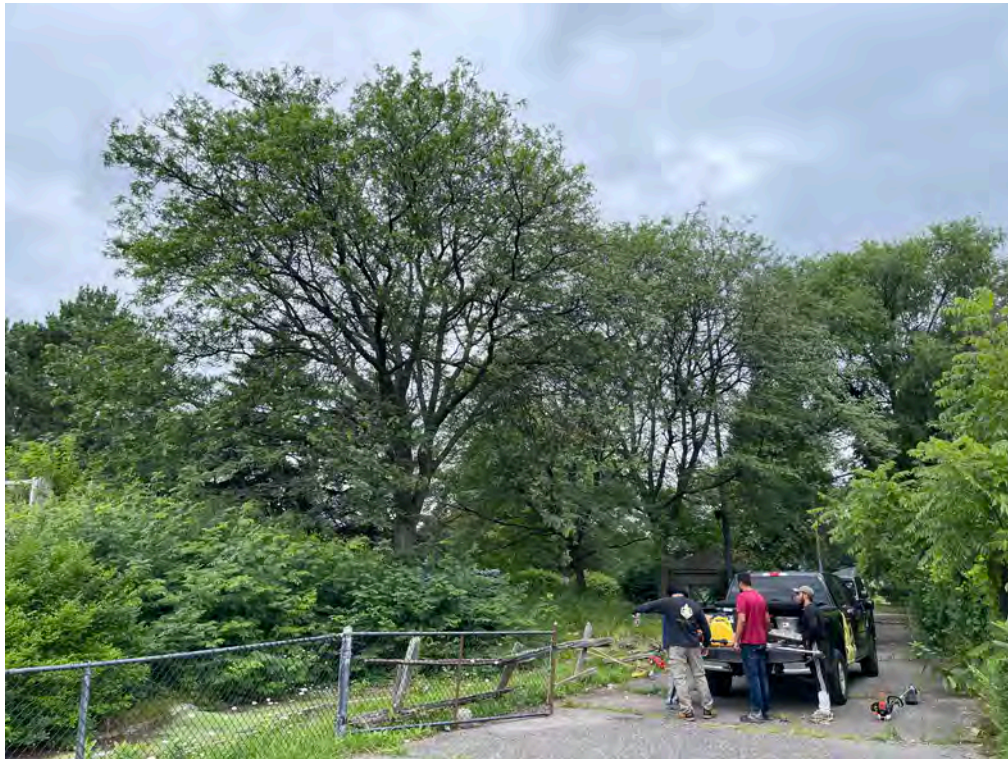
Trees 922, 923

Tree #	Common Name	Botanical Name	DBH (CM)	Condition	Comments	Recommendation
922	Honey Locust	Gleditsia triacanthos	38	F	Moderate deadwood in canopy	Remove due to construction
923	Honey Locust	Gleditsia triacanthos	58	F	Moderate deadwood in canopy	Remove due to construction
924	Silver Maple	Acer saccharinum	66	F	3 stem at 0.9 metres, minor deadwood in canopy	Remove due to construction
925	Austrian Pine	Pinus nigra	59	F/P	Moderate to significant deadwood in canopy	Remove due to construction
926	White Spruce	Picea glauca	26	F/P	Elevated canopy, moderate to significant deadwood in canopy	Remove due to construction
927	Colorado Blue Spruce	Picea pungens var. glauca	43	F	Moderate deadwood in canopy	Remove due to construction
928	Colorado Blue Spruce	Picea pungens var. glauca	40	F/P	Moderate to significant deadwood in canopy	Remove due to construction
929	Austrian Pine	Pinus nigra	48	F/P	Significant deadwood in canopy	Remove due to construction

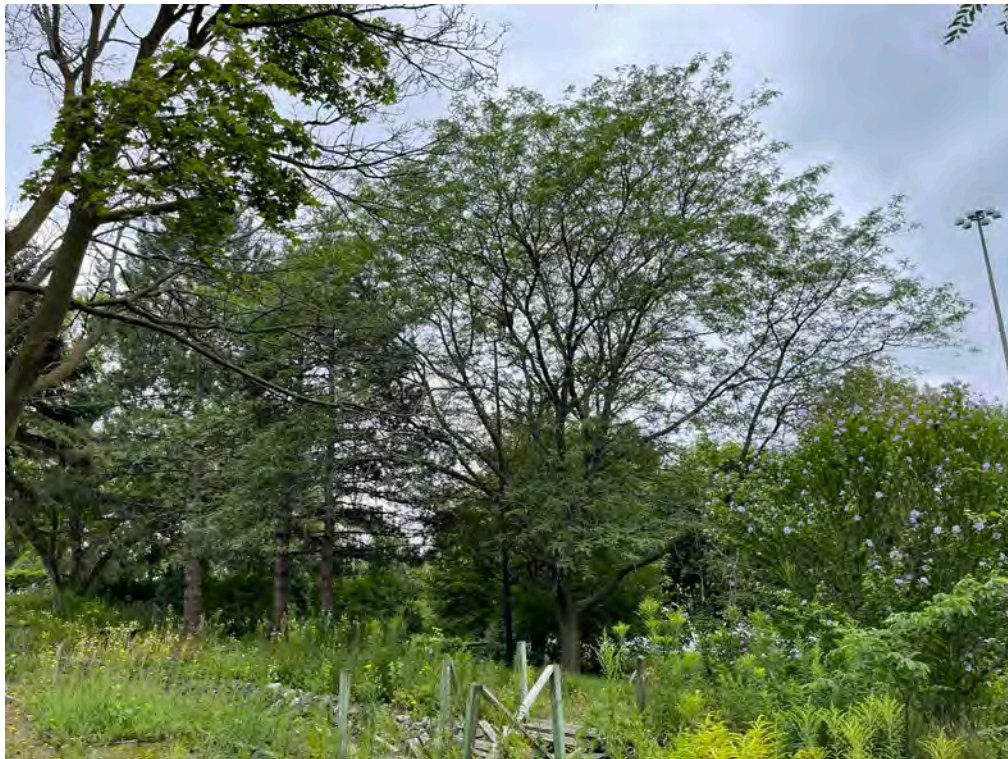
Trees 929 – 932

930	Austrian Pine	Pinus nigra	48	P	Significant deadwood in canopy	Remove due to construction
931	Austrian Pine	Pinus nigra	31	P	Significant deadwood in canopy	Remove due to construction
932	Honey Locust	Gleditsia triacanthos	52	F	Minor to moderate deadwood in canopy	Remove due to construction
933	Norway Maple	Acer platanoides	49	P/D	Tree is 85% dead, significant deadwood in canopy, cavity in trunk, internal rot evident	Remove due to condition
934	Honey Locust	Gleditsia triacanthos	58	F	Minor deadwood in canopy	Remove due to construction
935	Siberian Elm	Ulmus pumila	97	F/P	Co-dominant at 1.2 metres, multiple limbs previously failed, cavity in trunk, minor deadwood in canopy	Remove due to construction

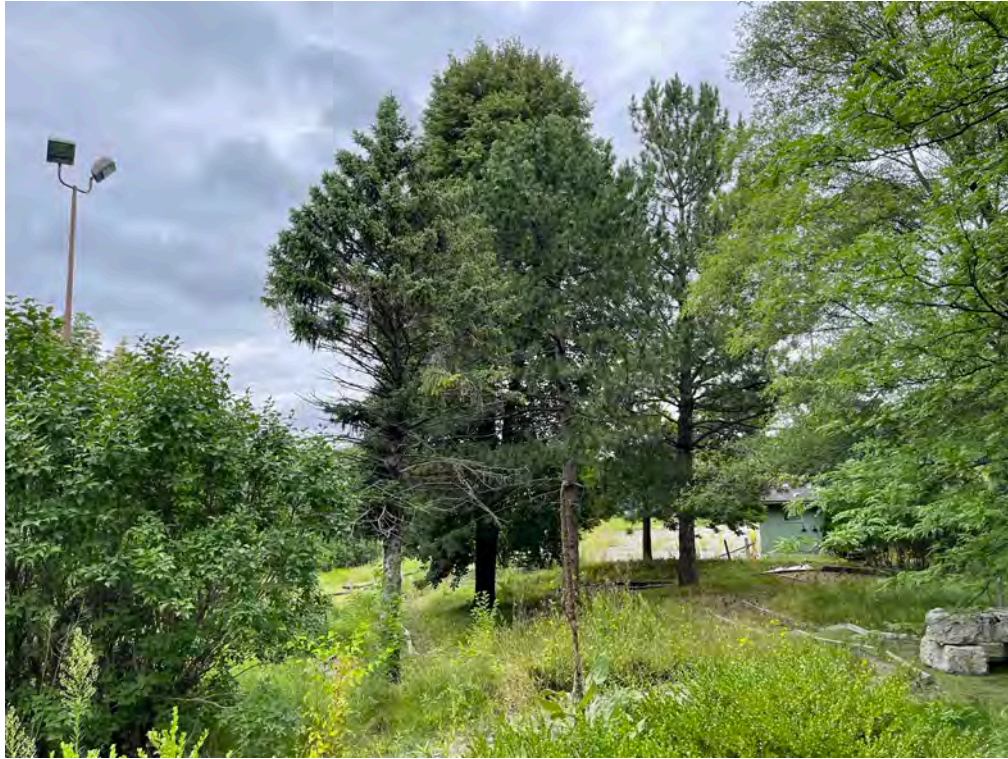
Trees 936 – 939

936	Colorado Blue Spruce	<i>Picea pungens</i> var. <i>glauca</i>	34	P	Moderate to significant deadwood in canopy	Remove due to construction
937	Austrian Pine	<i>Pinus nigra</i>	43	P	Significant deadwood in canopy	Remove due to construction
938	Austrian Pine	<i>Pinus nigra</i>	46	F/P	Moderate to significant deadwood in canopy	Remove due to construction
939	Little Leaf Linden	<i>Tilia cordata</i>	66	F		Remove due to construction
940	Norway Maple	<i>Acer</i> <i>platanoides</i>	35	F		Remove due to construction
941	Honey Locust	<i>Gleditsia</i> <i>triacanthos</i>	50	F	Moderate deadwood in canopy	Remove due to construction
942	Honey Locust	<i>Gleditsia</i> <i>triacanthos</i>	67	F	Moderate to significant deadwood in canopy	Remove due to construction
943	Little Leaf Linden	<i>Tilia cordata</i>	57	F		Remove due to construction
944	Honey Locust	<i>Gleditsia</i> <i>triacanthos</i>	36	F	Minor deadwood in canopy	Remove due to construction

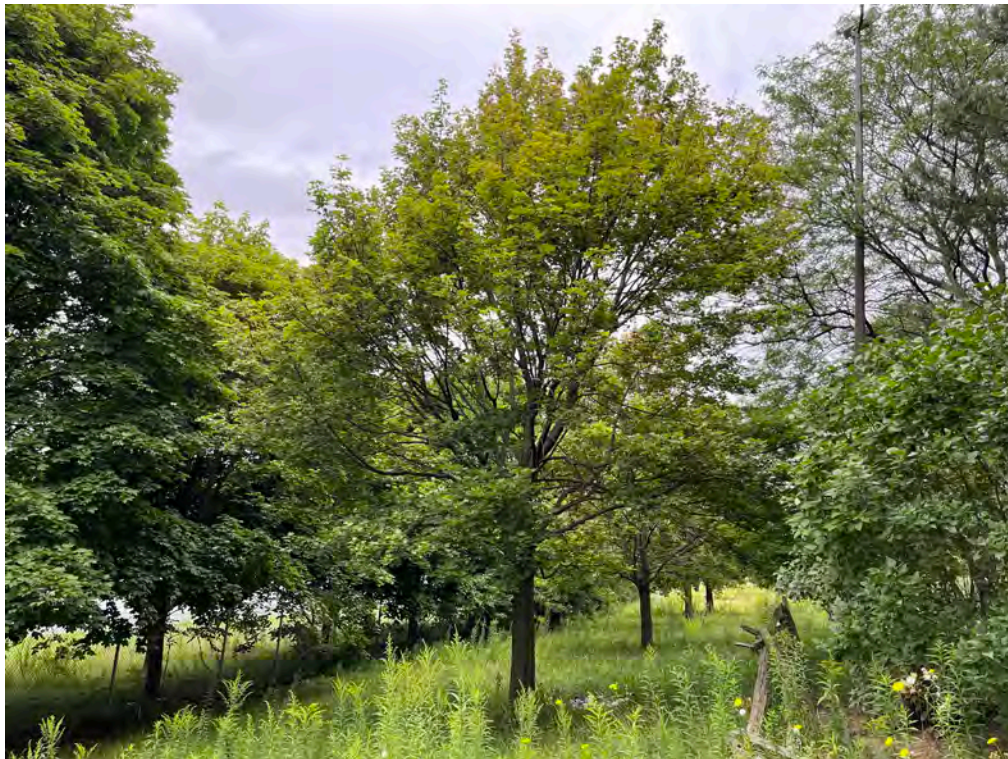
Tree 945

945	Norway Maple	<i>Acer</i> <i>platanoides</i>	35	F		Retain
946	Norway Maple	<i>Acer</i> <i>platanoides</i>	31	F	Minor deadwood in canopy	Retain
947	Norway Maple	<i>Acer</i> <i>platanoides</i>	34	F	Minor deadwood in canopy	Retain
948	Norway Maple	<i>Acer</i> <i>platanoides</i>	39	F		Retain
949	Manitoba Maple	<i>Acer negundo</i>	31	F	4 stem at 0.3 metres, growing through fence, minor deadwood in canopy	Remove due to construction
950	Norway Maple	<i>Acer</i> <i>platanoides</i>	23	F/P	Mildew disease evident, moderate deadwood in canopy, growing through fence	Remove due to construction
951	Norway Maple	<i>Acer</i> <i>platanoides</i>	20	P	Mildew disease evident, growing through fence, significant deadwood in canopy	Remove due to construction
952	Norway Maple	<i>Acer</i> <i>platanoides</i>	24	F/P	Growing through fence, moderate deadwood in canopy	Remove due to construction
953	Norway Maple	<i>Acer</i> <i>platanoides</i>	20	F	Growing through fence	Remove due to construction

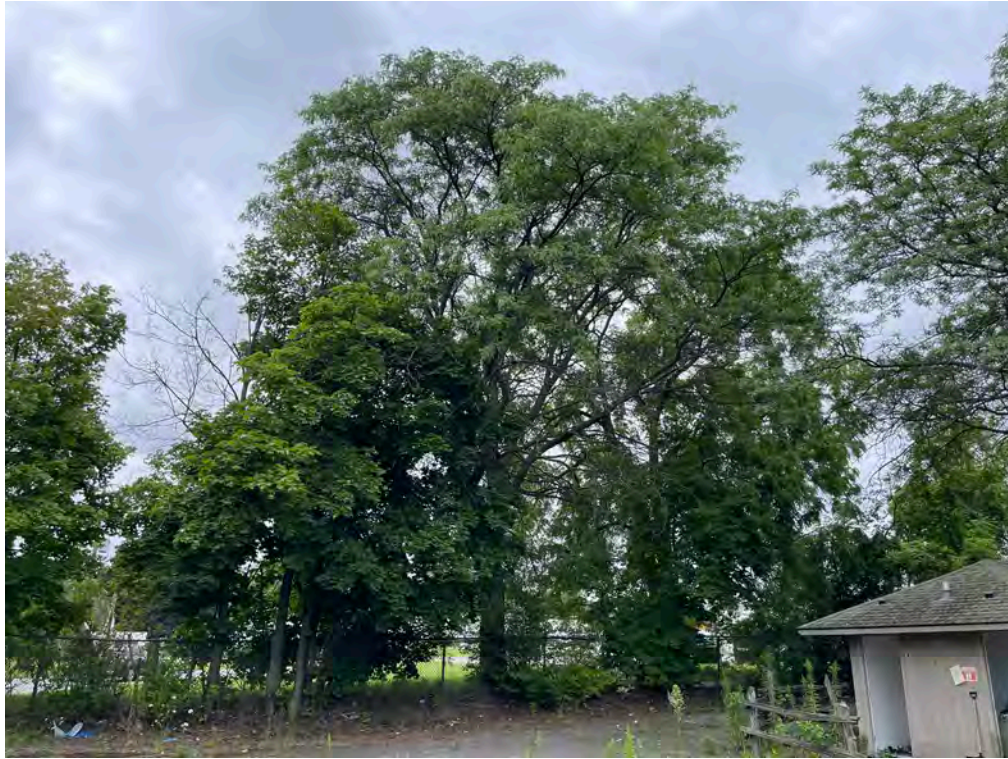
Trees 950 – 957

954	Norway Maple	<i>Acer</i> <i>platanoides</i>	22	F	2 stem at base, moderate deadwood in upper canopy	Remove due to construction
955	Honey Locust	<i>Gleditsia</i> <i>triacanthos</i>	71	F/P	Moderate to significant deadwood in canopy	Retain

956	Norway Maple	Acer platanoides	15	F		Retain
957	Black Walnut	Juglans nigra	92	F	Minor deadwood in canopy, co-dominant limbs fused at 2.0 metres	Retain
958	Norway Maple	Acer platanoides	20	F	Minor deadwood in canopy	Retain
959	Norway Maple	Acer platanoides	15	P/D	Growing through fence, tree is 50% dead	Remove due to construction
960	Norway Maple	Acer platanoides	15	F/P	Growing through fence, moderate lean, moderate deadwood in canopy	Retain
961	Norway Maple	Acer platanoides	37	P	Moderate to significant deadwood in canopy, mildew disease evident, 2 stem at base	Retain
962	Black Walnut	Juglans nigra	13	F		Retain
963	Black Walnut	Juglans nigra	37	F	Minor deadwood in canopy	Retain
964	Black Walnut	Juglans nigra	15	F/P	Elevated canopy, vines growing throughout	Retain
965	Manitoba Maple	Acer negundo	36	F	Vines growing throughout	Retain
966	White Mulberry	Morus alba	17	F		Retain
967	Siberian Elm	Ulmus pumila	62	F	Minor deadwood in canopy, vines growing throughout	Retain

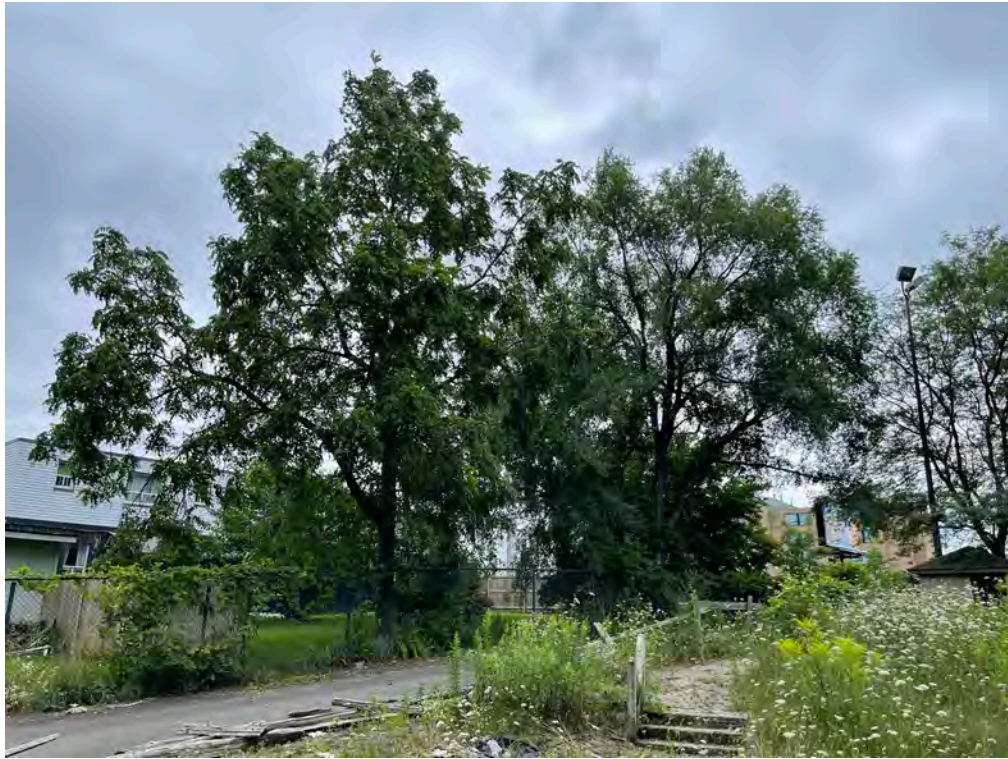
Trees 967, 968

968	Black Walnut	Juglans nigra	39	F	Minor deadwood in canopy	Retain
