**Tree Inventory and Preservation Plan
6285 & 6289 Main Street
Niagara Falls, Ontario**

5 December 2023

KUNTZ FORESTRY CONSULTING INC. Project P3604

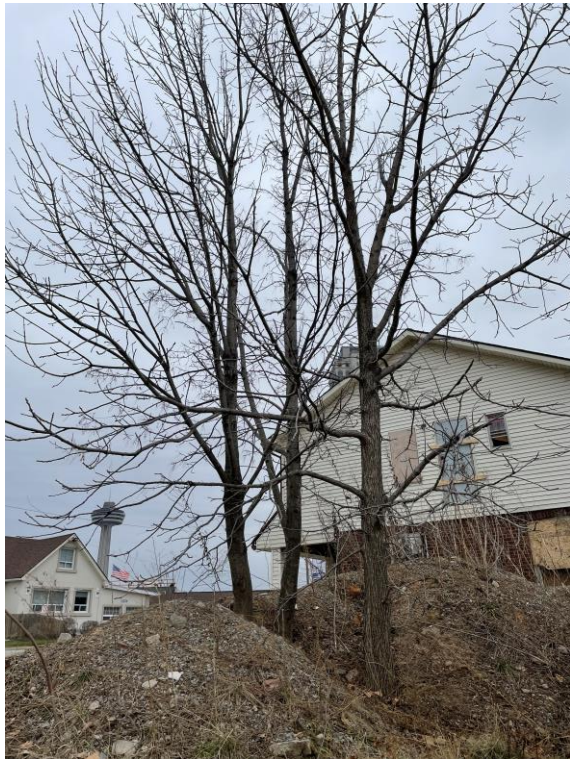
Image 1. From left to right, Trees 563 – 565

Tree #	Common Name	Scientific Name	DBH	TI	CS	CV	CDB	DL	Comments	Action
563	White Ash	<i>Fraxinus americana</i>	18	F	FG	PF		3.0	Fill piled at base, epicormic branching (L), Emerald Ash Borer (M)	Remove
564	White Ash	<i>Fraxinus americana</i>	12.5, 11.5	F	FG	PF		2.0	Union at 0.5m, Emerald Ash Borer (M), fill piled at base, epicormic branching (L)	Remove
565	Black Walnut	<i>Juglans nigra</i>	22	F	G	F		3.0	Fill piled at base	Remove
566	Black Walnut	<i>Juglans nigra</i>	19	F	G	F		3.0	Fill piled at base	Remove
567	White Ash	<i>Fraxinus americana</i>	53.5	P	P	P	95	5.0	Emerald Ash Borer (H), moribund, only epicormic branching alive, epicormic branching (H), deadwood (H)	Remove
568	Sycamore Maple	<i>Acer pseudoplatanus</i>	49.5	F	F	F	15	6.0	Union at 1.5m, pruning wounds (M), deadwood (L), decay (M) in crown, asymmetrical crown (L)	Remove
569	Norway Spruce	<i>Picea abies</i>	35	G	G	F		5.0		Remove
570	Eastern White Cedar	<i>Thuja occidentalis</i>	36	F	F	F		4.0	Lean (L), pruning wounds (M), epicormic branching (L), stem wounds (L)	Remove

The removal of 13 trees will be required to accommodate the proposed development. The required tree removals include Trees 563 – 575.

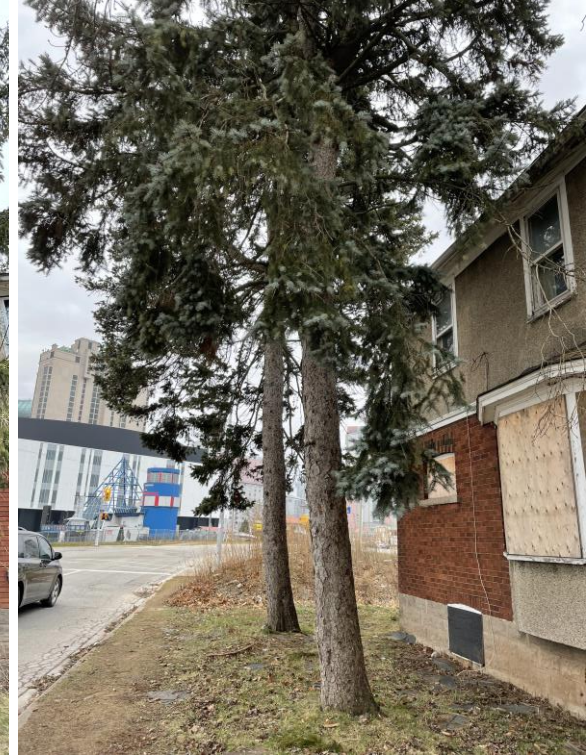
Image 6. Trees 571 (far) and 572 (near)

571	Blue Spruce	<i>Picea pungens</i>	39	F	F	F		4.0	Lean (L), poor form (L), crook (M) in crown	Remove
572	Blue Spruce	<i>Picea pungens</i>	37	F	F	F		4.0	Lean (L), poor form (L), crook (M) in crown	Remove
573	Silver Maple	<i>Acer saccharinum</i>	55	PF	PF	F	10	7.0	Burls (L), lean (L), poor unions, multiple branch attachments, cavities (M) in crown, deadwood (L), poor form (L), asymmetrical crown (L)	Remove
574	Eastern White Cedar	<i>Thuja occidentalis</i>	32.5	F	FG	FG		4.0	Lean (L), asymmetrical crown (L), pruning wounds (L), stem wounds (L)	Remove
575	Eastern White Cedar	<i>Thuja occidentalis</i>	10, 6, 6	FG	F	PF	15	1.0	Sweep (L), browning foliage, deadwood (L)	Remove
A	Blue Spruce	<i>Picea pungens</i>	42.5	G	G	F		3.0		Preserve
B	Blue Spruce	<i>Picea pungens</i>	38.5	G	G	F		3.0		Preserve
C	Blue Spruce	<i>Picea pungens</i>	31	G	G	F		3.0		Preserve
D	Blue Spruce	<i>Picea pungens</i>	34	G	G	F		3.0		Preserve

Trees 566 and 575 are located on a neighbouring property and as such, written permission from the respective neighbouring property owner will be required prior to the removal of these trees. Trees 571 – 574 are located within the Main Street right-of-way and as such, permission from the City of Niagara Falls will be required prior to the removal of these trees. All other trees identified for removal are located within the boundaries of the subject site.

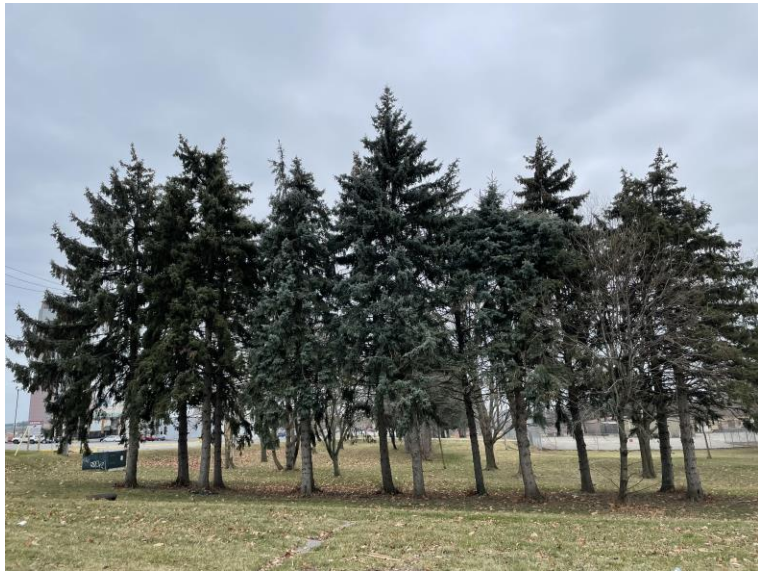
Image 9. Facing south towards Trees A – N

E	Blue Spruce	<i>Picea pungens</i>	32.5	G	G	F		3.0		Preserve
F	Blue Spruce	<i>Picea pungens</i>	30.5	G	FG	F		3.0	Codominance in crown	Preserve

G	Blue Spruce	<i>Picea pungens</i>	36	G	G	F		3.0		Preserve
H	Blue Spruce	<i>Picea pungens</i>	35	FG	FG	F		3.0	Lean (L), crook (L) in crown	Preserve
I	Blue Spruce	<i>Picea pungens</i>	31	G	G	F		3.0		Preserve
J	Blue Spruce	<i>Picea pungens</i>	37.5	FG	FG	F		3.0	Lean (L), codominance in crown	Preserve
K	Blue Spruce	<i>Picea pungens</i>	37	G	G	F		3.0		Preserve
L	Sycamore Maple	<i>Acer pseudoplatanus</i>	22	F	FG	F		3.0	Lean (M), epicormic branching (L), pruning wounds (L) with decay (L), multiple branch attachments	Preserve
M	Blue Spruce	<i>Picea pungens</i>	40.5	G	G	F		3.0		Preserve
N	Blue Spruce	<i>Picea pungens</i>	39	FG	FG	F		4.0	Crook (L) in crown	Preserve
O	Serviceberry species	<i>Amelanchier sp.</i>	16, 11.5, 10.5	PF	PF	PF	40	3.0	V-union at base, union at 0.2m, decay (H) in trunk, epicormic branching (H), deadwood (M)	Preserve
P	Serviceberry species	<i>Amelanchier sp.</i>	12, 11.5, 10	PF	FG	F	10	3.0	V-union at base, union at 0.2m, decay (H) in trunk, deadwood (L), spiral leaders	Preserve

Tree preservation fencing has not been prescribed for Trees A – N or U. These trees are located sufficiently far (i.e. more than six metres) from the anticipated limit of disturbance such that tree preservation fencing will not be required.

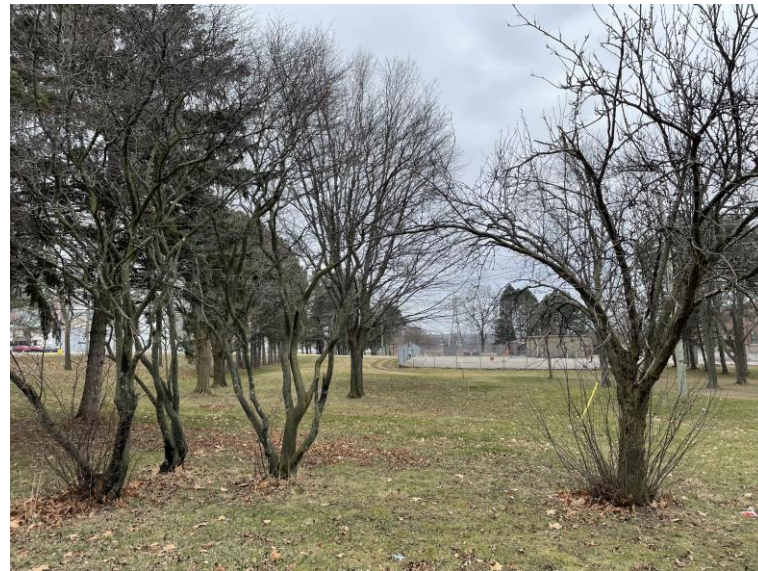
Image 10. From left to right, Trees O – R

Q	Serviceberry species	<i>Amelanchier sp.</i>	17, 13, 11, 11, 8	PF	FG	F	10	3.0	Epicormic branching (M), deadwood (L), v-union at 0.1m, union at 1m, decay (H) in trunk	Preserve
R	Mountain Ash species	<i>Sorbus sp.</i>	33	PF	PF	PF	40	4.0	Multiple branch attachments, decay (H) in trunk, epicormic branching (H), deadwood (M)	Preserve
S	Magnolia species	<i>Magnolia sp.</i>	29.5	G	FG	F		3.0	Epicormic branching (M), pruning wounds (L)	Preserve
T	Magnolia species	<i>Magnolia sp.</i>	26, 24	F	FG	F		3.0	V-union at 1m (codominance) with included bark, epicormic branching (M), pruning wounds (L), included brick (M) between leaders	Preserve
U	Magnolia species	<i>Magnolia sp.</i>	25, 24.5	FG	FG	F		4.0	V-union at 1m (codominance) with included bark, epicormic branching (M), pruning wounds (L)	Preserve

Tree preservation fencing has been prescribed adjacent to Trees O – T, along the boundary of the subject site. Should the subject site be bound by construction fence,
