Re: Arborist Report and Tree Protection Plan – 6546 Fallsview Blvd – Niagara Falls

Arborist Report
&
Tree Protection Plan

6546 Fallsview Blvd
Niagara Falls, ON

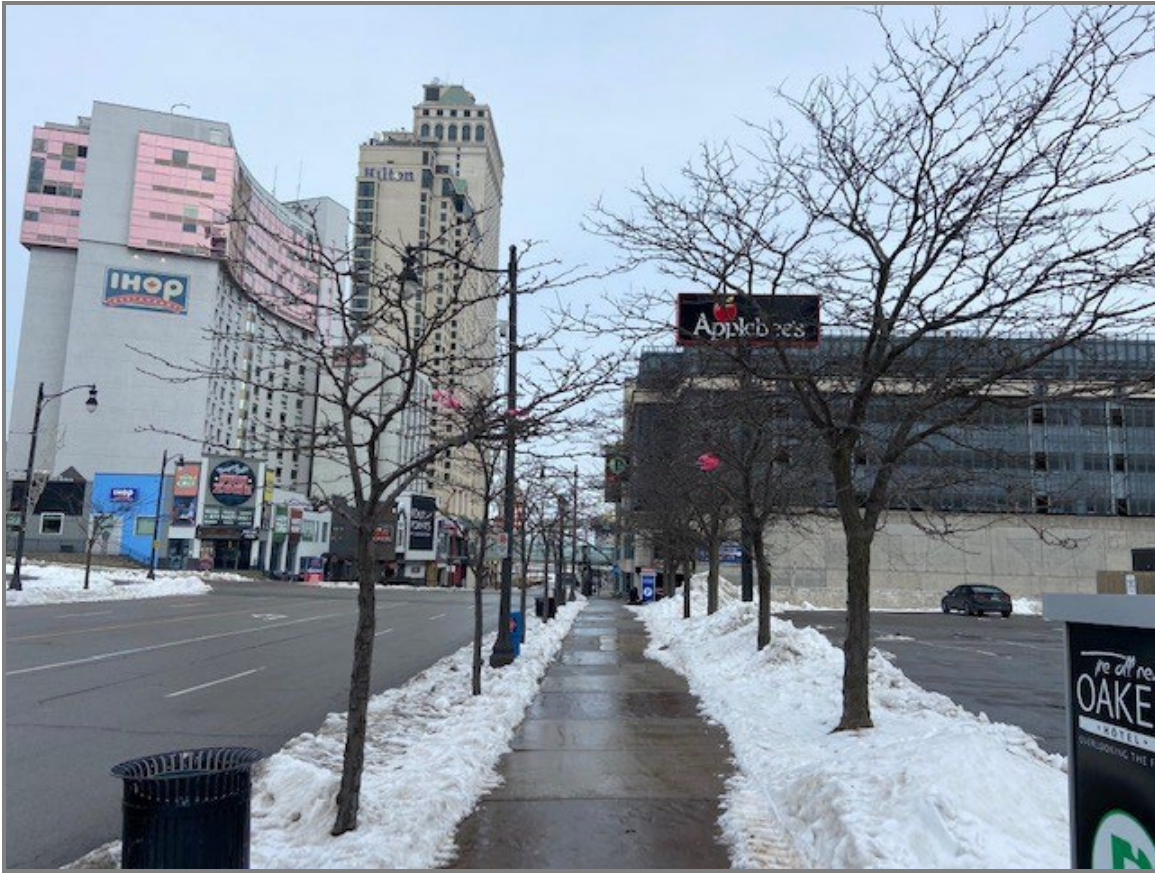
Tree #	Species Common Name (Biological Name)	D ¹ B H (cm)	Condition ²	Category ³	Comments and Recommendations	Recommendation ⁴	M ⁵ T P Z (M)
121	Honey Locust <i>Gleditsia triacanthos</i>	23	F	1	- deadwood, weak union - in conflict with proposed underground parking	R	1.8
122	Honey Locust <i>Gleditsia triacanthos</i>	22	F	1	- deadwood, weak union - in conflict with proposed underground parking	R	1.8
123	Honey Locust <i>Gleditsia triacanthos</i>	22	G	1	- deadwood - in conflict with proposed underground parking	R	1.8
124	Honey Locust <i>Gleditsia triacanthos</i>	20	F	1	- deadwood - in conflict with proposed underground parking	R	1.8
125	Honey Locust <i>Gleditsia triacanthos</i>	26	F	1	- deadwood, epicormic growth - in conflict with proposed underground parking	R	1.8
126	Honey Locust <i>Gleditsia triacanthos</i>	22	F	1	- deadwood, epicormic growth - in conflict with proposed underground parking	R	1.8

Photo #1: Trees no. 121—126 and C11-C16 looking north.

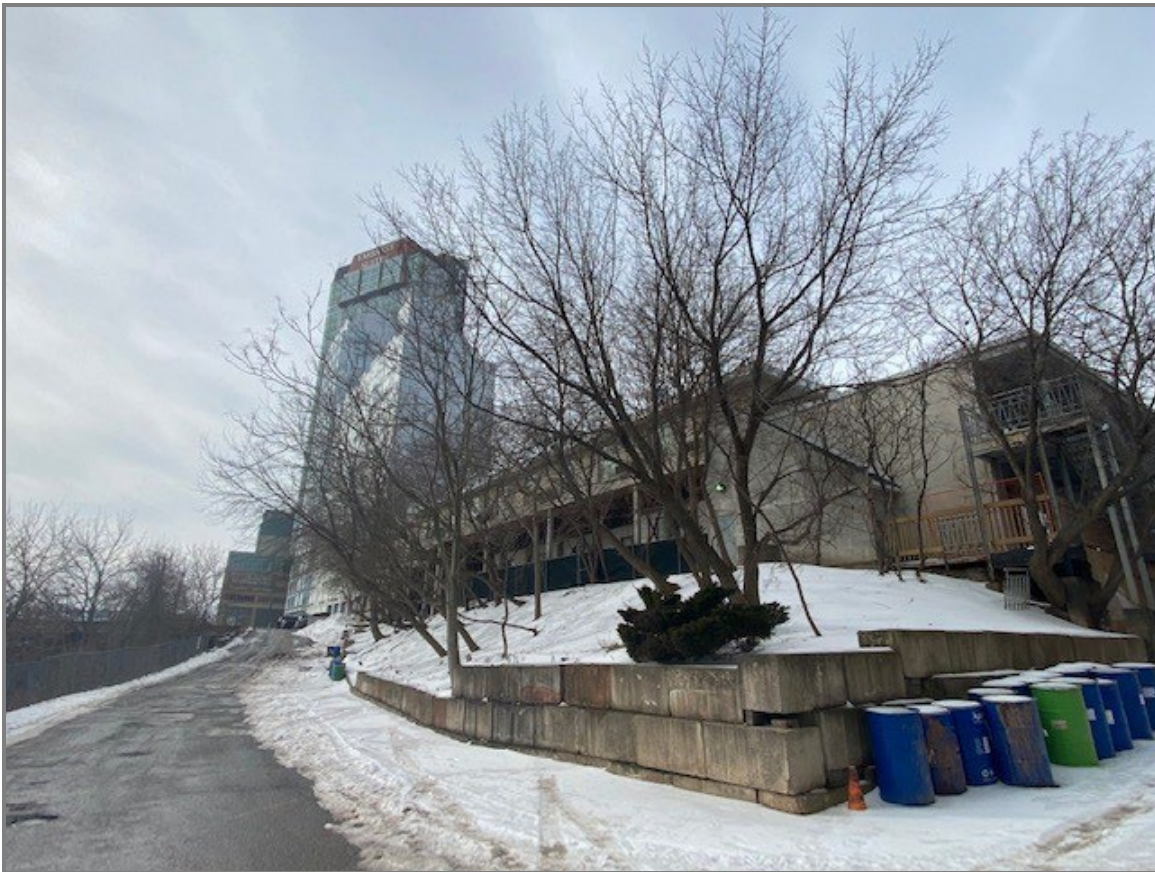
127	Manitoba Maple <i>Acer negundo</i> (26) Trembling Aspen <i>Populus tremuloides</i> (1) Black Walnut <i>Juglans nigra</i> (1) Staghorn Sumac <i>Rhamnus spp.</i> (4) White Mulberry <i>Morus alba</i> (1)	14- 59	F	1	- group of trees - in conflict with proposed underground parking	R	1.8- 3.6

Photo #2: Trees no. 127-128 looking southwest.

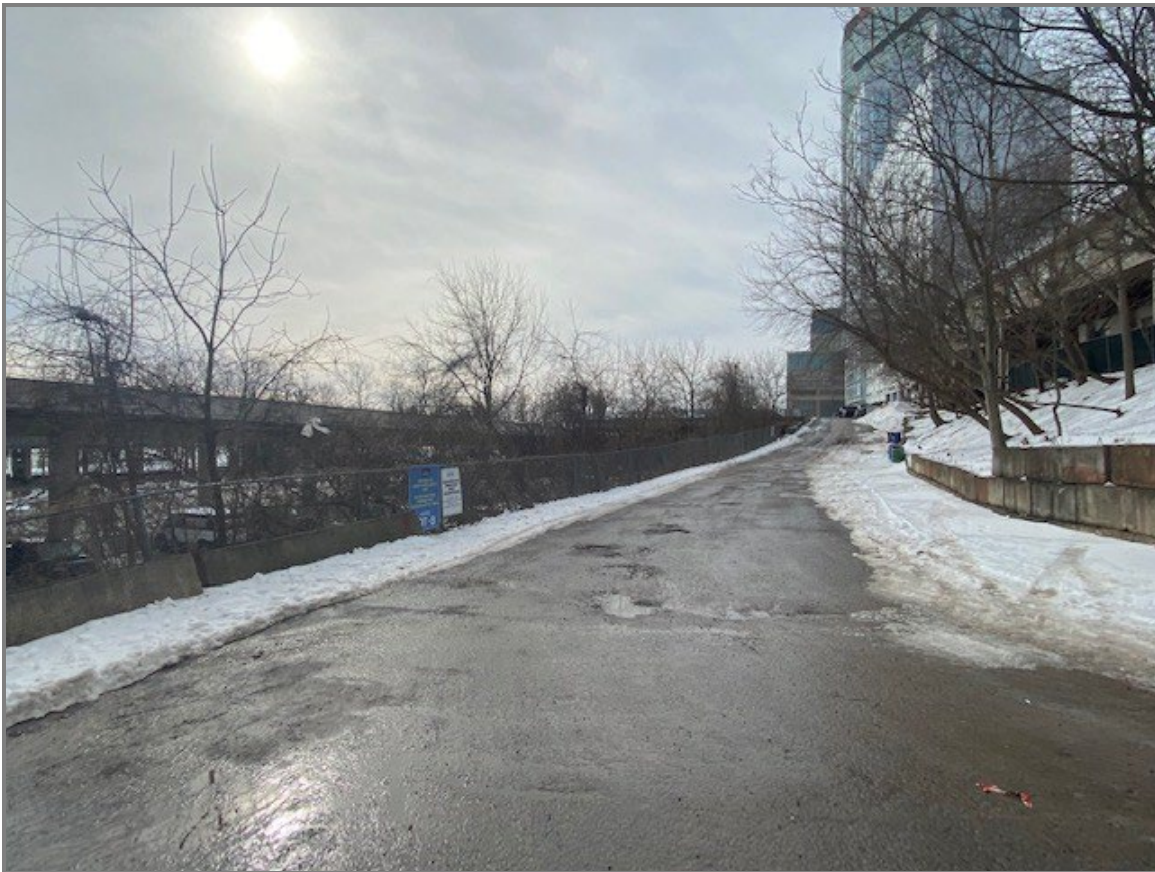
Tree #	Species Common Name (Biological Name)	D B H (cm)	Condition	Category	Comments and Recommendations	Recommendation	M T P Z (M)
128	Tree of Heaven <i>Ailanthus altissima</i>	30	F	1	- deadwood, storm break - in conflict with proposed underground parking	R	2.4
129	Manitoba Maple <i>Acer negundo</i> (15)	11-34	F	1	- group of trees - in conflict with proposed underground parking	R	1.8-2.4
C1	Honey Locust <i>Gleditsia triacanthos</i>	1	P	4	- poor form, in decline - in conflict with proposed landscaping	R	1.2
C2	Honey Locust <i>Gleditsia triacanthos</i>	6	F	4	- deadwood - in conflict with proposed landscaping	R	1.2
C3	Honey Locust <i>Gleditsia triacanthos</i>	7	F	4	- deadwood, unbalanced - in conflict with proposed landscaping	R	1.2
C4	Honey Locust <i>Gleditsia triacanthos</i>	7	P	4	- deadwood, poorly planted - in conflict with proposed landscaping	R	1.2
C5	Honey Locust <i>Gleditsia triacanthos</i>	9	F	4	- deadwood, unbalanced - in conflict with proposed landscaping	R	1.2

Photo #3: Trees no. 129 looking south.

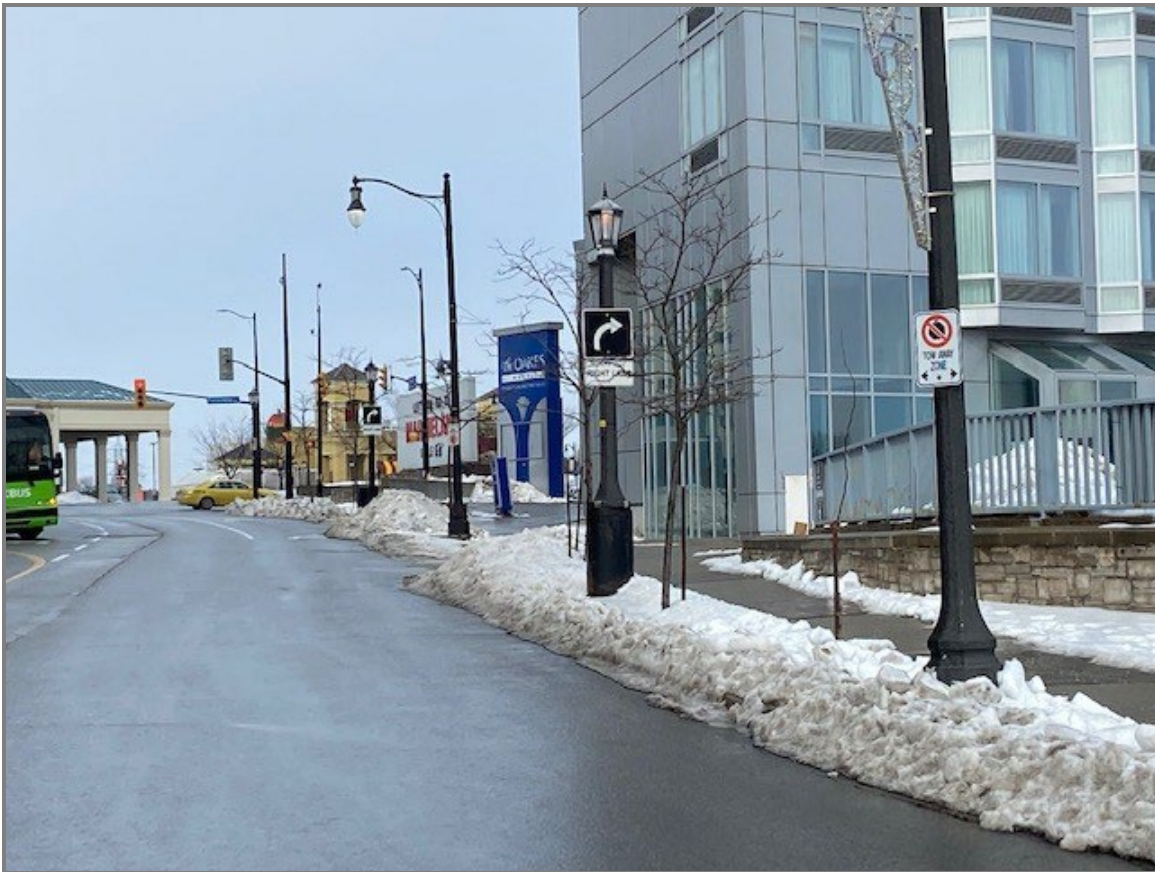
C6	Honey Locust <i>Gleditsia triacanthos</i>	7	F	4	- deadwood, poor form - in conflict with proposed landscaping	R	1.2
C7	Honey Locust <i>Gleditsia triacanthos</i>	10	F	4	- deadwood, seam in trunk - in conflict with proposed landscaping	R	1.8
C8	Honey Locust <i>Gleditsia triacanthos</i>	7	F	4	- deadwood - in conflict with proposed landscaping	R	1.2
C9	Honey Locust <i>Gleditsia triacanthos</i>	8	F	4	- deadwood, poor form - in conflict with proposed landscaping	R	1.2
C10	Honey Locust <i>Gleditsia triacanthos</i>	21	F	4	- deadwood, epicormic growth - in conflict with proposed landscaping	R	1.8
C11	Honey Locust <i>Gleditsia triacanthos</i>	12	F	4	- deadwood, in decline - in conflict with proposed landscaping	R	1.8
C12	Honey Locust <i>Gleditsia triacanthos</i>	10	F	4	- deadwood, seam in trunk - in conflict with proposed landscaping	R	1.8
C13	Honey Locust <i>Gleditsia triacanthos</i>	12	F	4	- deadwood, seam in trunk - in conflict with proposed landscaping	R	1.8

Photo #4: Trees no. C1-C6 looking west.

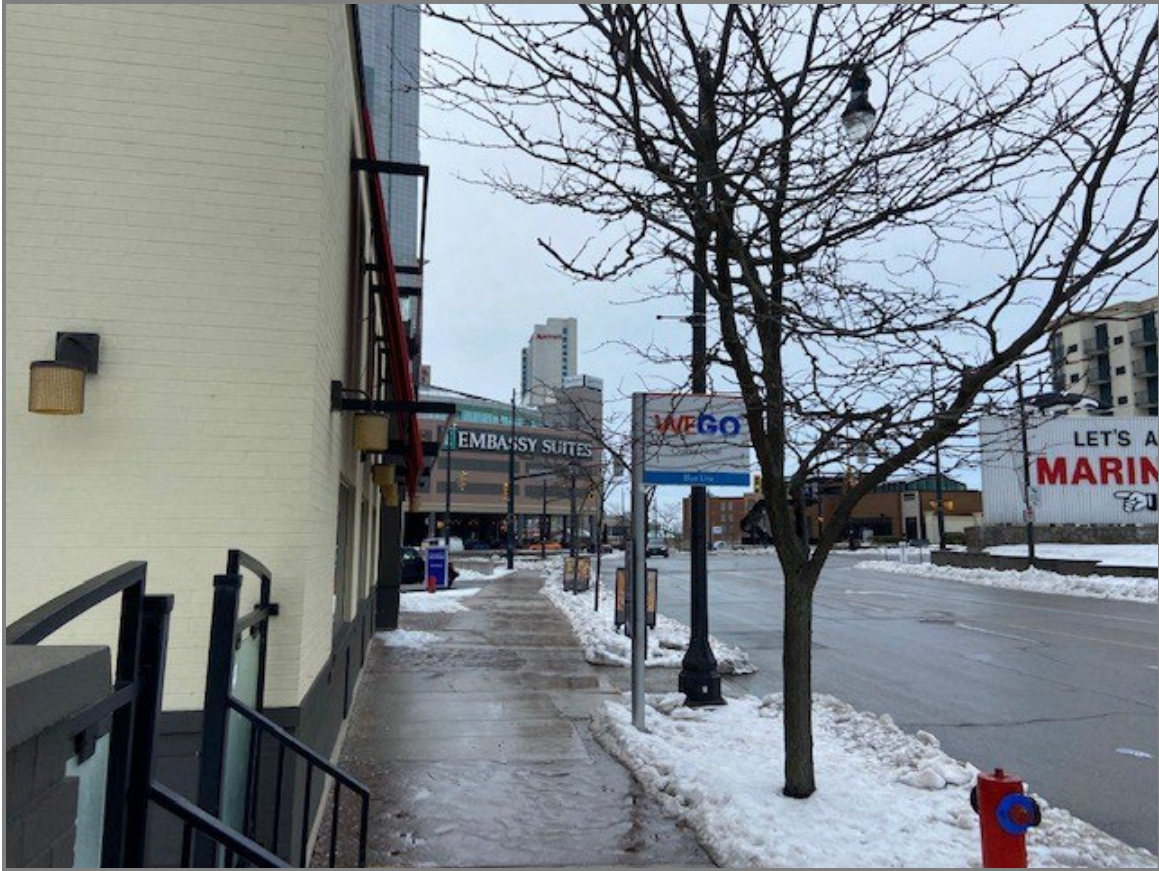
Photo #5: Trees no. C7-C10 looking south.
