PROJECT No.: SM 220069-E

September 30, 2024

**SUPPLEMENTAL ENVIRONMENTAL CONSIDERATIONS
RIVERFRONT – CHIPPAWA PARKWAY
NIAGARA FALLS, ONTARIO**

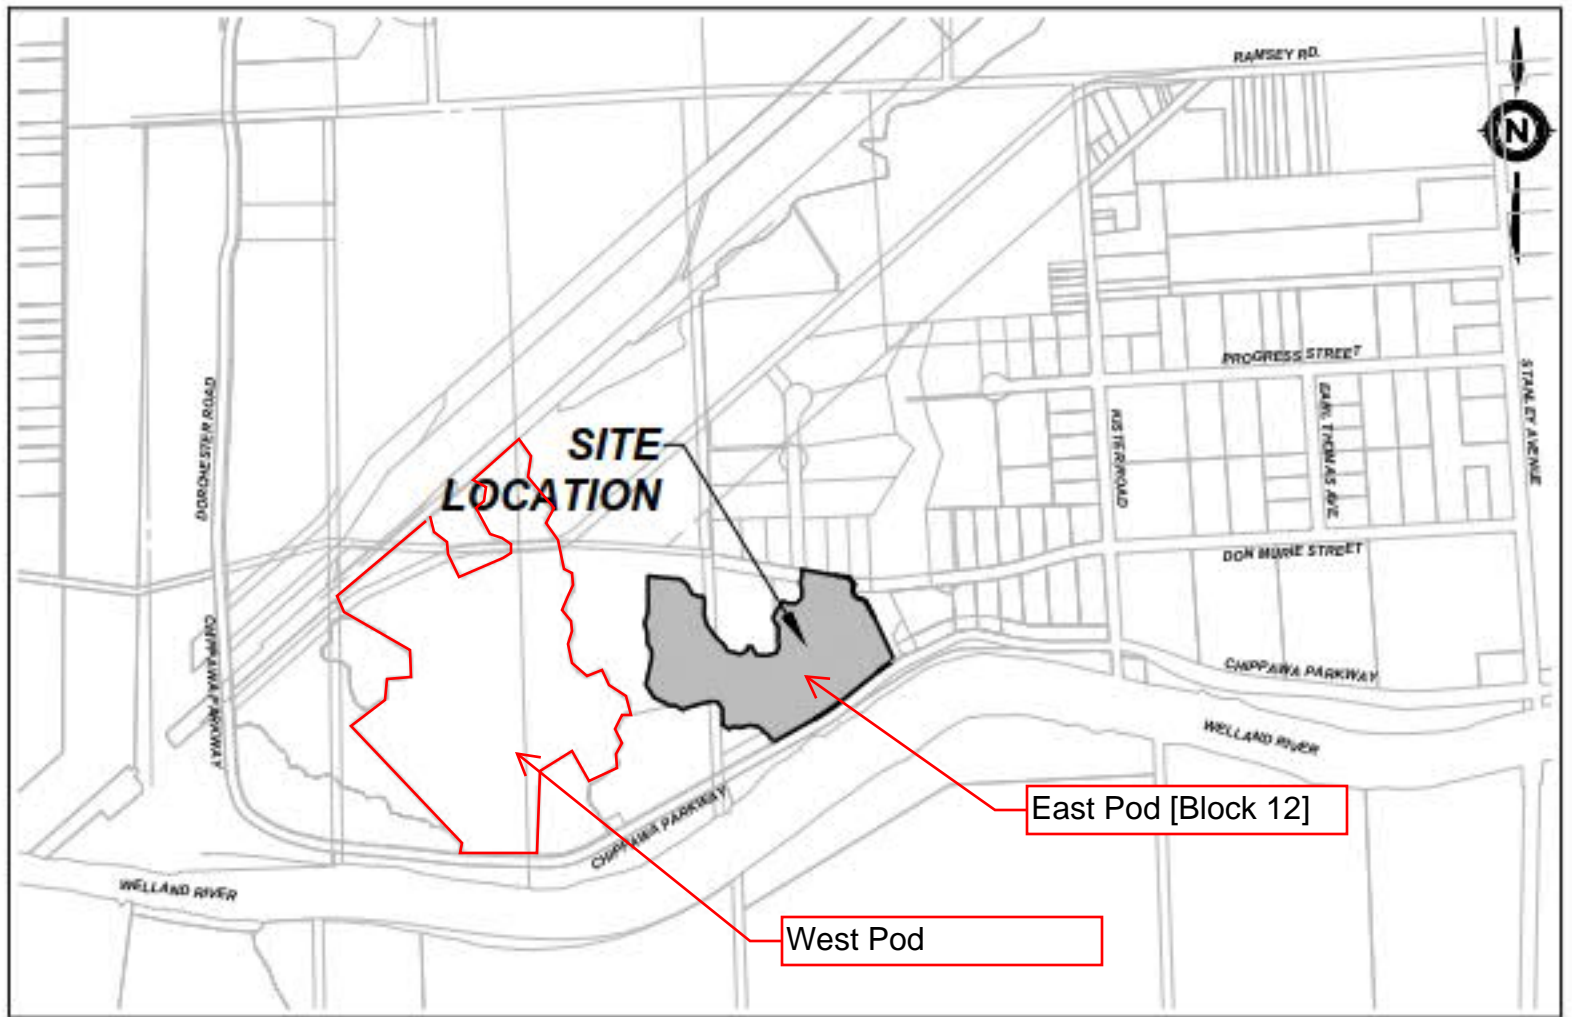
LOCATION PLAN (1:10000)

- Supplemental sampling was conducted in the area of BH103 and BH429, each located within the East Pod [Block 12], which is the present area of development. This confirmed the previously reported elevated levels of Thallium and Antimony were in fact isolated results, and not considered to be representative.
- It is anticipated that the same situation is the case at BH101, which is located in the northwest corner of the west pod, with the minor elevated Thallium value being isolated and non-representative. However, as this was not part of the development plans at the time further assessment was not yet conducted.

- As the filing of a Record of Site Condition is not required, given there is no change in land use to a more sensitive case, there is no specific requirement to remove the impacted soil. As such, there is not an immediate action required regarding the Thallium exceedance at BH 101. As the borehole is located north west of the proposed development plan at this time it is unlikely that any impacted soils, if in fact present, will be exported from site as excess soils. At such time when this would become necessary additional testing to confirm and delineate the exceedance would be conducted.

BH101 - isolated location of elevated Thallium, reported by others. Future assessment warranted if excess material to be removed from the site.

BH429 - isolated location of elevated Antimony, reported by others. Supplemental testing done prior to earthworks demonstrated as non-representative. No further concern.

BH103 - isolated location of elevated Thallium, reported by others. Supplemental testing done prior to earthworks demonstrated as non-representative. No further concern.
