**PHASE TWO CONCEPTUAL SITE MODEL**  
**4078 VICTORIA AVENUE, NIAGARA FALLS, ON**

**Project Location:**  
4078 Victoria Avenue  
Niagara Falls, ON

**Prepared For:**  
Build Up Victoria Inc.

**NSSL File No.:** NS2241-04

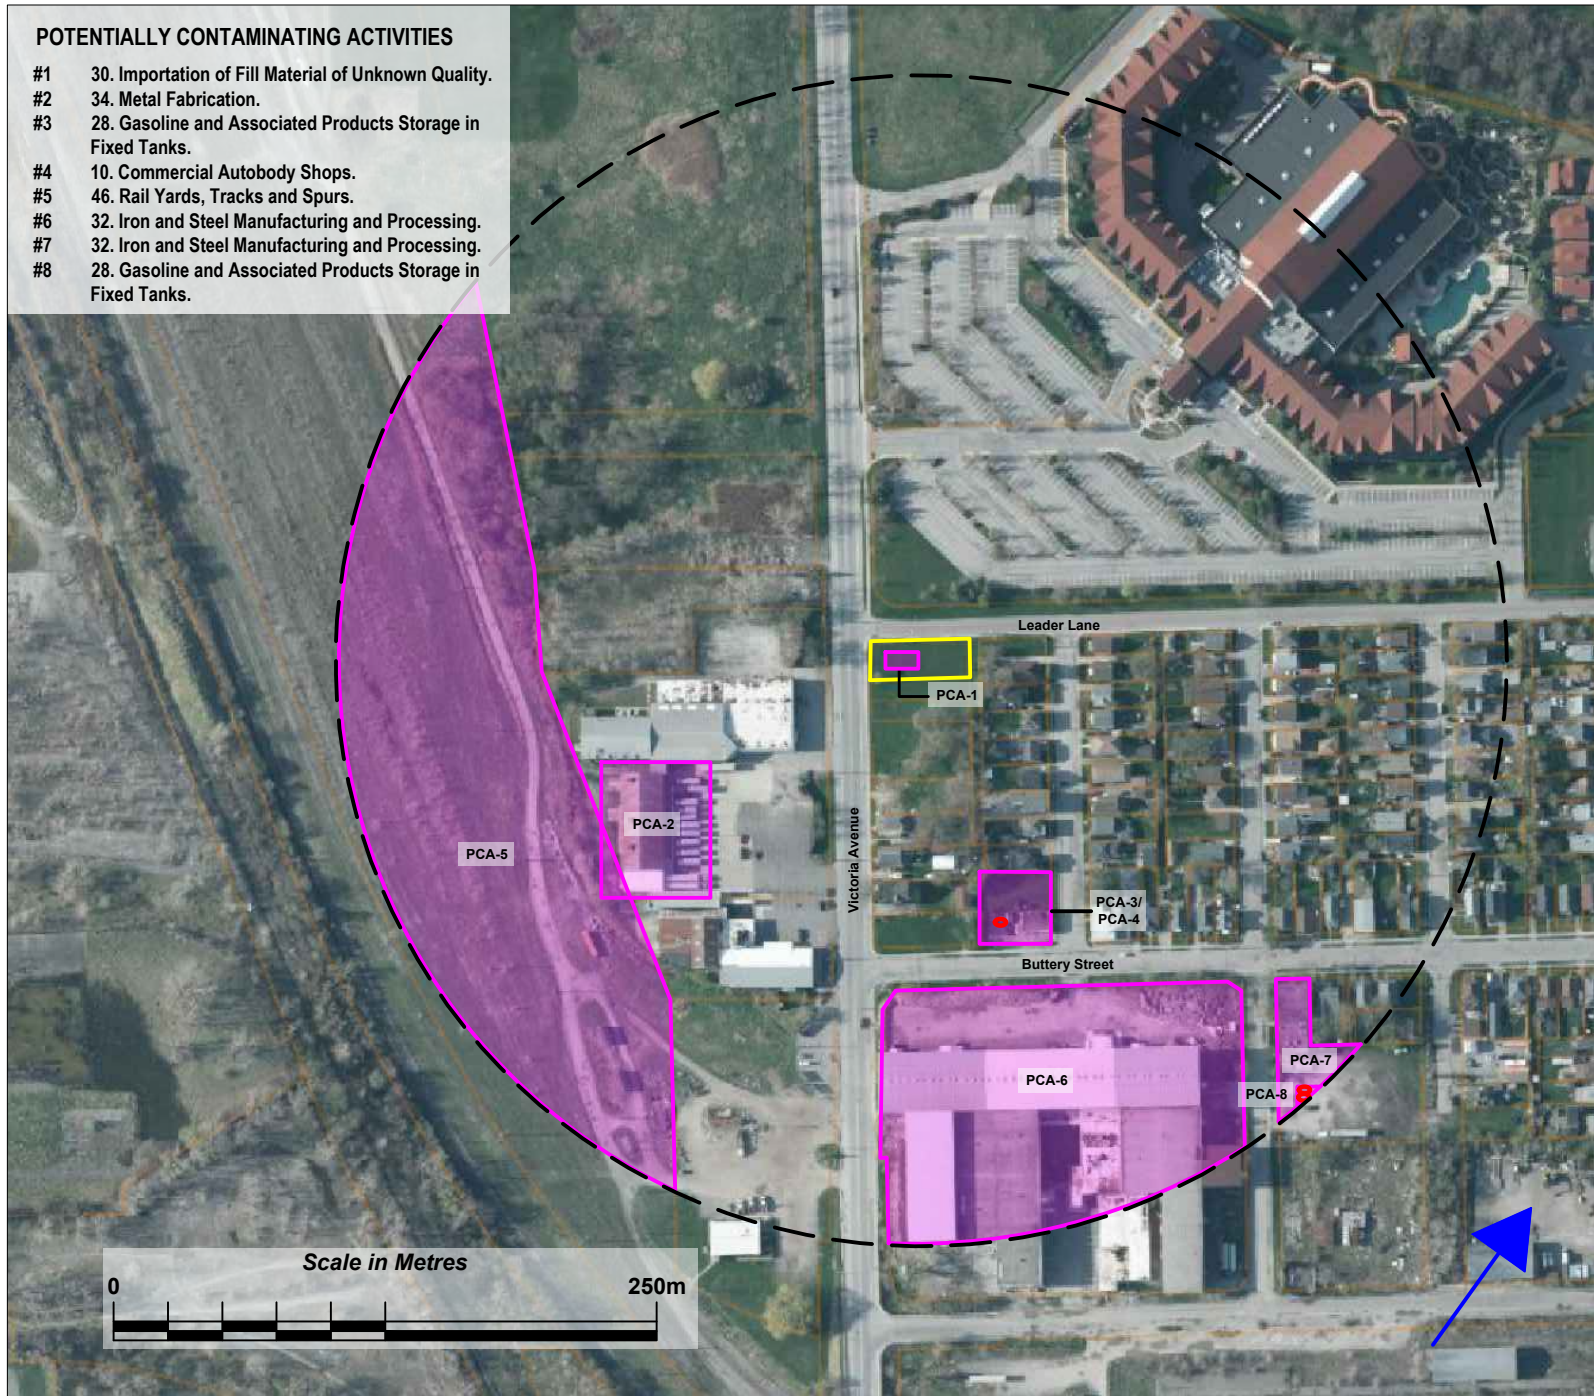
NO: **Figure 2A**

The Phase One ESA identified a total of eight [8] Potentially Contaminating Activities within the Phase One Study Area [see Figure 2A], as according to Ontario Regulation 153/04 [as amended] PCA list including:

The distances between the off-site PCAs to the Phase Two ESA study site, along with consideration for downgradient or cross [trans] gradient locations relative to the inferred groundwater flow direction resulted in one [1] on-site Area of Potential Environmental Concern to the study site's soil as described further below [see Figure 2B].

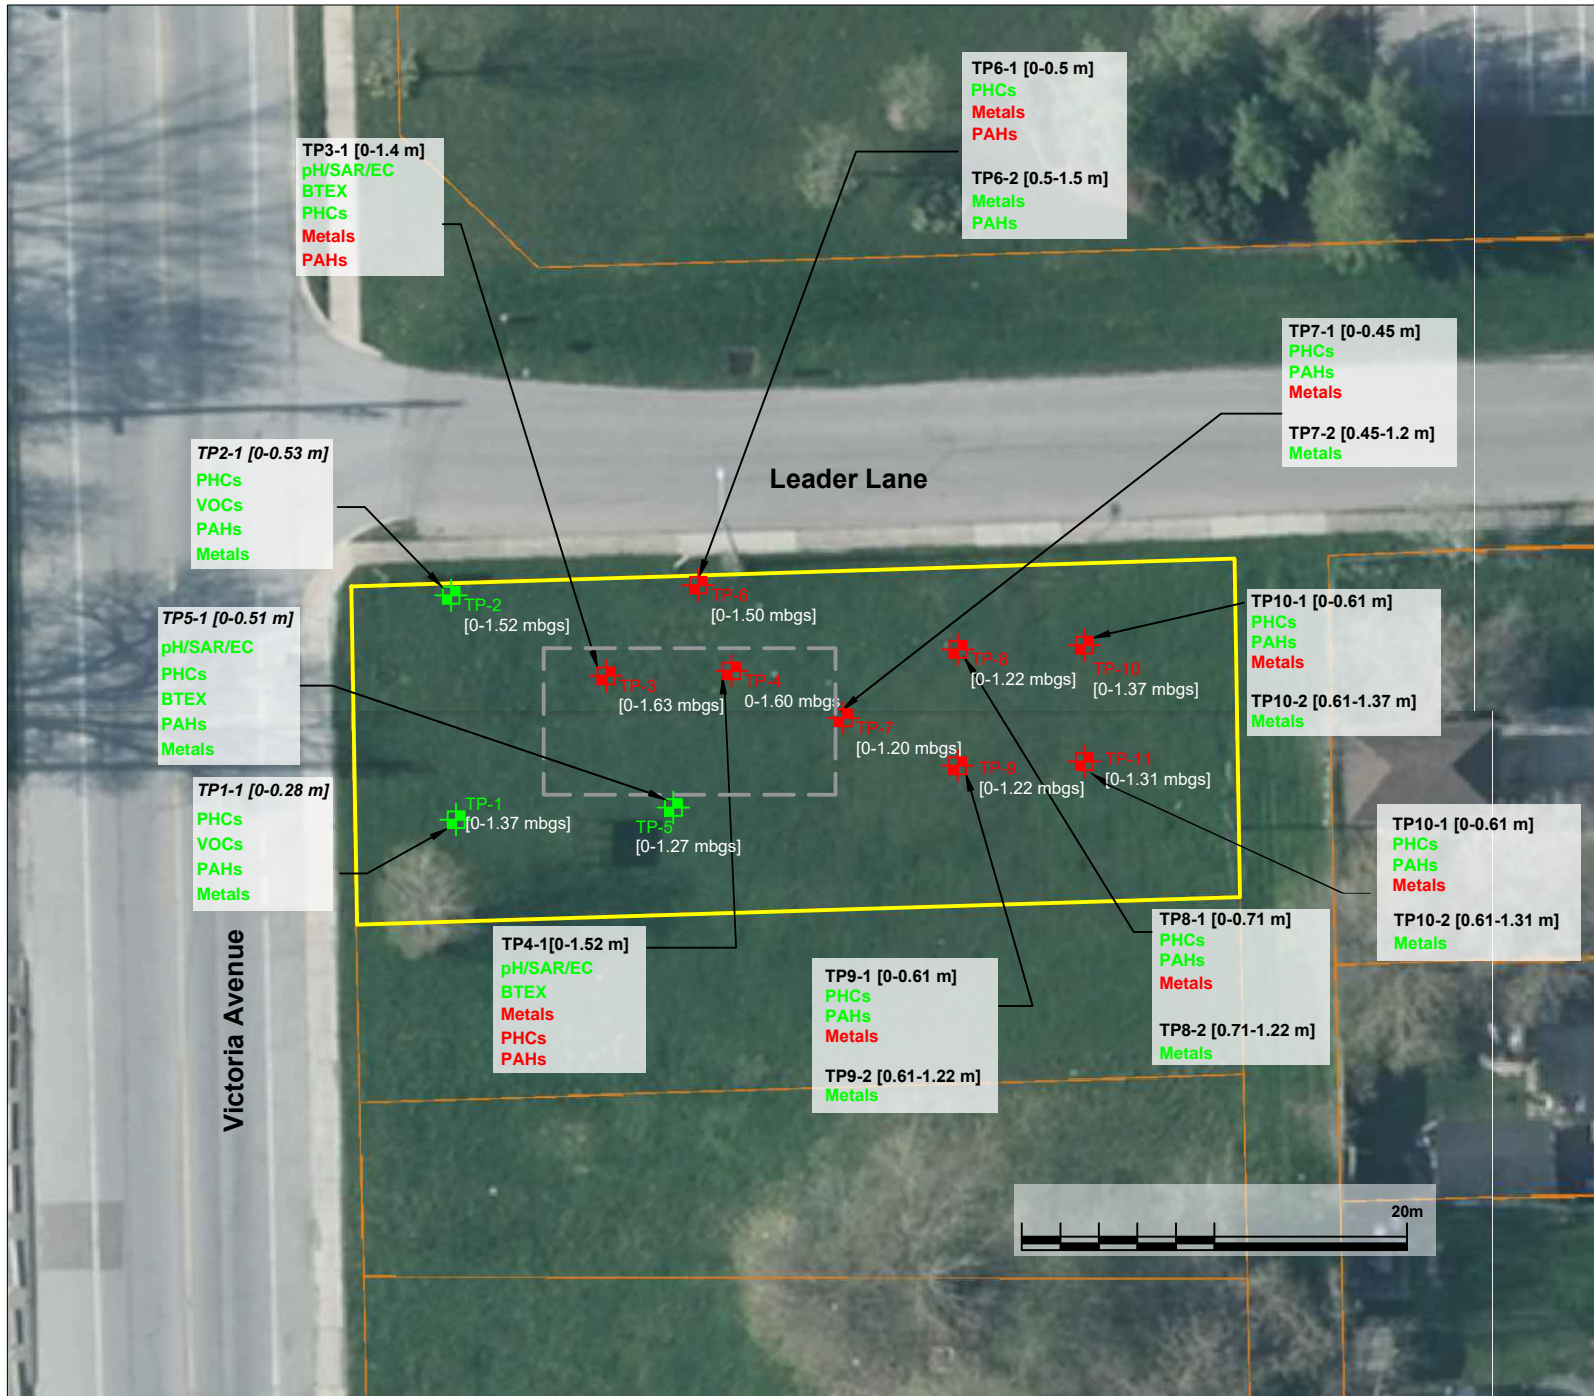
NO:  
**Figure 4**

The Metals exceedances were identified at test pit locations TP-3 and TP-4, and TP-6 to TP-11 at depths ranging between 0 to 1.52 metres below ground surface [m bgs]. These impacts were attributed to poor quality fill material that was likely deposited on-site post building demolition and distributed across the property during site re-grading.

As with the Metals exceedances described above, the PAH and PHC impacts were attributed to poor quality fill material placed on-site following removal of the original residential dwelling. No other potential off-site or on-site likely sources were identified during the Phase Two ESA and remedial investigations.

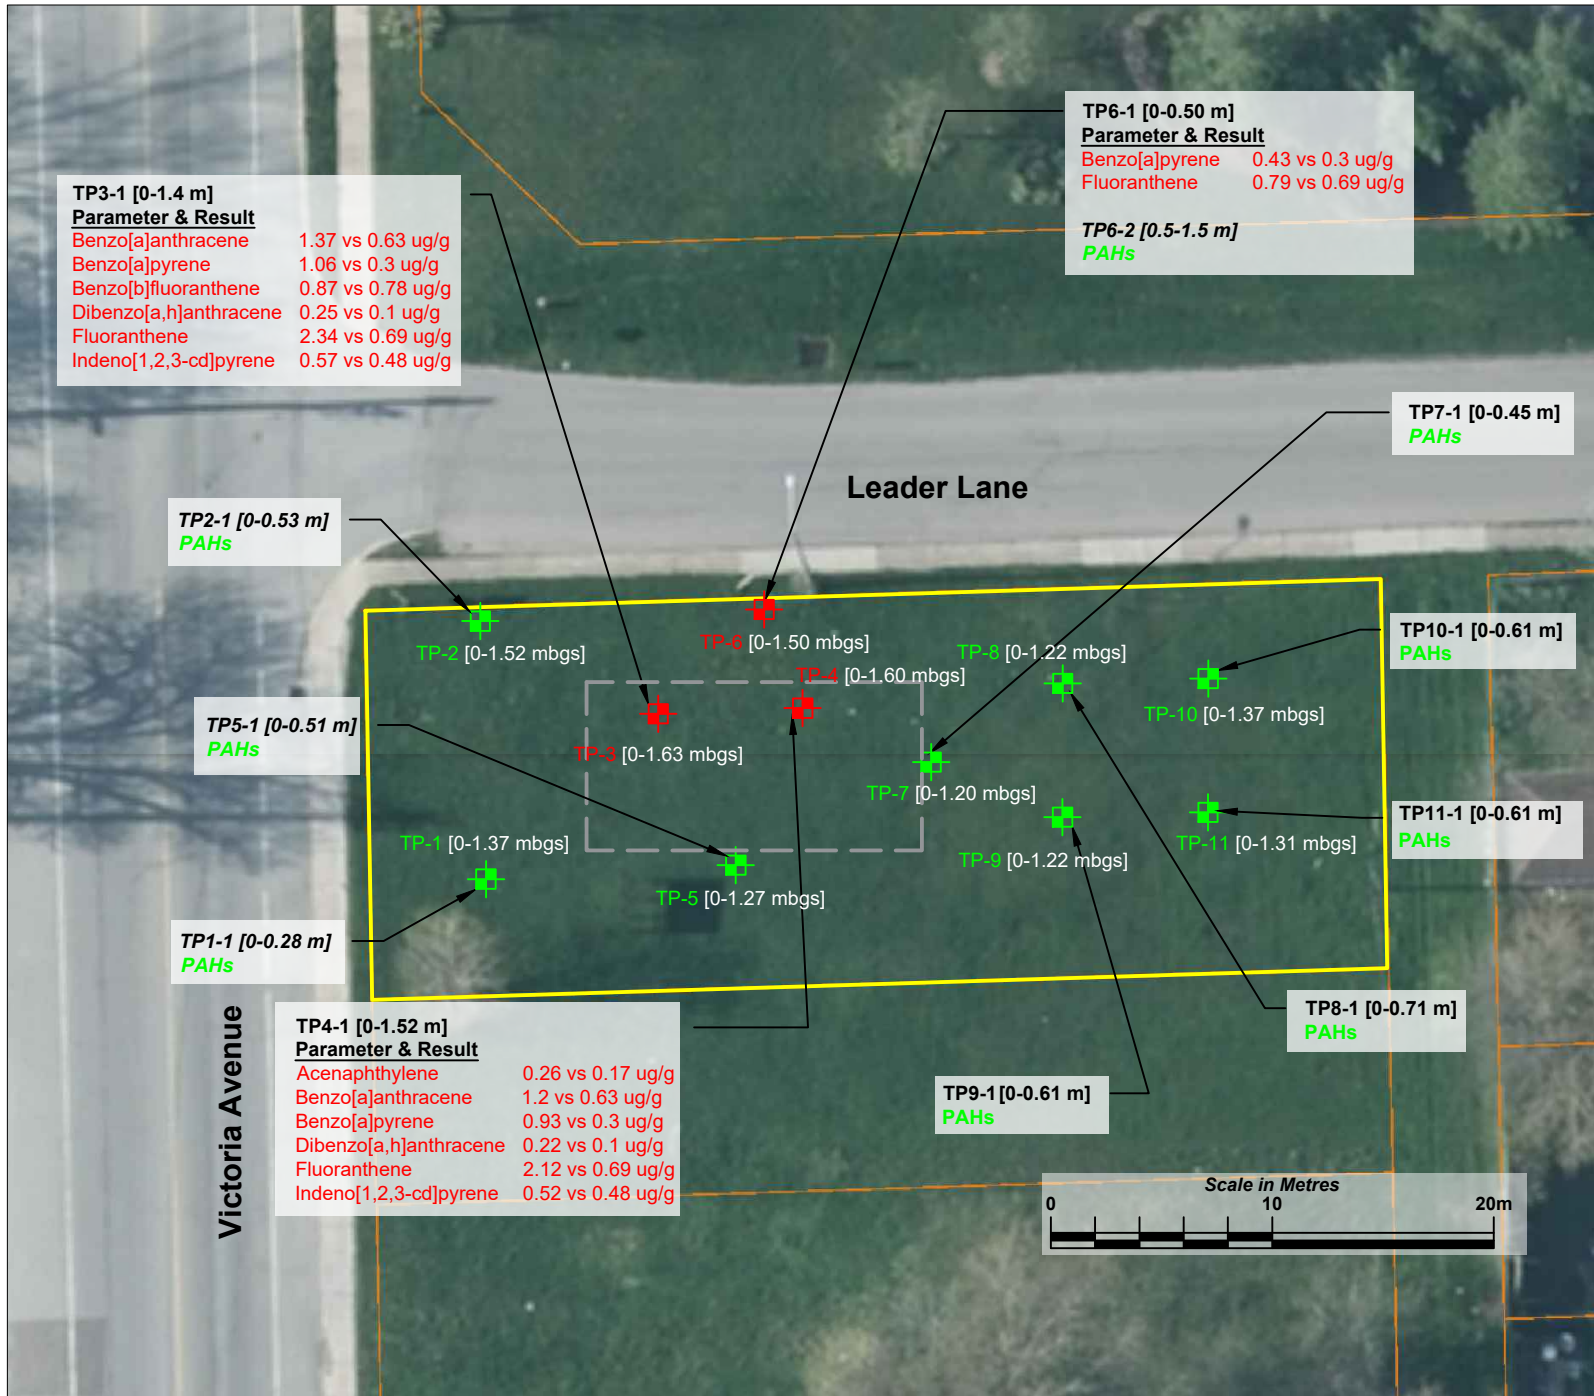
NO:  
**Figure 4B**

Test pits TP-3, TP-4 and TP-6 exhibited elevated results for PAHs from 0 to 1.52 m bgs. TP-3 and TP-4 were located within the former residential building footprint, and TP-6 was located north of the building along the northern property boundary.

**TP3-1 [0-1.4 m]**  
**Parameter & Result**

Benzo[a]anthracene	1.37 vs 0.63 ug/g
Benzo[a]pyrene	1.06 vs 0.3 ug/g
Benzo[b]fluoranthene	0.87 vs 0.78 ug/g
Dibenzo[a,h]anthracene	0.25 vs 0.1 ug/g
Fluoranthene	2.34 vs 0.69 ug/g
Indeno[1,2,3-cd]pyrene	0.57 vs 0.48 ug/g

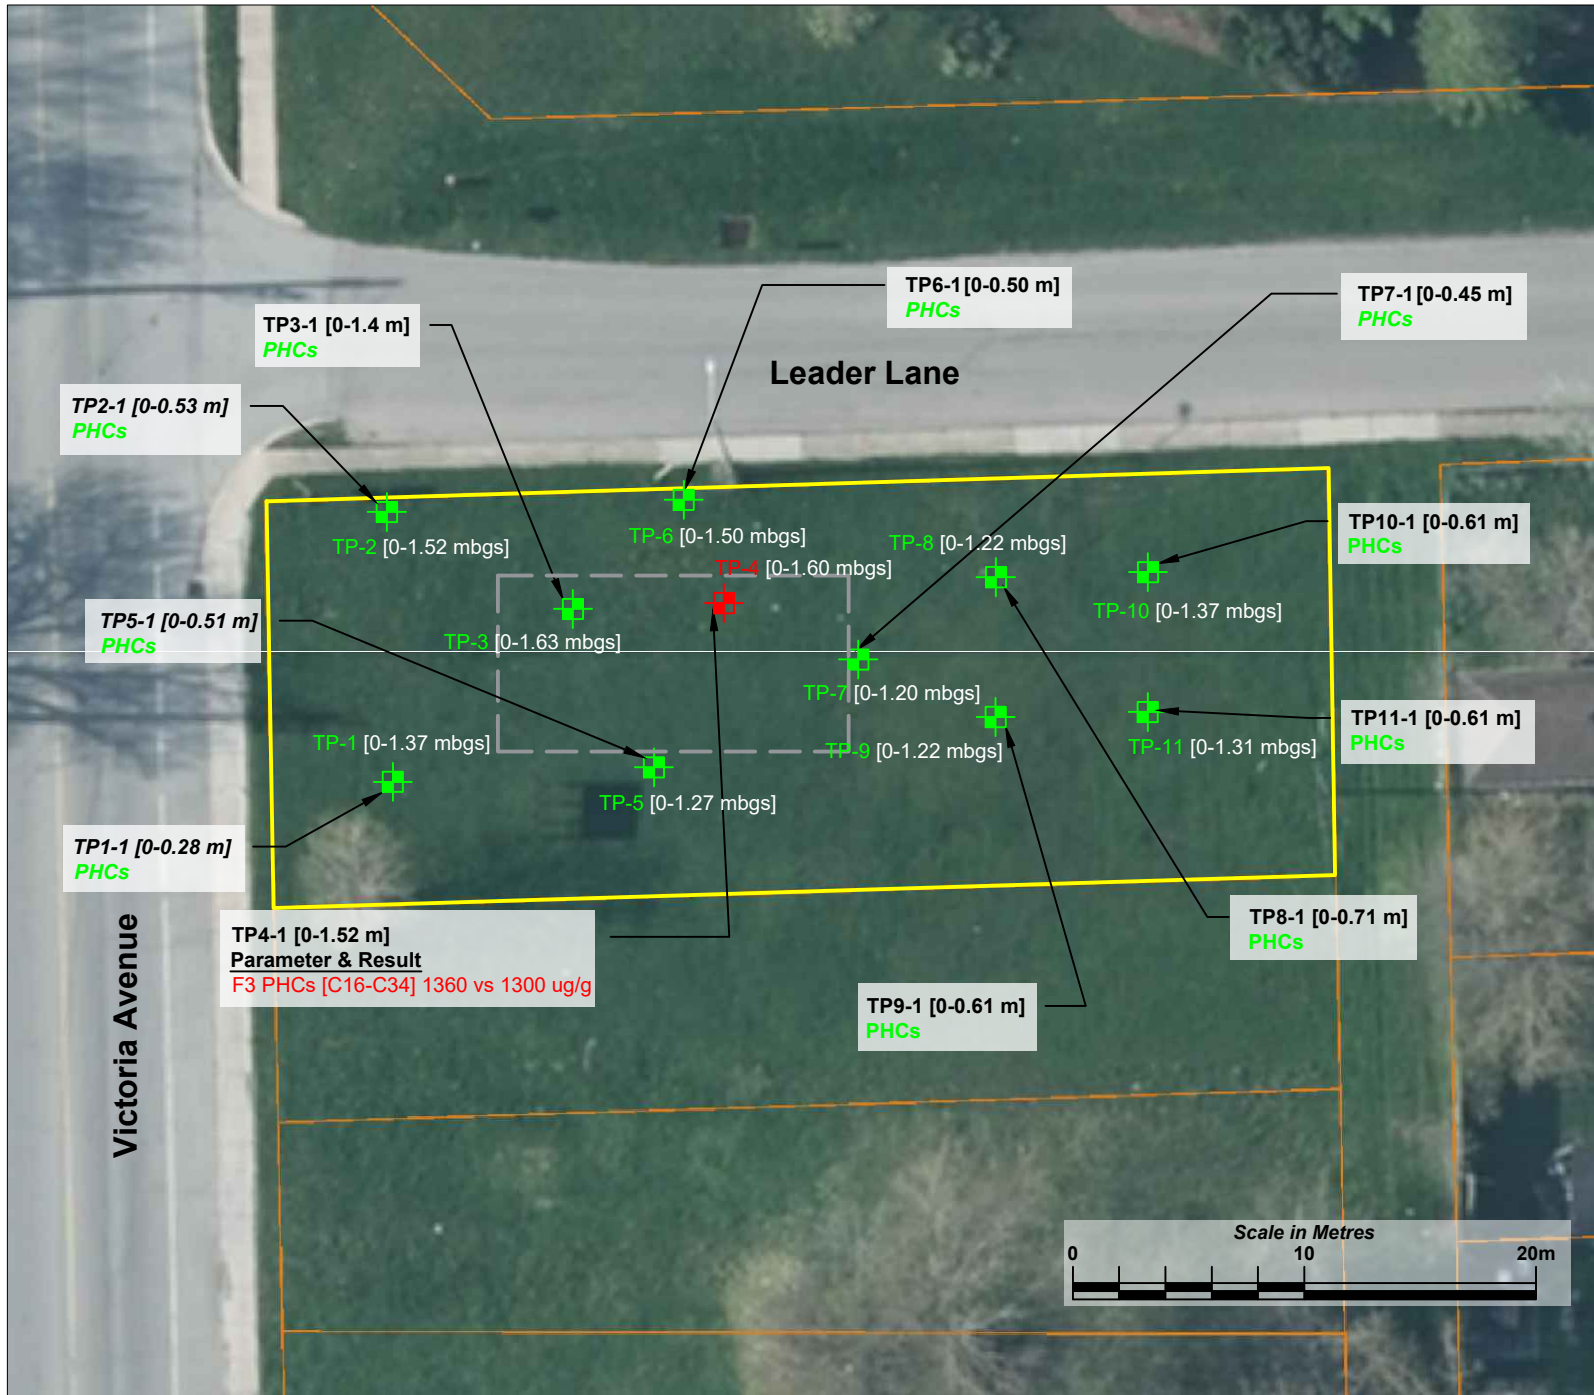
NO:  
**Figure 4C**

One soil test result exceeded applicable Table 2 criteria for PHCs [F3] at sample location TP-4 with 1360 ug/g vs 1300 ug/g. The PHC-impacted soil was identified between 0.1 to 1.52 m bgs, located within the footprint of the historic residential dwelling.

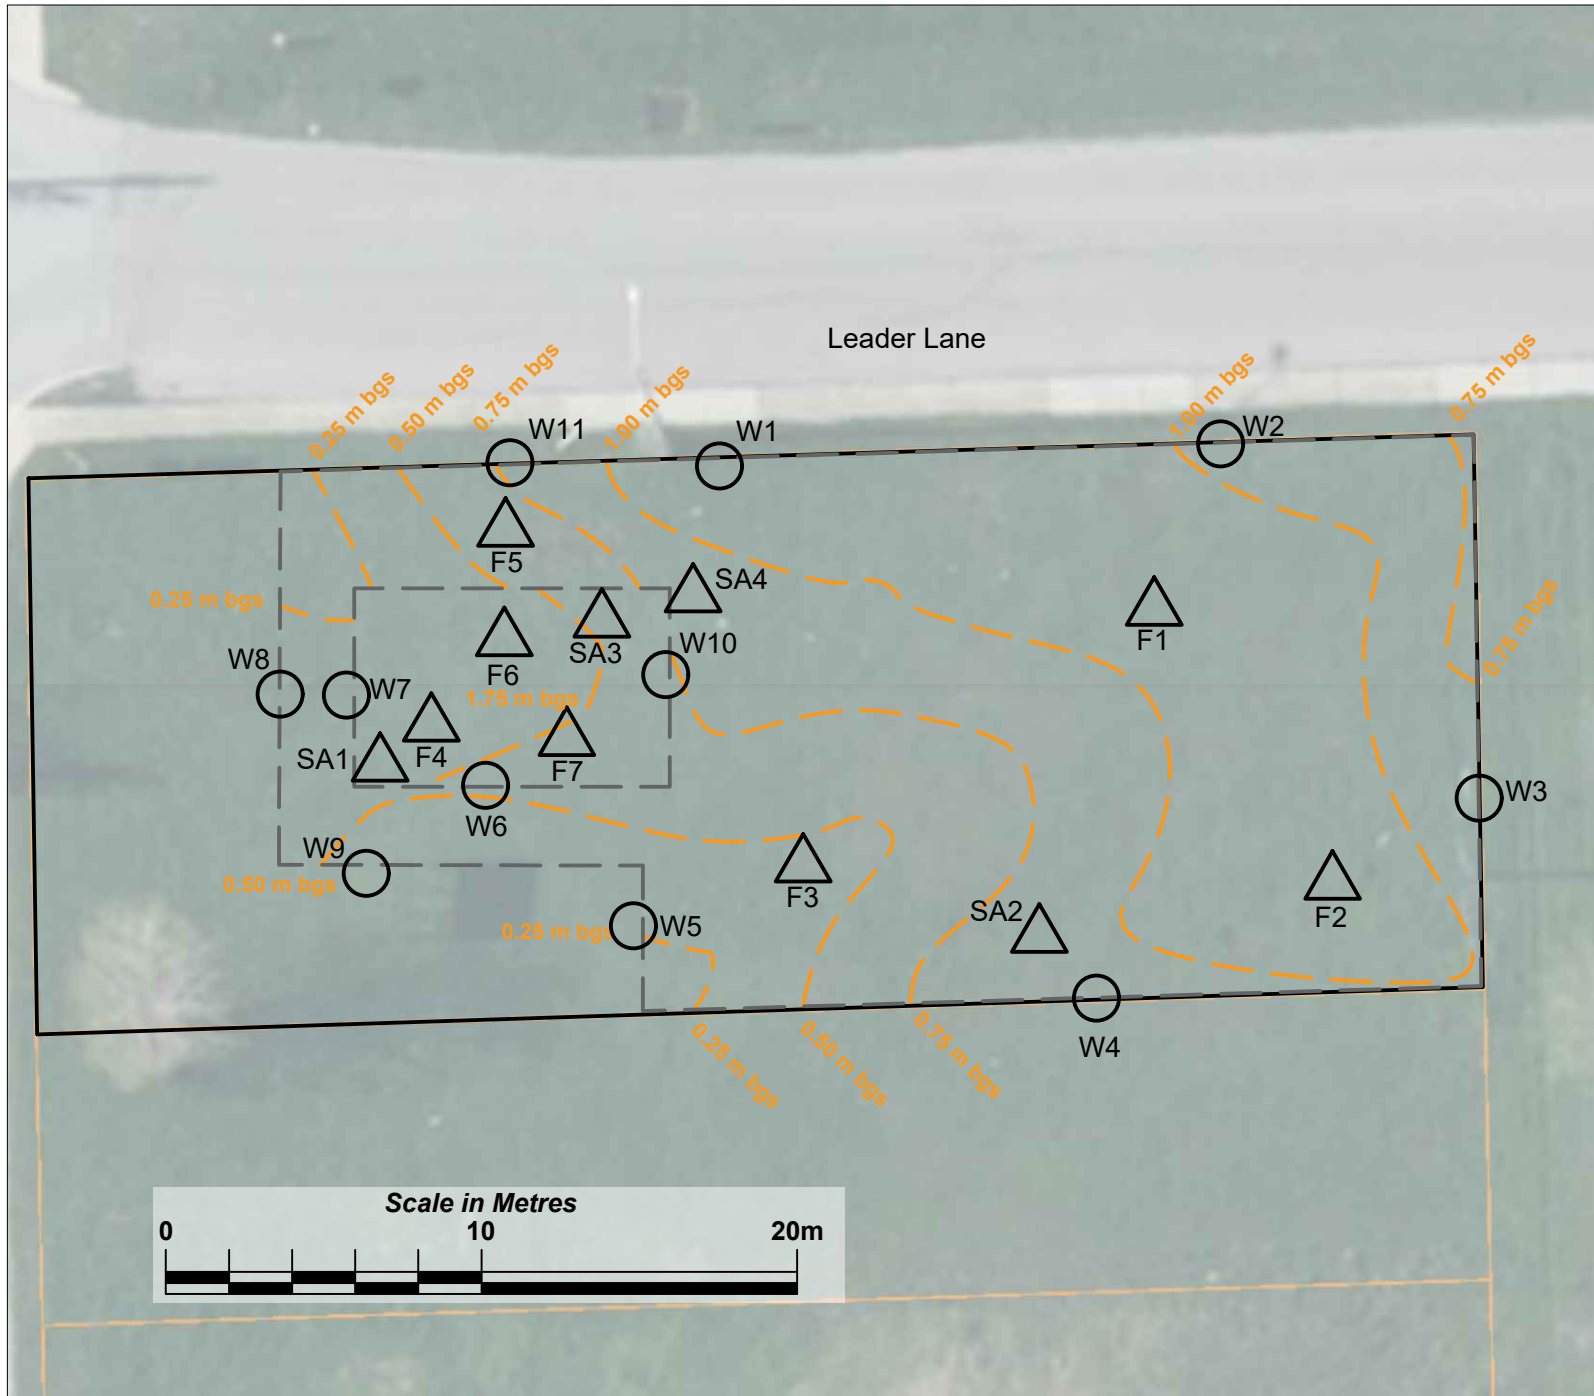
NO:  
**Figure 8B**

The test sample results were compared against Table 2 Residential criteria, fine soil texture. All test results met the applicable criteria except for sample W-3, located at the eastern limits of the Phase Two ESA property boundary. Although W-3 did not meet Table 2 Standards, contaminated soil was removed to the maximum extent on-site across the eastern property boundary [to the eastern property line]. See Figures 8 and 8a to 8c for Verification Results. Cross-sectional figures depicting the extent of the excavation and soil sample locations at the Phase Two Property following remediation are provided on Figures 9a to 9h.
