Re: Arborist Report and Tree Protection Plan – 6546 Fallsview Blvd (Parking) – Niagara Falls

Arborist Report
&
Tree Protection Plan

6546 Fallsview Blvd
(Parking)
Niagara Falls, ON

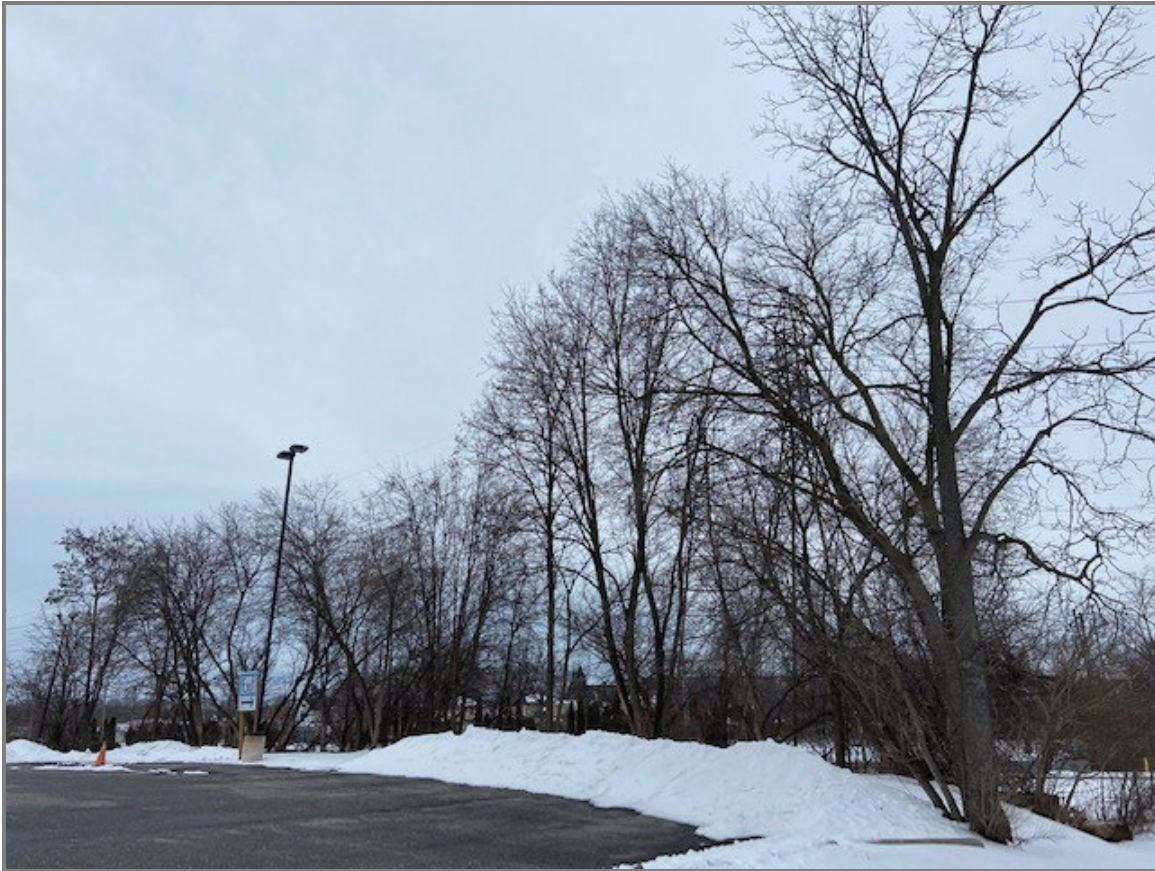
Photo #1: Trees no. 130-142, C1-C2 and trees less than 10cm DBH looking south.

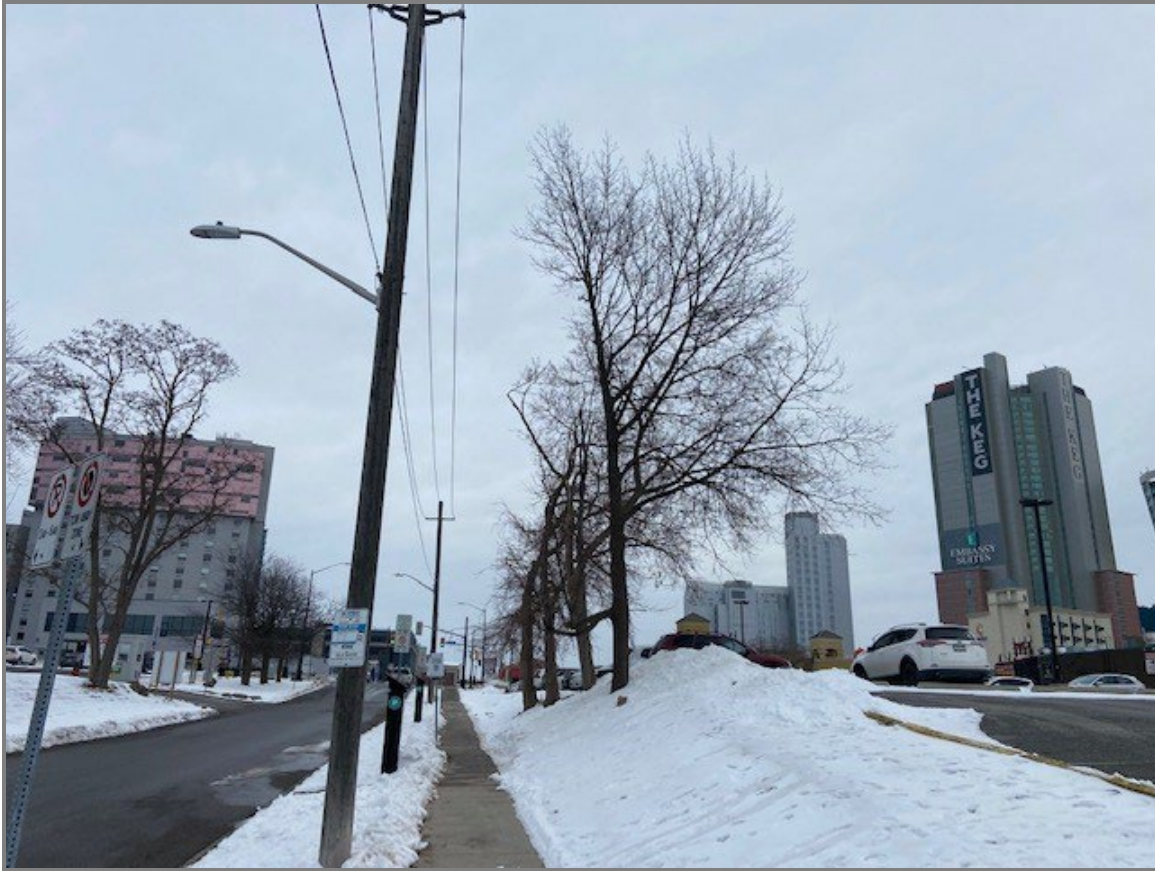
1. As listed above, there are fifty-four trees greater than 10cm DBH involved with this project, seven of which are located within the City road allowance, being trees no. C1-C7. All seven City owned trees are in conflict with the proposed grading/landscaping and are to be removed. Authorization from the City is required prior to the removal of these seven trees.

Photo #2: Trees no. C3-C7 looking east.
