**2430 ST. PAUL AVENUE, NIAGARA FALLS, ON  
TREE SURVEY, ANALYSIS AND PRESERVATION REPORT**

ST. PAUL AVENUE, NIAGARA FALLS, ON  
REGIONAL MUNICIPALITY OF NIAGARA

OUR FILE: LA 797-23

DECMEBER 2023

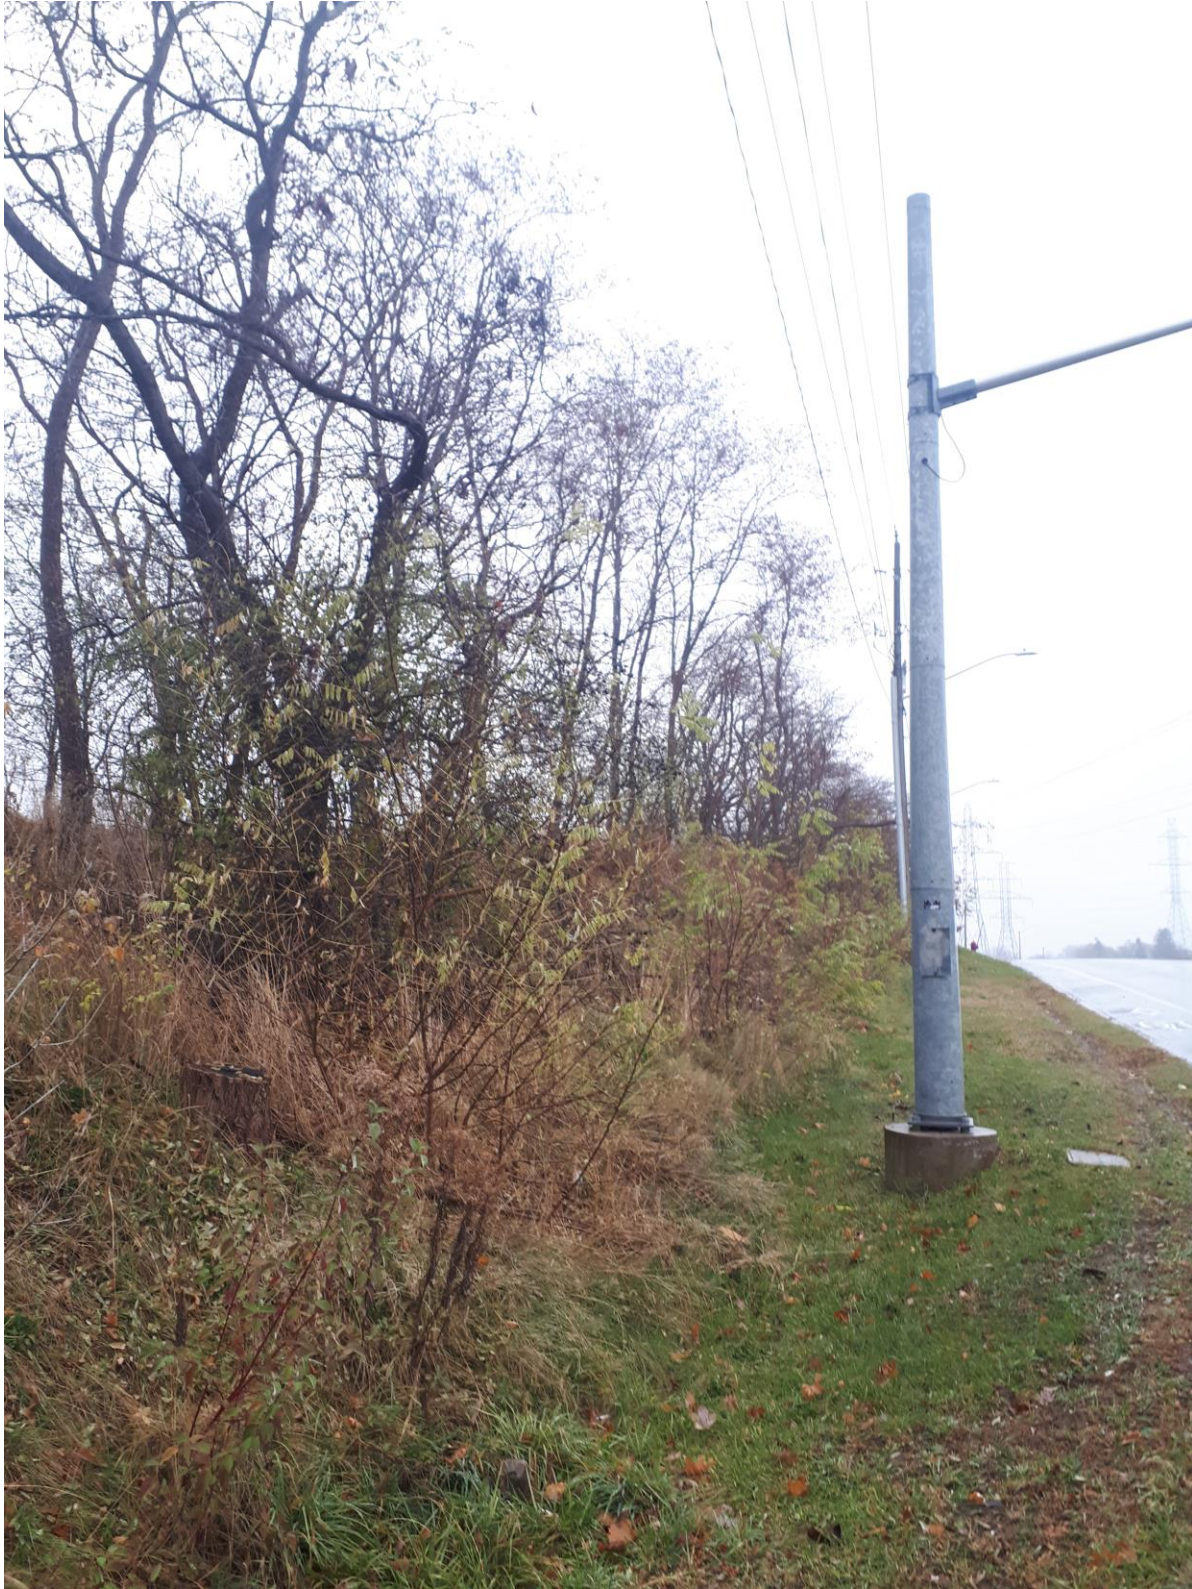
**Photo A:** Black locust trees located in the south Right of Way allowance for retention. Photo looking east on Mountain Road. Existing honey locust trees removed by power authority.

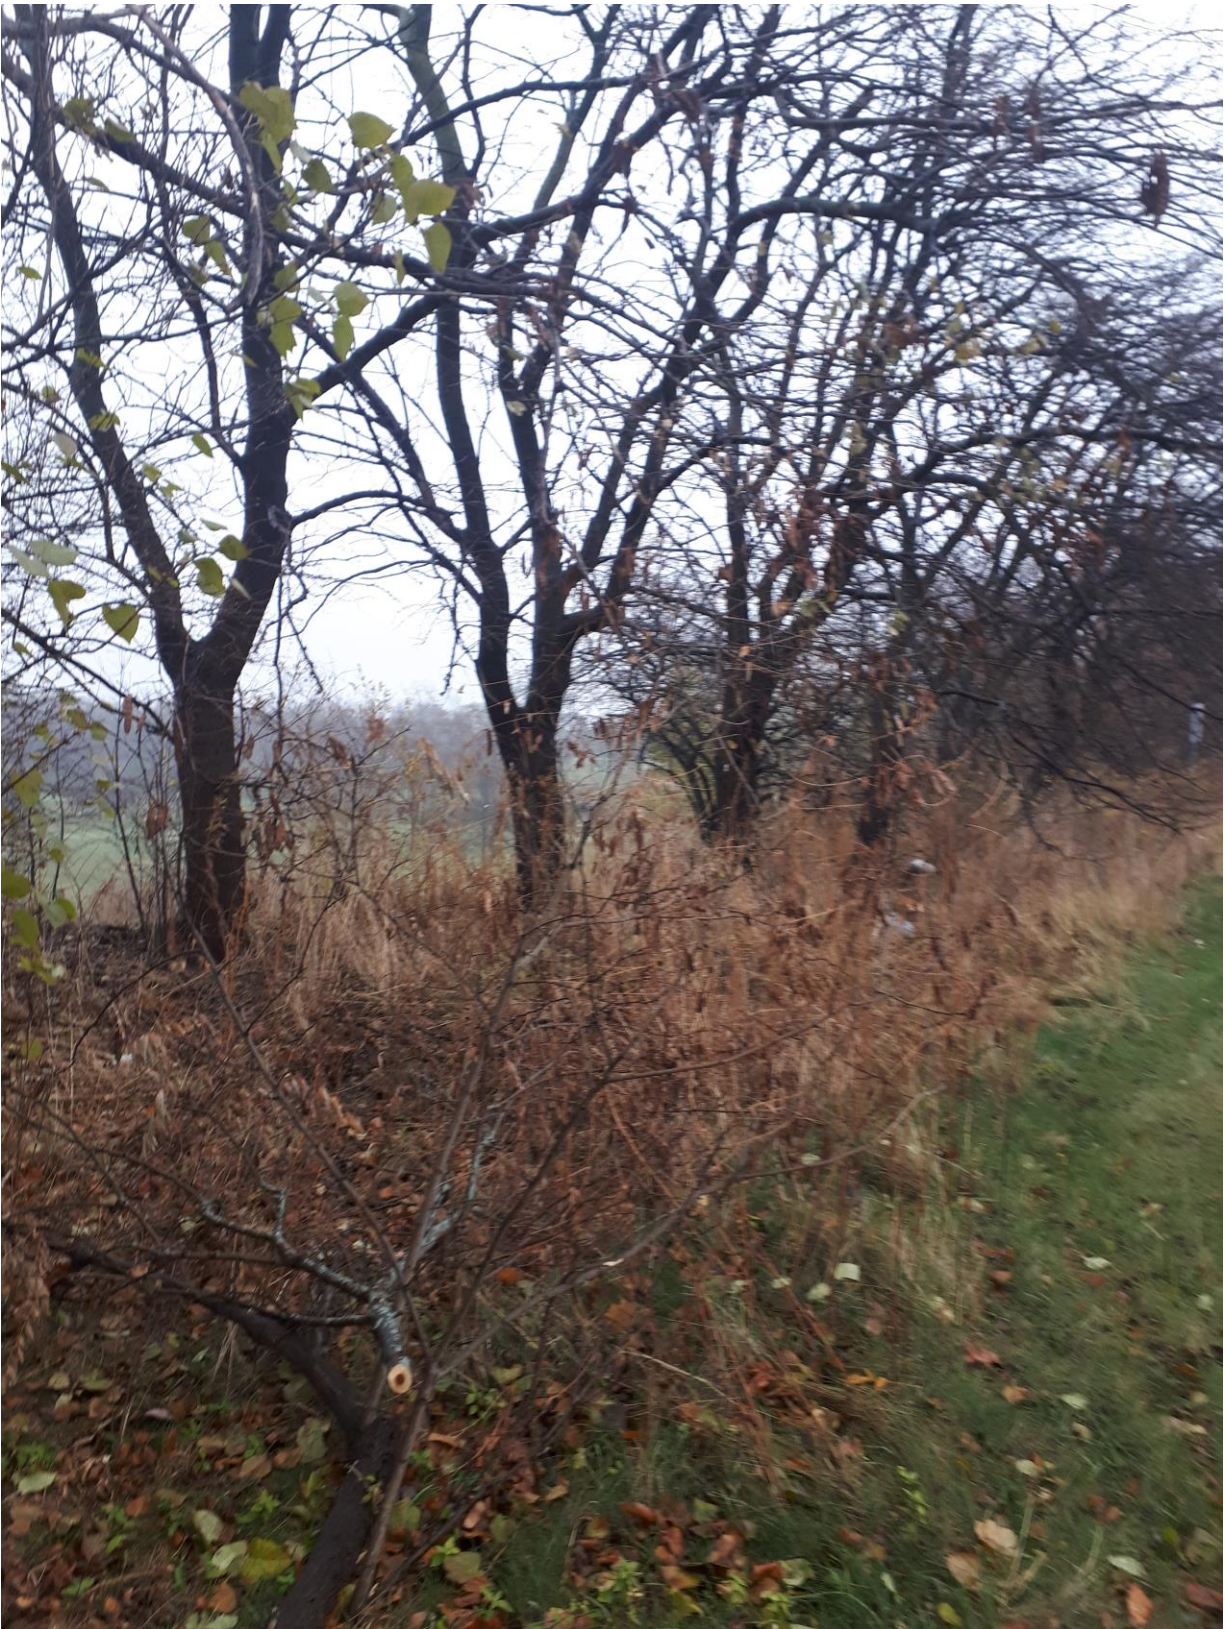
The White Mulberry (*Morus alba*) (Tree no. 51-52, 54-60, 62, 64-65, 78) trees are primarily located within the south property line Right-of-Way allowance of the site and presented a range of stress indicators, including poor trunk form, visible decay, epicormic branching, branch dieback, multiple leaders, and the presence of riverbank grapevine (**Photo B, Appendix D**). Many of the White Mulberries along the south property line have been undercut meaning their roots have been excavated underneath to accommodate the proposed works on the subject site.

**Photo B:** Photo of White Mulberry Trees along the south property line of the subject site. Photo taken looking north.

2. That Tree Nos. 8-16, 21-29, 45, 46, 51-60 located on the Niagara Region Right of Way Allowance and the subject site are in conflict with the proposed building envelopes and are in poor to fair health. These trees are recommended for removal as delineated in **TP-1 & TP-2 in Appendix B**. Trees located on the Right of Way allowance require the consent of the City of Niagara Falls in order to be removed.

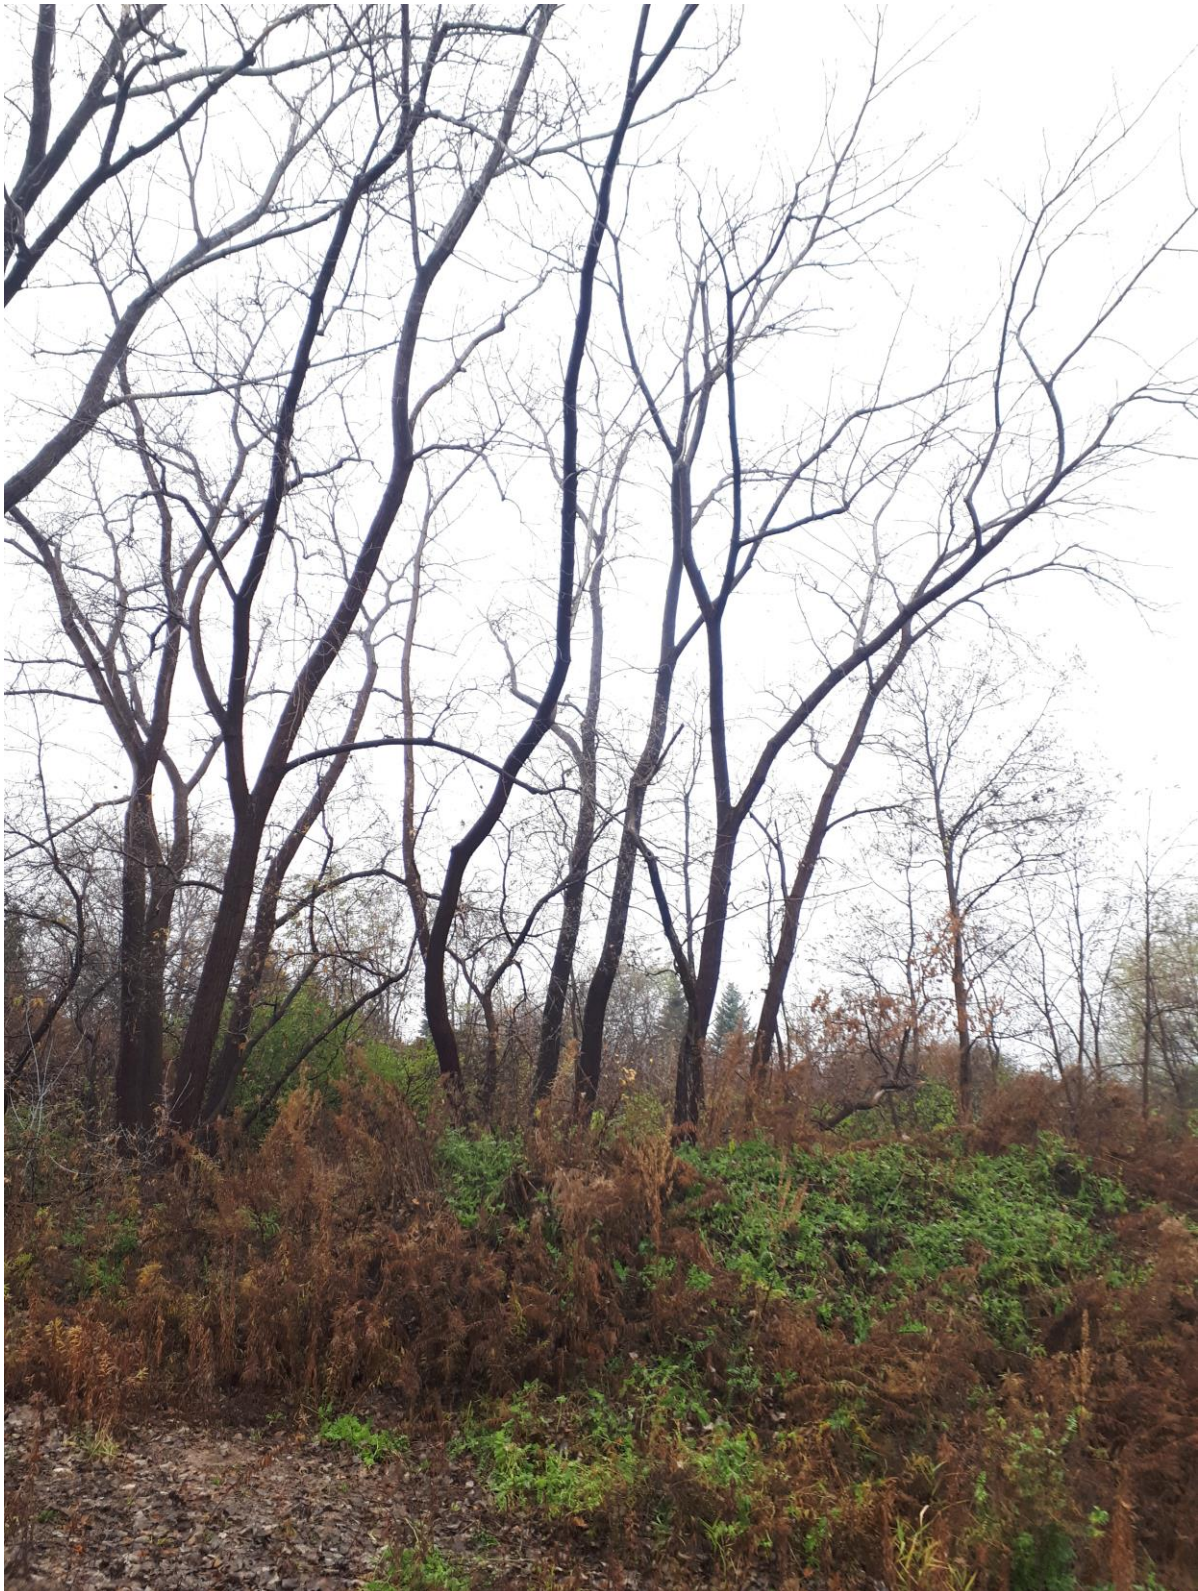
The Eastern Cottonwood (*Populus deltoides*) trees (Tree no. 11-21, 79) are located near the west property line and within the ROWA. This patch of Cottonwoods is of significant size and have large canopies however, their large size presents multiple health and structural concerns (**Photo C, Appendix D**). Observations include features such as broken leaders, visible decay in the canopies, poor trunk form, excessive leans, epicormic branching, and branch dieback.

**Photo C:** Photo of large canopied Eastern Cottonwood along the western property line and Right of Way Allowance. Photo taken looking west
