November 18, 2013

RE: Honey Locust Tree Assessment – Eagle Valley Golf Club

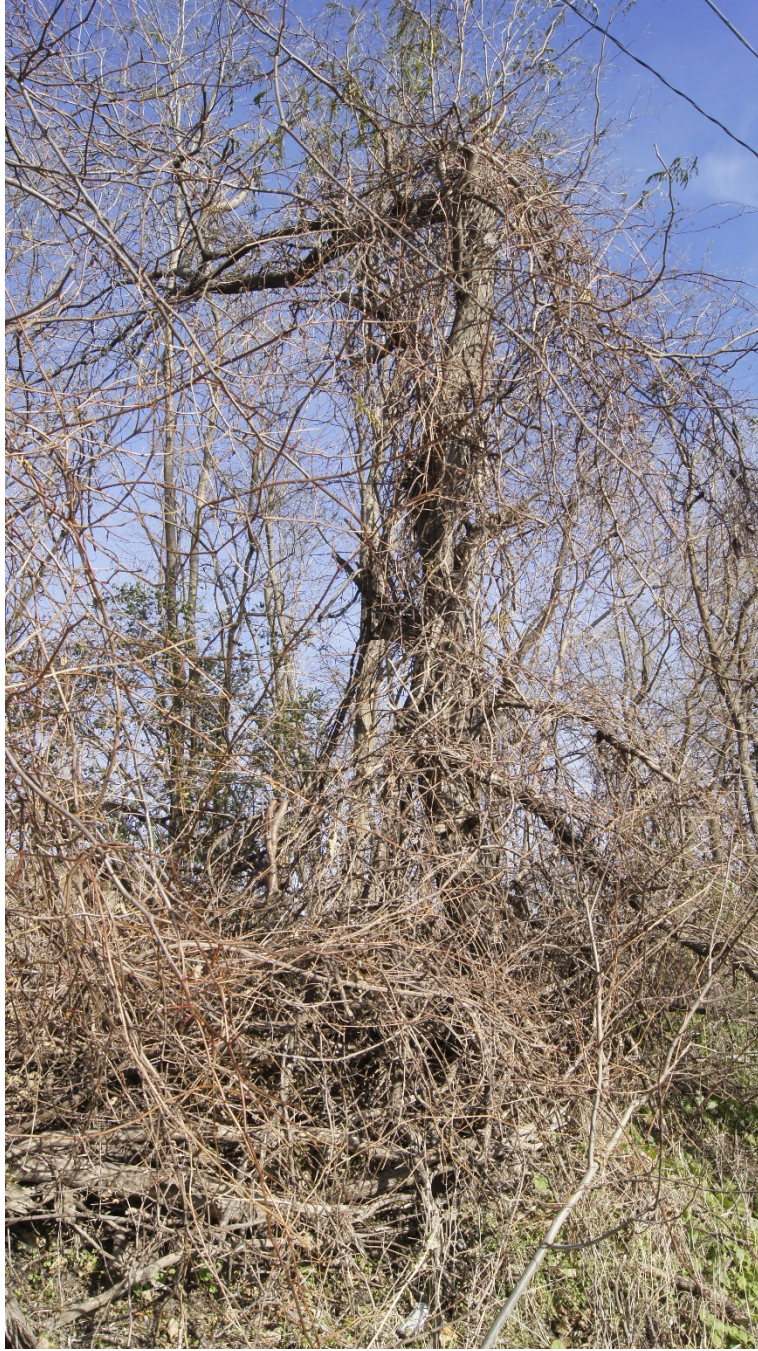
Tree #1.

Tree # 1 is located adjacent to Mountain Road, in close proximity to the planned Mountain Road entrance to the Subject Property (see Appendix A). Based on our assessment, this tree appears to have experienced significant pruning to minimize interference with hydro wires, a practice which appears to have negatively affected tree health. From our assessment, Tree #1 appears to be in poor condition.

Since pruning appears to have limited the extent of the tree crown, we estimated that the tree roots extend beyond the drip-line of this tree, likely to approximately 5m from the trunk. Assuming tree roots extend approximately 5m from the base, it is our opinion that the majority of tree roots will not be significantly impacted by the construction of the driveway entrance or grading works, and provided the

mitigation measures recommended below are implemented during construction, tree health should not be impacted by the proposed development.

As indicated above, it is our opinion that the proposed project will not have a significant impact on any of the Honey Locust trees, however minor impacts to Trees 1 and 5-7 are possible. In order to minimize any impacts to these trees, or other trees to be retained in close proximity of the work area, it is our recommendation that the following mitigation measures be implemented prior to and during construction to protect the health of trees.

- A limit of work fence should be installed where possible no less than 1m from the drip-line of remaining trees to minimize root compaction and injury;
- Grading and placing of fill should be avoided within the drip-line of any trees to remain on site. Any fill to be placed within the drip-lines should be composed of sandy material to maintain gas exchange by the root system;
- In the event any lateral tree roots are encountered and damaged, the following tree root pruning procedures are recommended:
 - a. Make vertical cuts through the root zone to avoid impacting unnecessary roots

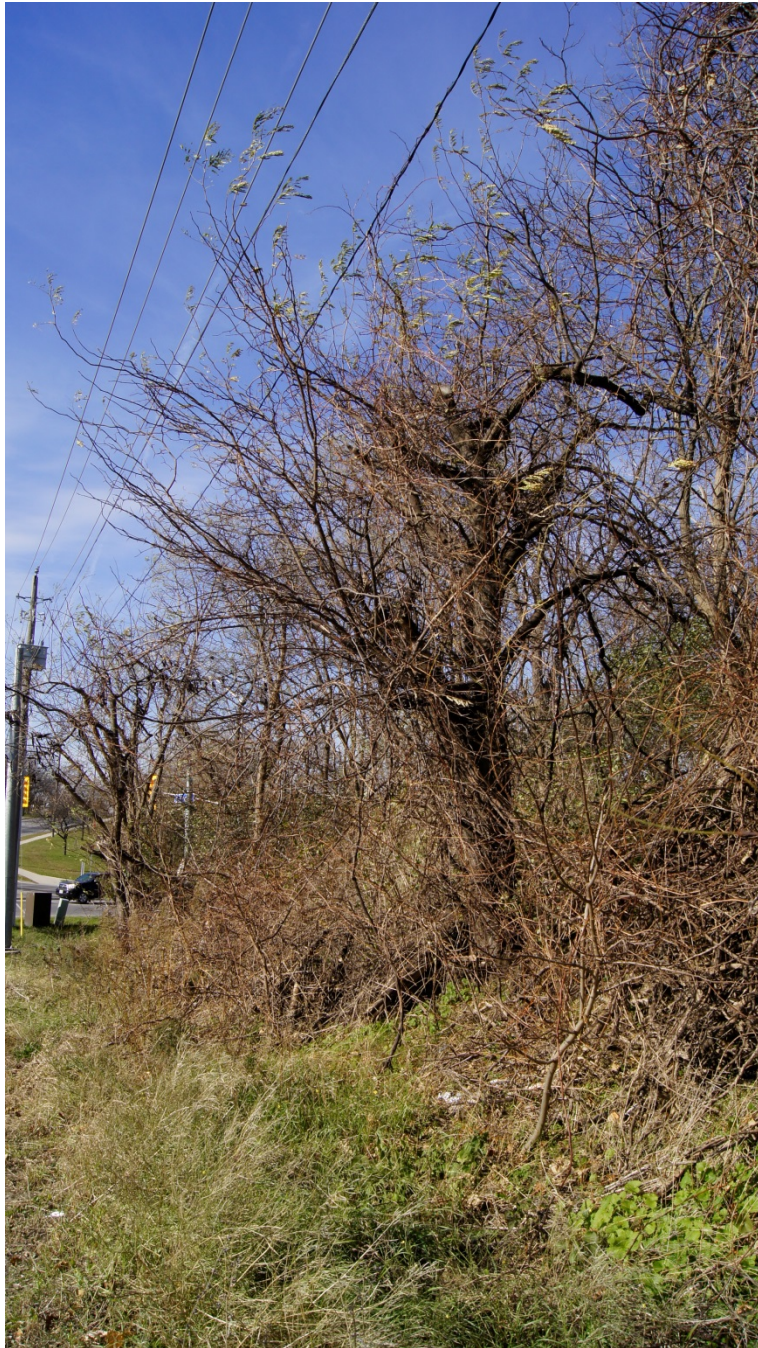
Similar to Tree #1, this tree is also located adjacent to Mountain Road and appears to have experienced significant pruning by hydro crews. Based on our assessment, Tree #2 appears to be in poor condition. From our assessment, it appears that the roots of this tree are located outside any area proposed for construction or grading, and therefore it is our opinion that the proposed works will have no direct impact on the health of Tree #2.

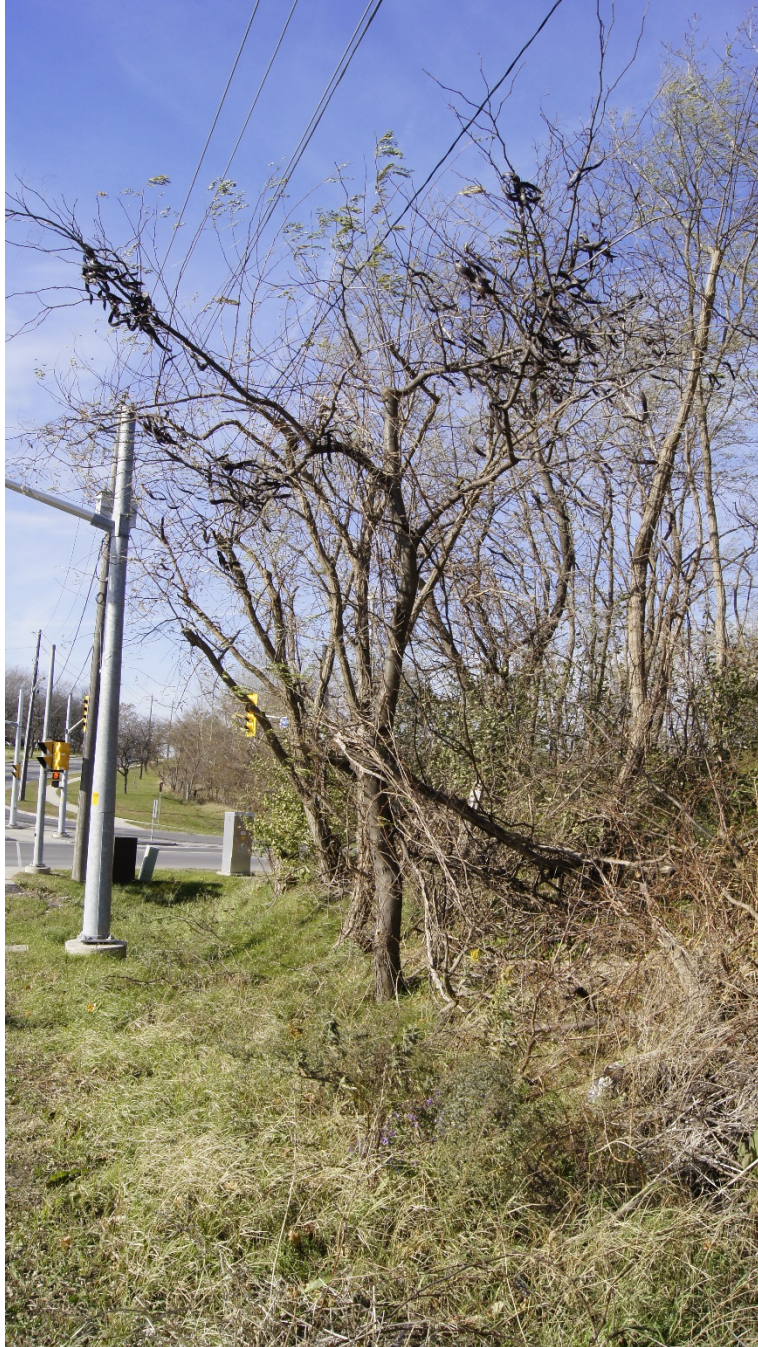
Tree numbers 3 and 4 are also located on Mountain Road, near the intersection of St. Paul Avenue. These are the smallest of the Honey Locust trees adjacent to Mountain Road. From our assessment, Tree #3 appears to be in poor condition, while tree #4 is in fair condition. Based on our estimates, the drip-line of these trees extend approximately 3m from the trunk, although it is assumed roots likely extend an additional 1-2m beyond the drip-line. Based on our assumption of the root extents, Trees 3 and 4 will not be impacted by the proposed development.

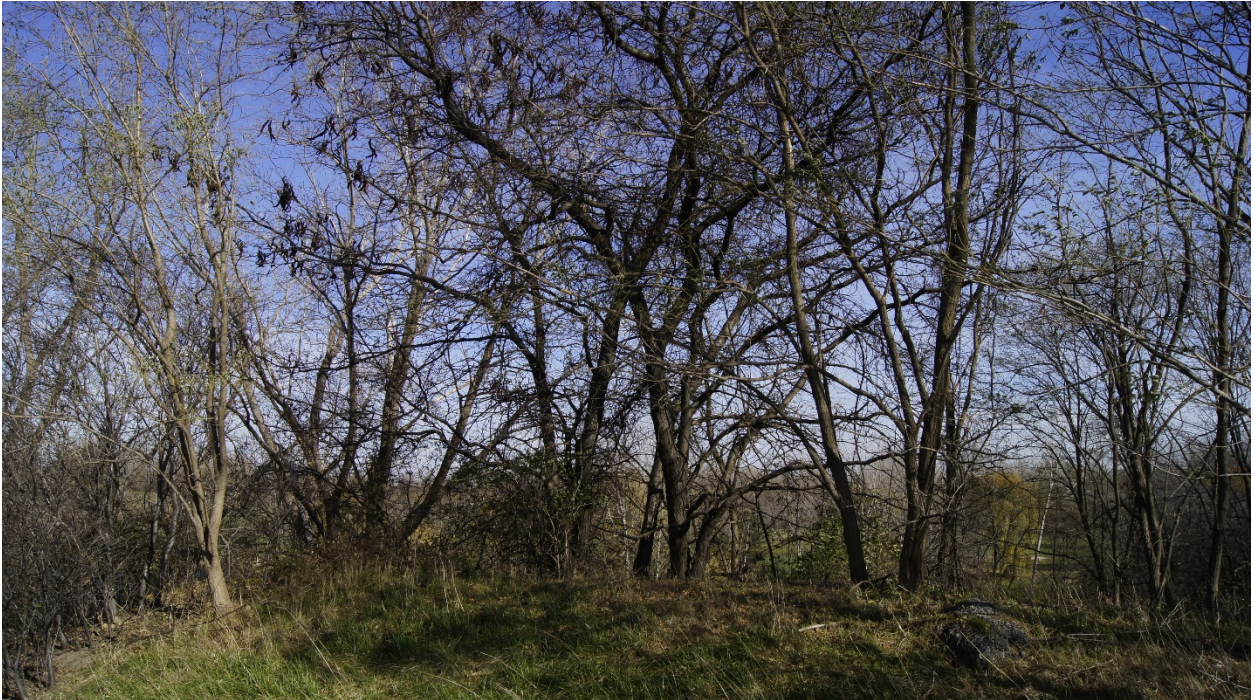
As illustrated in Appendix A, Trees 5-7 are located adjacent to St. Paul Avenue, all in very close proximity to one another. It should be noted that these trees are all located on a steep slope, approximately 1m from the top of the slope. Based on our assessment, these trees range in size from approximately 12cm to 22cm in diameter and are all in good condition. Although drip-lines vary for these trees, we estimate that the maximum extent of branches extend to approximately 9m from the tree trunks, with some roots possibly extending beyond the drip-line.

As illustrated in Appendix A, the St. Paul Avenue entrance is located well outside of the drip line of these trees, and therefore it is not likely that the driveway will significantly impact the health of Trees 5-7. From our review of the grading plan, it appears that fill is intended to be placed near periphery of the drip-line, however provided the mitigation measures below are implemented, impacts to tree health can be minimized.
