ARBORIST REPORT

7302 Kalar Rd.
Niagara Falls, ON
L2E 6S5

Created: August 17, 2023
Last revised: August 17, 2023

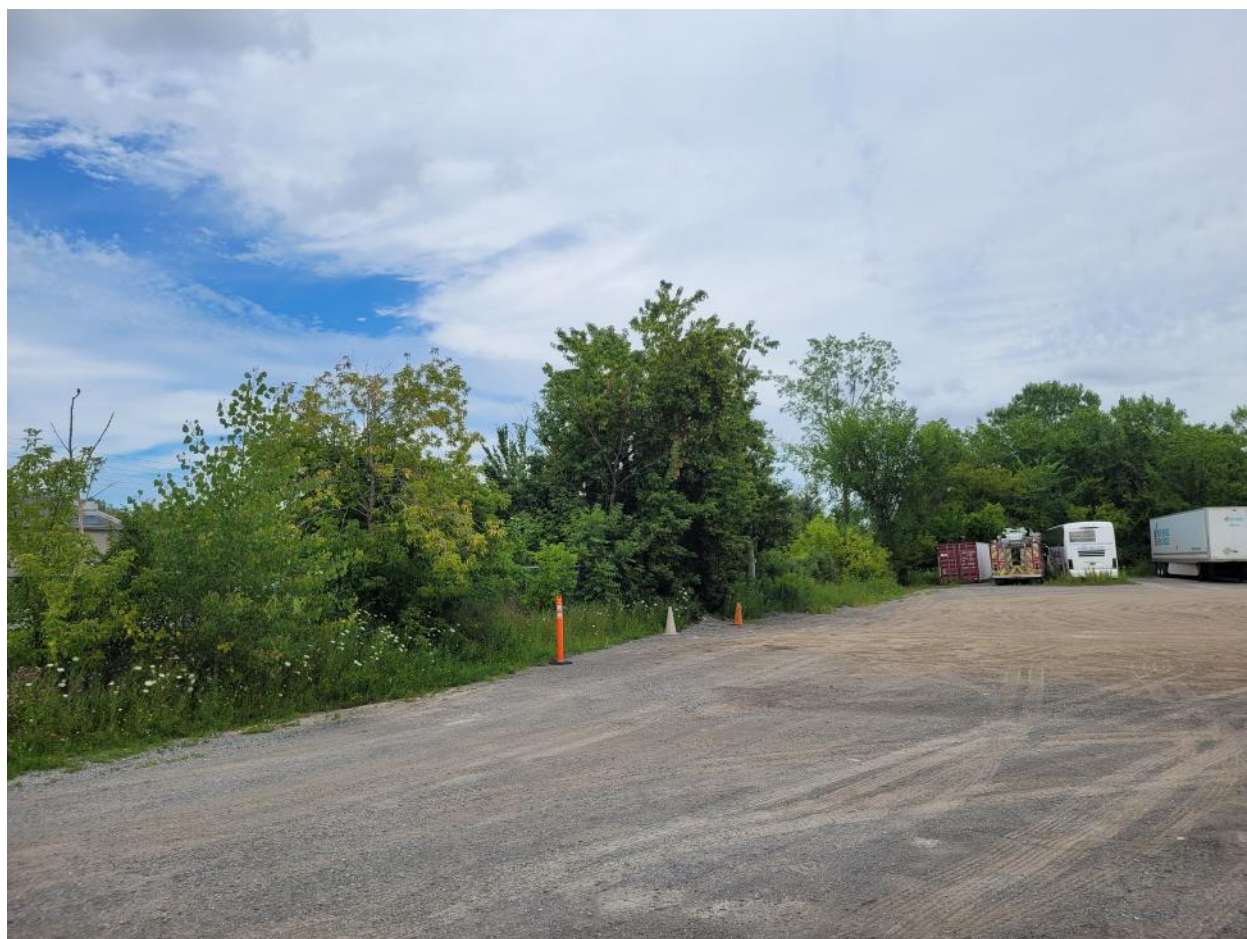
Photo 1. Trees 1-7.

Tree #	Species	DBH (cm)	Crown Radius (m)	Biological Condition	Structural Condition	Condition Comments	Min TPZ (m)	Ownership Category	Recommended Action & Details
1	<i>Acer negundo</i> (Manitoba maple)	19	2	Fair	Fair	Bifurcates at ~1.5m with fair union; fair shoot extension.	3	Private	Preserve
2	<i>Acer negundo</i> (Manitoba maple)	35	4	Fair	Fair	Two main stems from base (~25 & 25cm DBH); fair shoot extension.	5	Neighbor	Preserve

Tree #	Species	DBH (cm)	Crown Radius (m)	Biological Condition	Structural Condition	Condition Comments	Min TPZ (m)	Ownership Category	Recommended Action & Details
3	<i>Acer negundo</i> (Manitoba maple)	21	2.5	Fair	Fair	Two main stems from base (~15 & 15cm DBH); fair shoot extension.	4.5	Neighbor	Preserve
4	<i>Ulmus americana</i> (American elm)	35	4	Good	Fair	Multiple main leaders at ~2m; full crown.	5	Boundary	Preserve
5	<i>Pyrus calleryana</i> (Callery pear)	13	2	Good	Good	Good central leader; full crown.	3	Private	Injure - due to molok installation.
6	<i>Fraxinus pennsylvanica</i> (green ash)	13	0	Dead	Poor	Dead - Emerald Ash Borer.	1	Private	Remove - due to condition.
7	<i>Ulmus americana</i> (American elm)	12	2.5	Fair	Fair	Multiple leaders; fair shoot extension.	3.5	Private	Injure - due to proposed underground parking.
8	<i>Ulmus americana</i> (American elm)	13	4	Fair	Fair	Minorly sparse; multiple leaders.	5	Private	Remove - due to proposed underground parking.

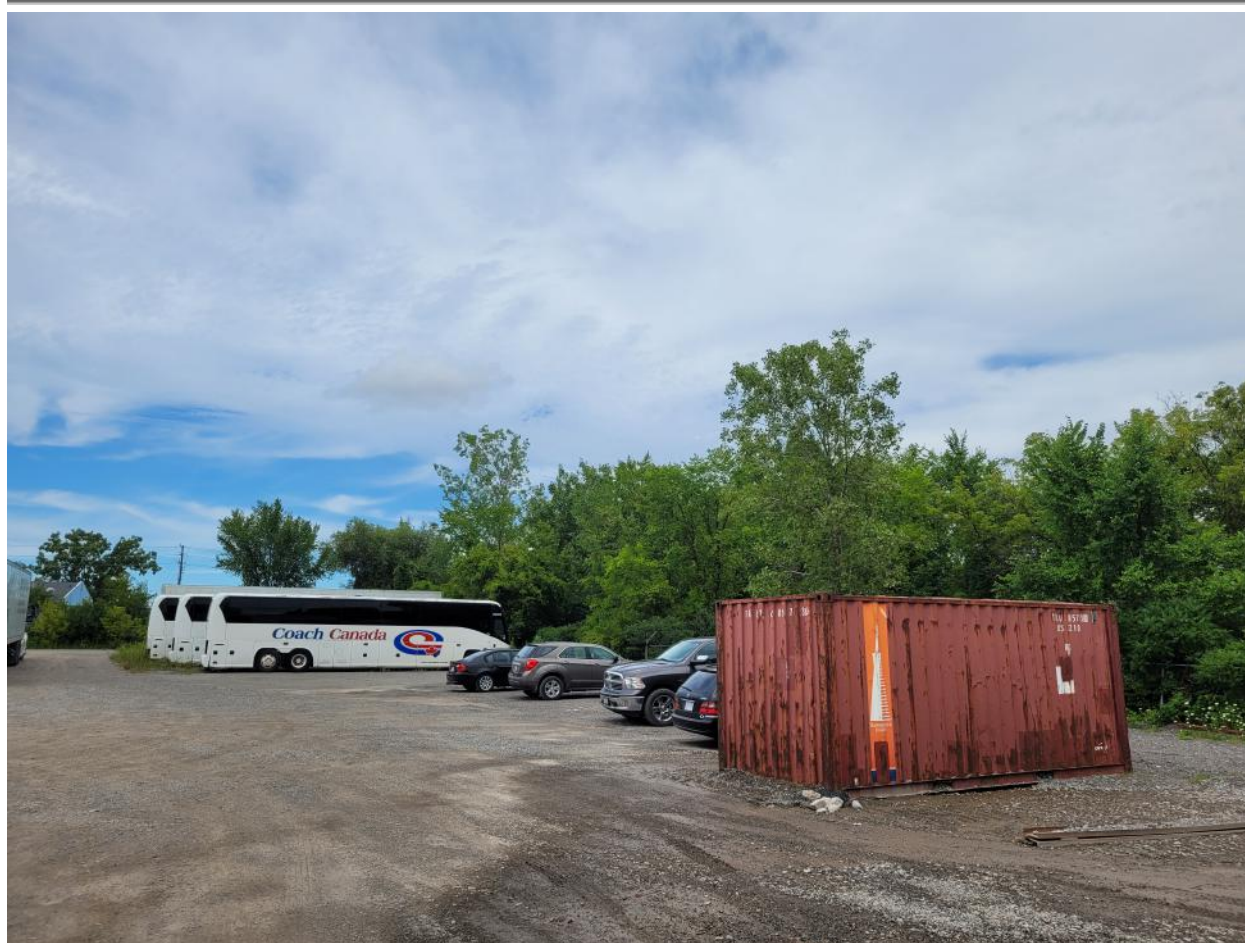
Photo 2. Trees 8-16.

9	<i>Acer negundo</i> (Manitoba maple)	36	3.5	Fair	Fair	Multiple stems (25, 20 & 17cm DBH); fair shoot extension.	4.5	Private	Remove - due to proposed underground parking.
10	<i>Fraxinus pennsylvanica</i> (green ash)	14	2	Poor	Fair	Good central leader; significant dieback due to Emerald Ash Borer.	3	Private	Remove - due to proposed underground parking & parking lot.

Tree #	Species	DBH (cm)	Crown Radius (m)	Biological Condition	Structural Condition	Condition Comments	Min TPZ (m)	Ownership Category	Recommended Action & Details
11	<i>Ulmus americana</i> (American elm)	14	3	Fair	Fair	Minorly sparse; multiple leaders.	4	Private	Remove - due to proposed underground parking & parking lot.
12	<i>Ulmus americana</i> (American elm)	10	2.5	Fair	Fair	Minorly sparse; multiple leaders.	3.5	Private	Remove - due to proposed underground parking & parking lot.
13	<i>Ulmus americana</i> (American elm)	23	3	Fair	Fair	Minorly sparse; multiple leaders.	4	Private	Remove - due to proposed underground parking & parking lot.
14	<i>Populus deltoides</i> (Eastern cottonwood)	30	4	Fair	Fair	Decurrent habit; fair shoot extension.	5	Private	Remove - due to proposed underground parking & parking lot.
15	<i>Ulmus americana</i> (American elm)	18	2.5	Good	Fair	Multiple leaders; full crown.	3.5	Private	Remove - due to proposed underground parking & parking lot.

16	<i>Pyrus communis</i> (European pear)	10	2	Good	Fair	Fair central leader; heavy fruit.	3	Private	Remove - due to proposed underground parking & parking lot.

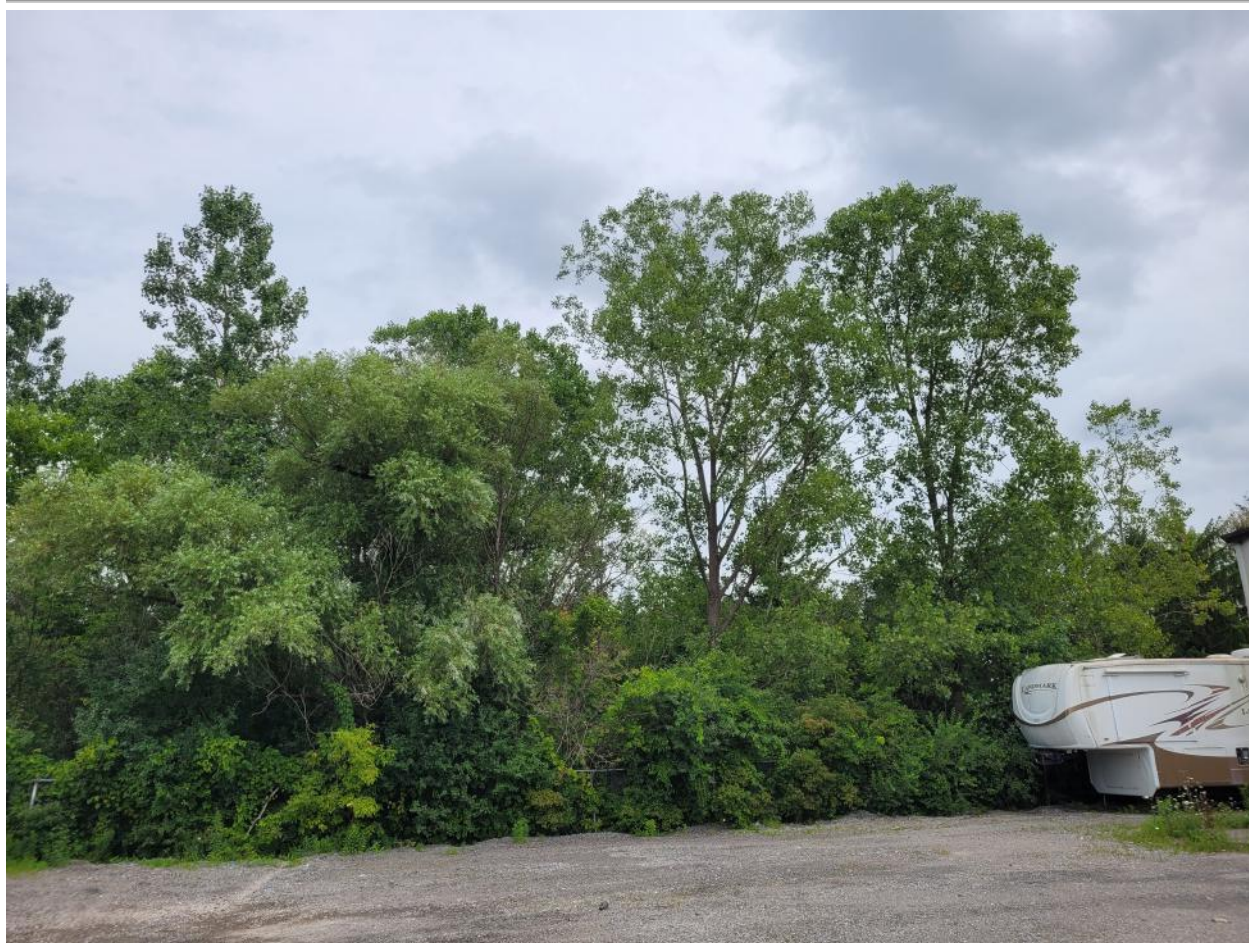
Photo 3. Trees 16-22.

Tree #	Species	DBH (cm)	Crown Radius (m)	Biological Condition	Structural Condition	Condition Comments	Min TPZ (m)	Ownership Category	Recommended Action & Details
17	<i>Salix alba</i> (white willow)	50	6	Good	Fair	Multiple leaders; good shoot extension.	7	Neighbor	Injure - due to proposed underground parking & parking lot.
18	<i>Fraxinus pennsylvanica</i> (green ash)	35	0	Dead	Poor	Dead - Emerald Ash Borer.	1	Private	Remove - due to condition.
19	<i>Populus deltoides</i> (Eastern cottonwood)	50	6	Fair	Fair	Decurrent habit; fair shoot extension.	7	Neighbor	Injure - due to proposed underground parking & parking lot.
20	<i>Populus deltoides</i> (Eastern cottonwood)	45	5	Good	Fair	Decurrent habit; good shoot extension.	6	Potential Boundary	Injure - due to proposed underground parking & parking lot.
21	<i>Populus deltoides</i> (Eastern cottonwood)	20	2.5	Fair	Good	Good central leader; fair shoot extension.	3.5	Private	Injure - due to proposed underground parking & parking lot.

22	<i>Prunus serotina</i> (black cherry)	33.5	4	Good	Fair	Multiple stems from base (~15, 16, 17, 10, 13 & 9cm DBH); full crown.	5	Private	Injure - due to proposed underground parking & parking lot.

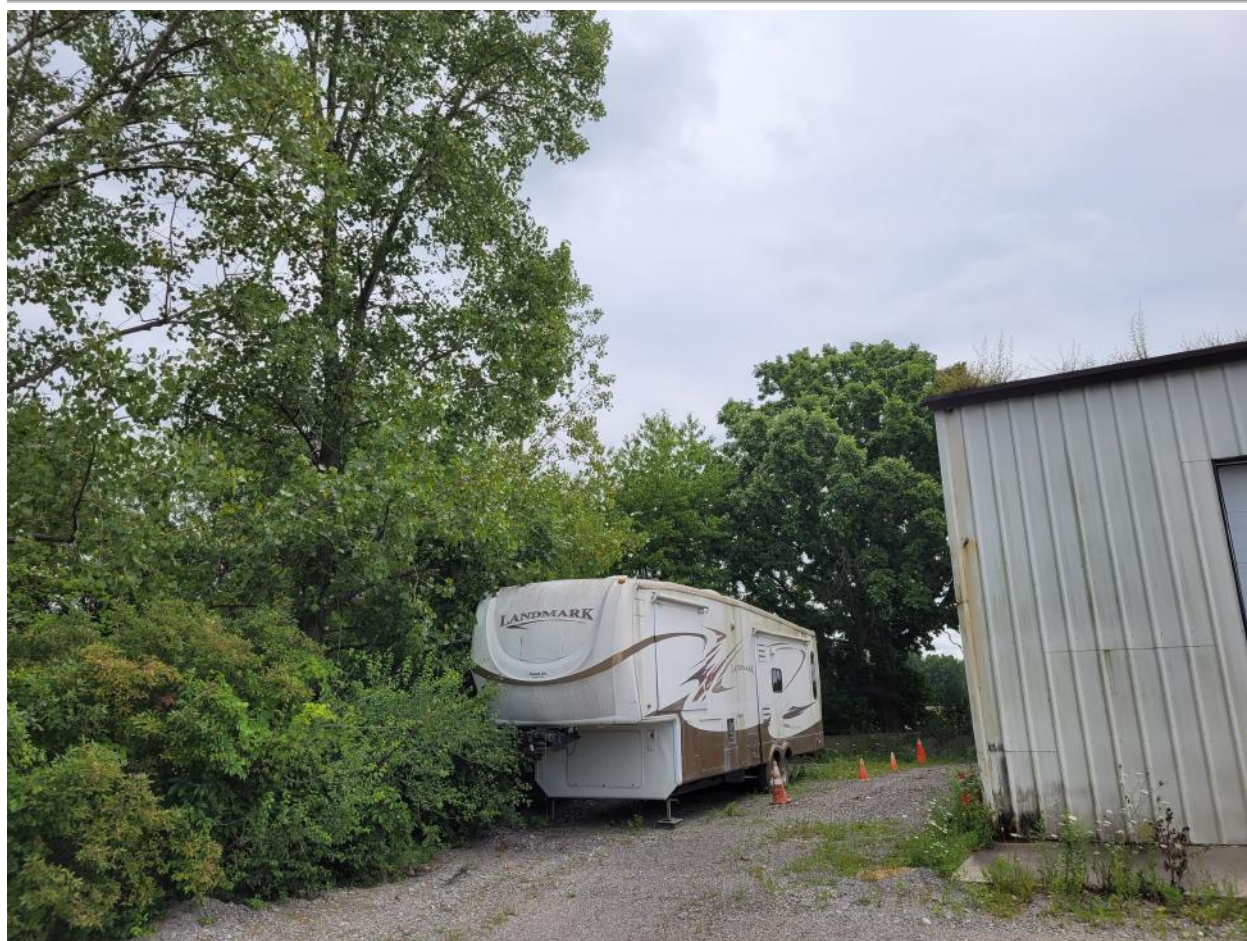
Photo 4. Trees 21-23.

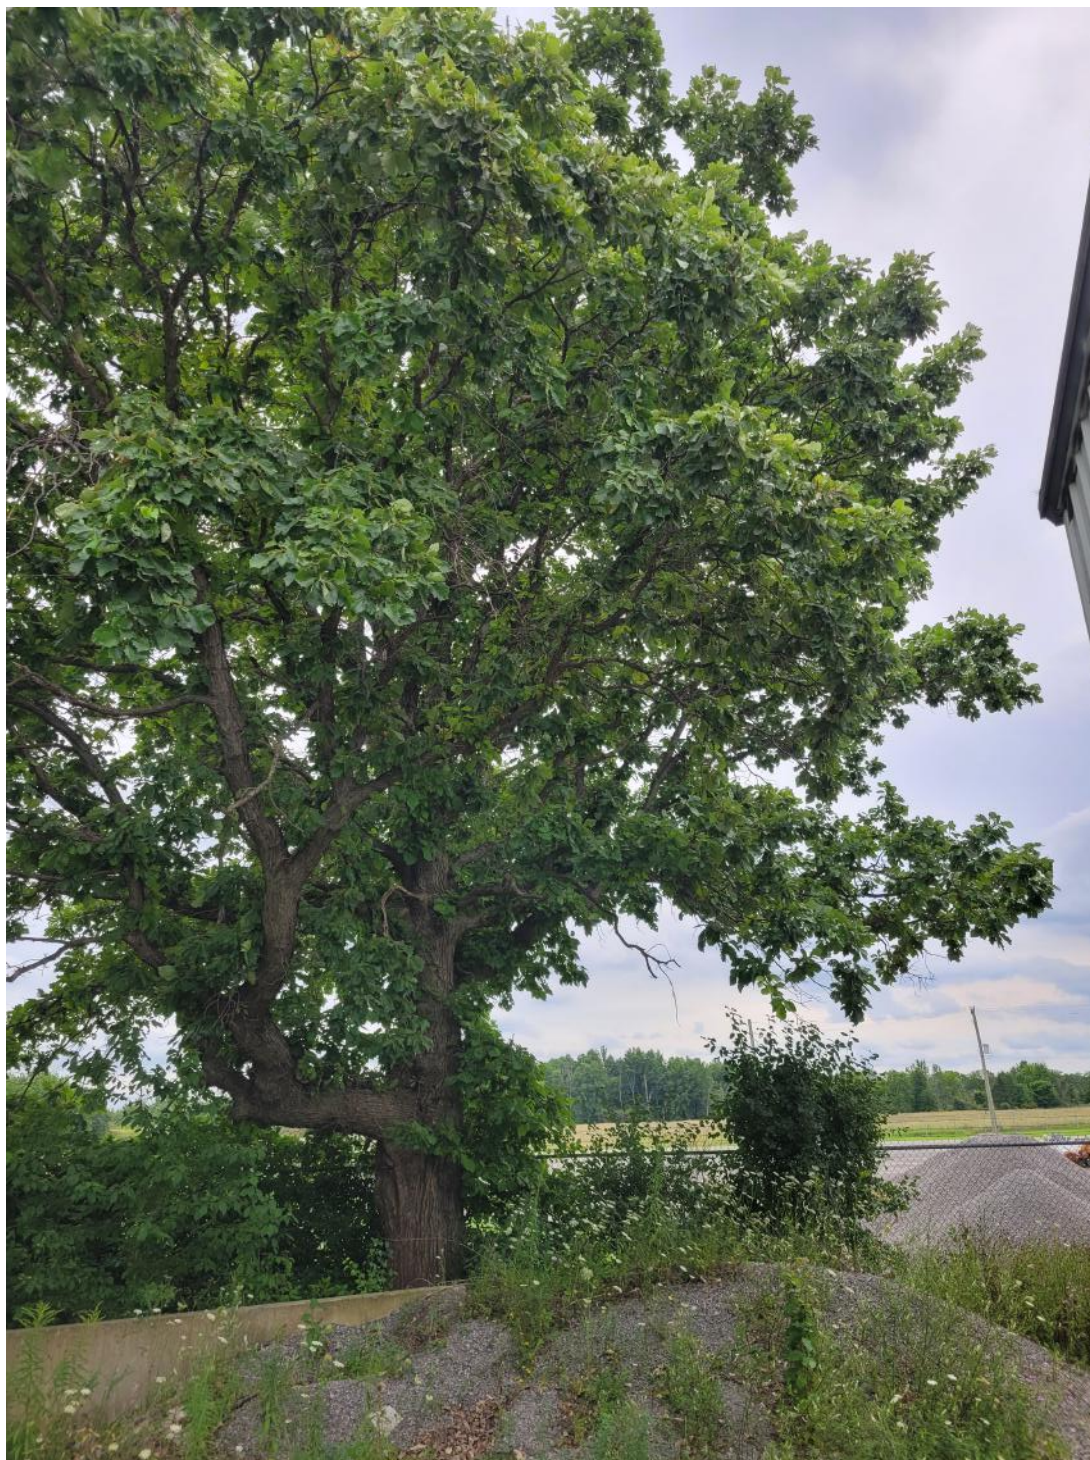
Photo 5. Tree 23.

Tree #	Species	DBH (cm)	Crown Radius (m)	Biological Condition	Structural Condition	Condition Comments	Min TPZ (m)	Ownership Category	Recommended Action & Details
23	<i>Quercus macrocarpa</i> (Bur oak)	87	7	Fair	Fair	Decurrent habit; minor tip dieback; epicormics on scaffold limbs.	8	Private	Injure - due to proposed underground parking & parking lot.
24	<i>Populus deltoides</i> (Eastern cottonwood)	50	6	Good	Fair	Decurrent crown; full crown.	7	Neighbor	Preserve
25	<i>Ulmus americana</i> (American elm)	22	3.5	Fair	Fair	Decurrent top; fair shoot extension.	4.5	Private	Preserve

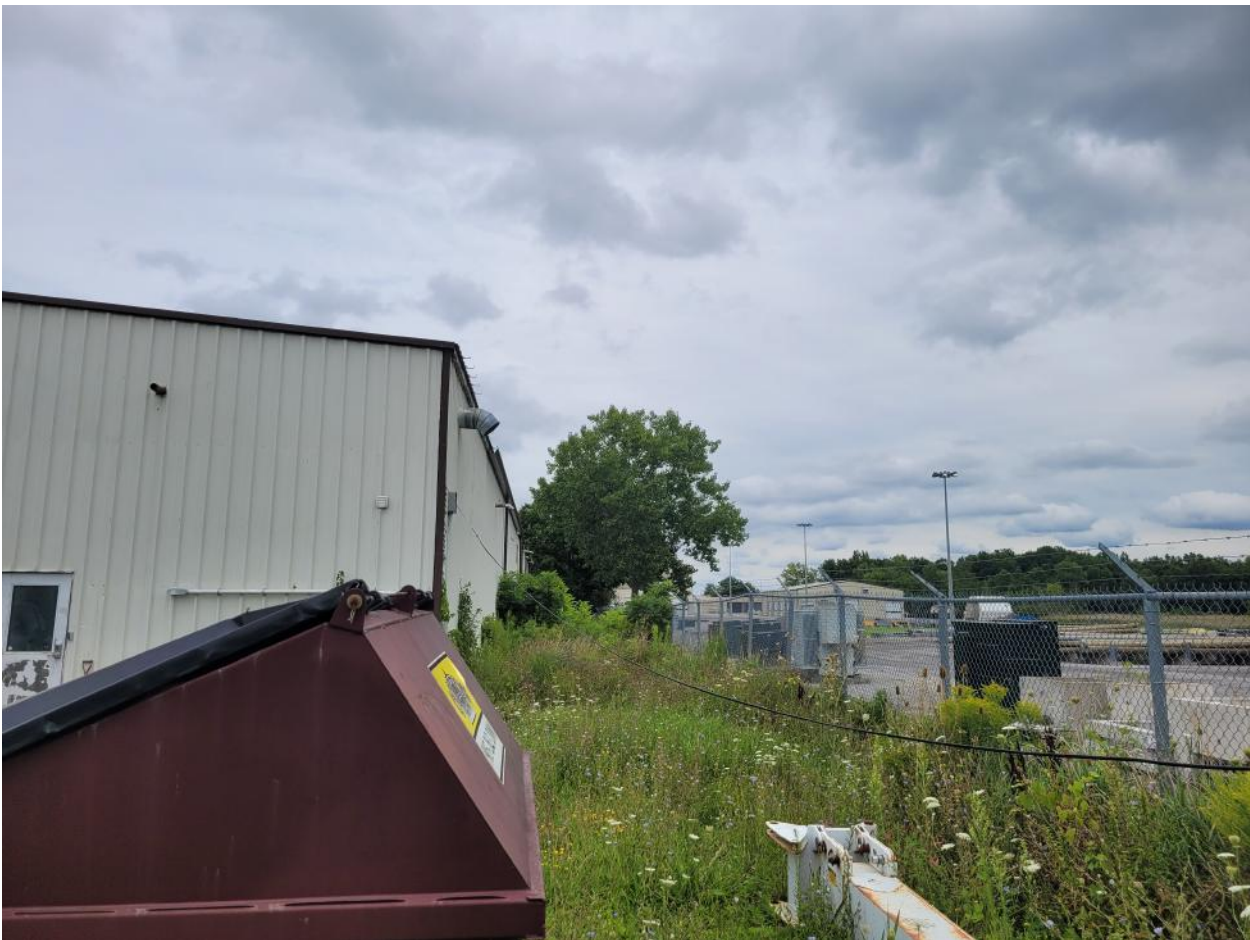
Photo 6. Tree 24.

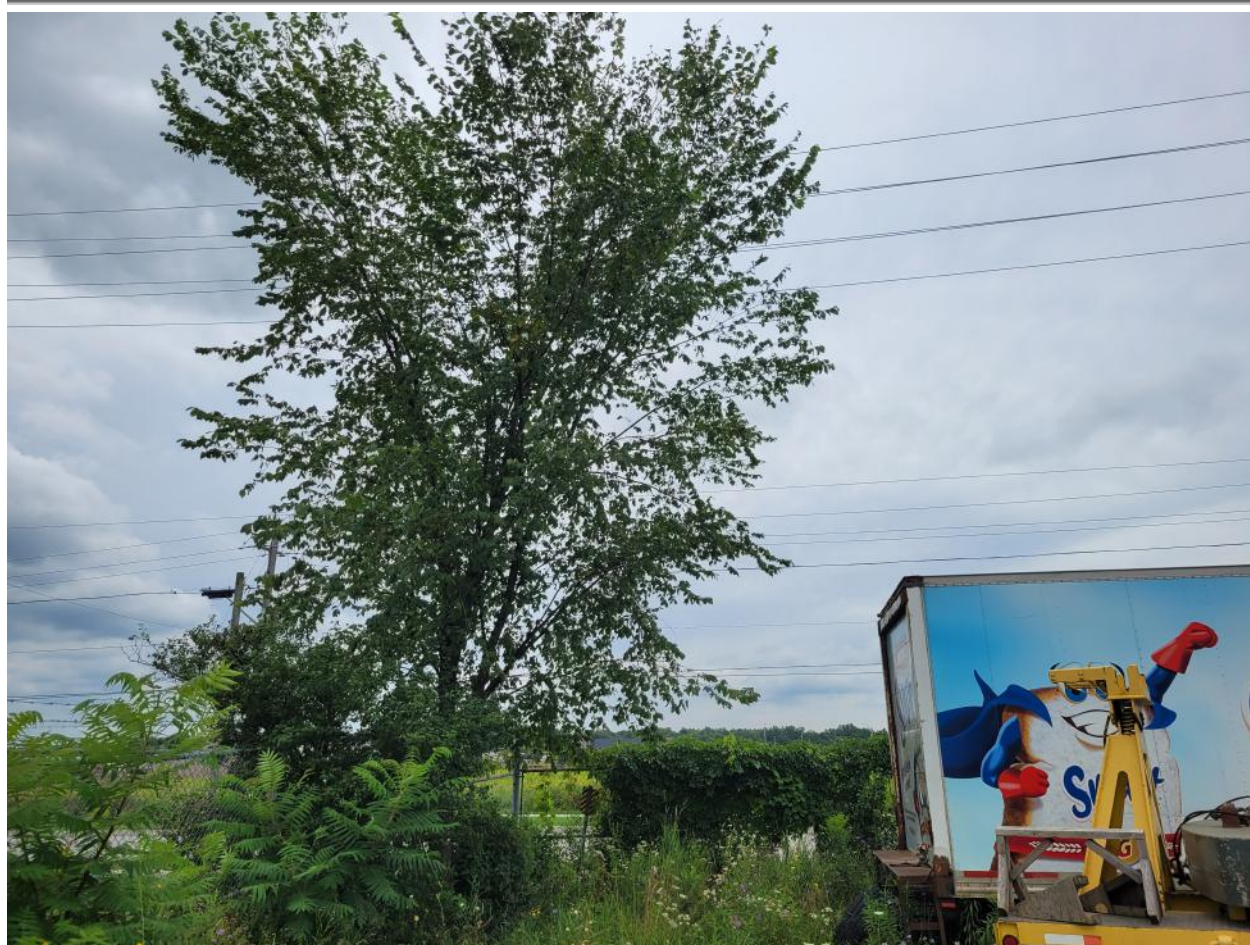
Photo 7. Tree 25.

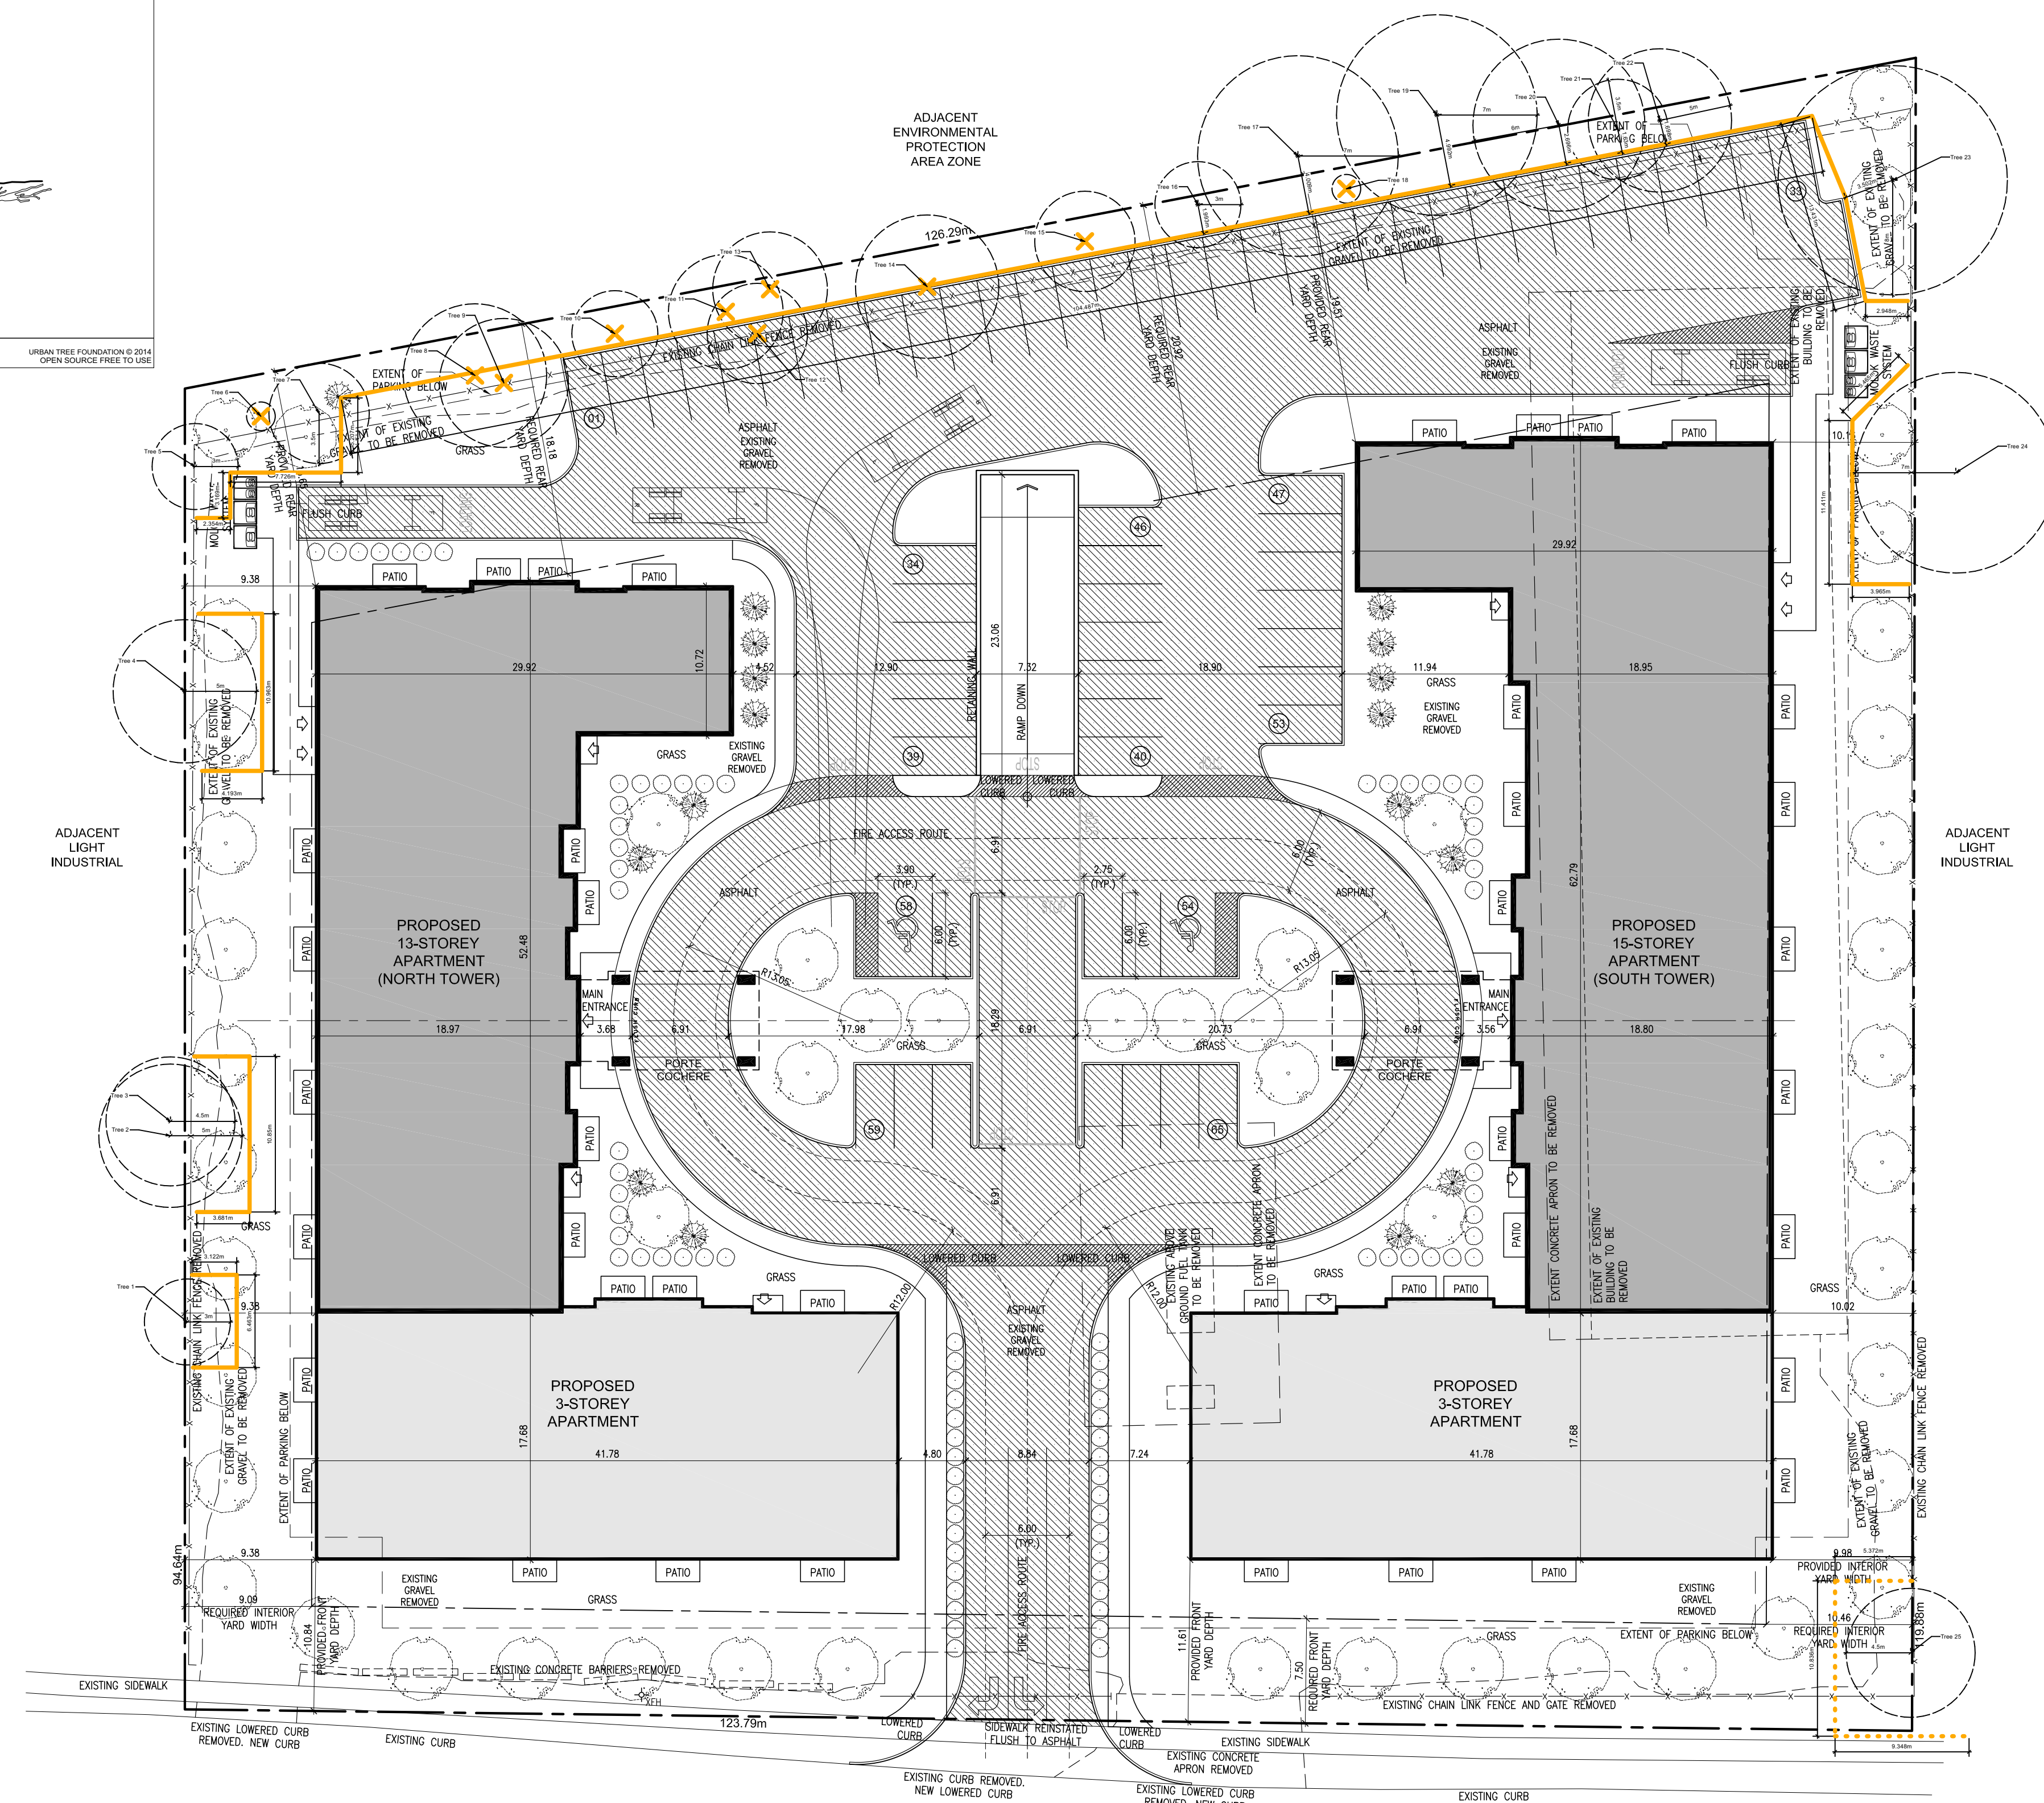
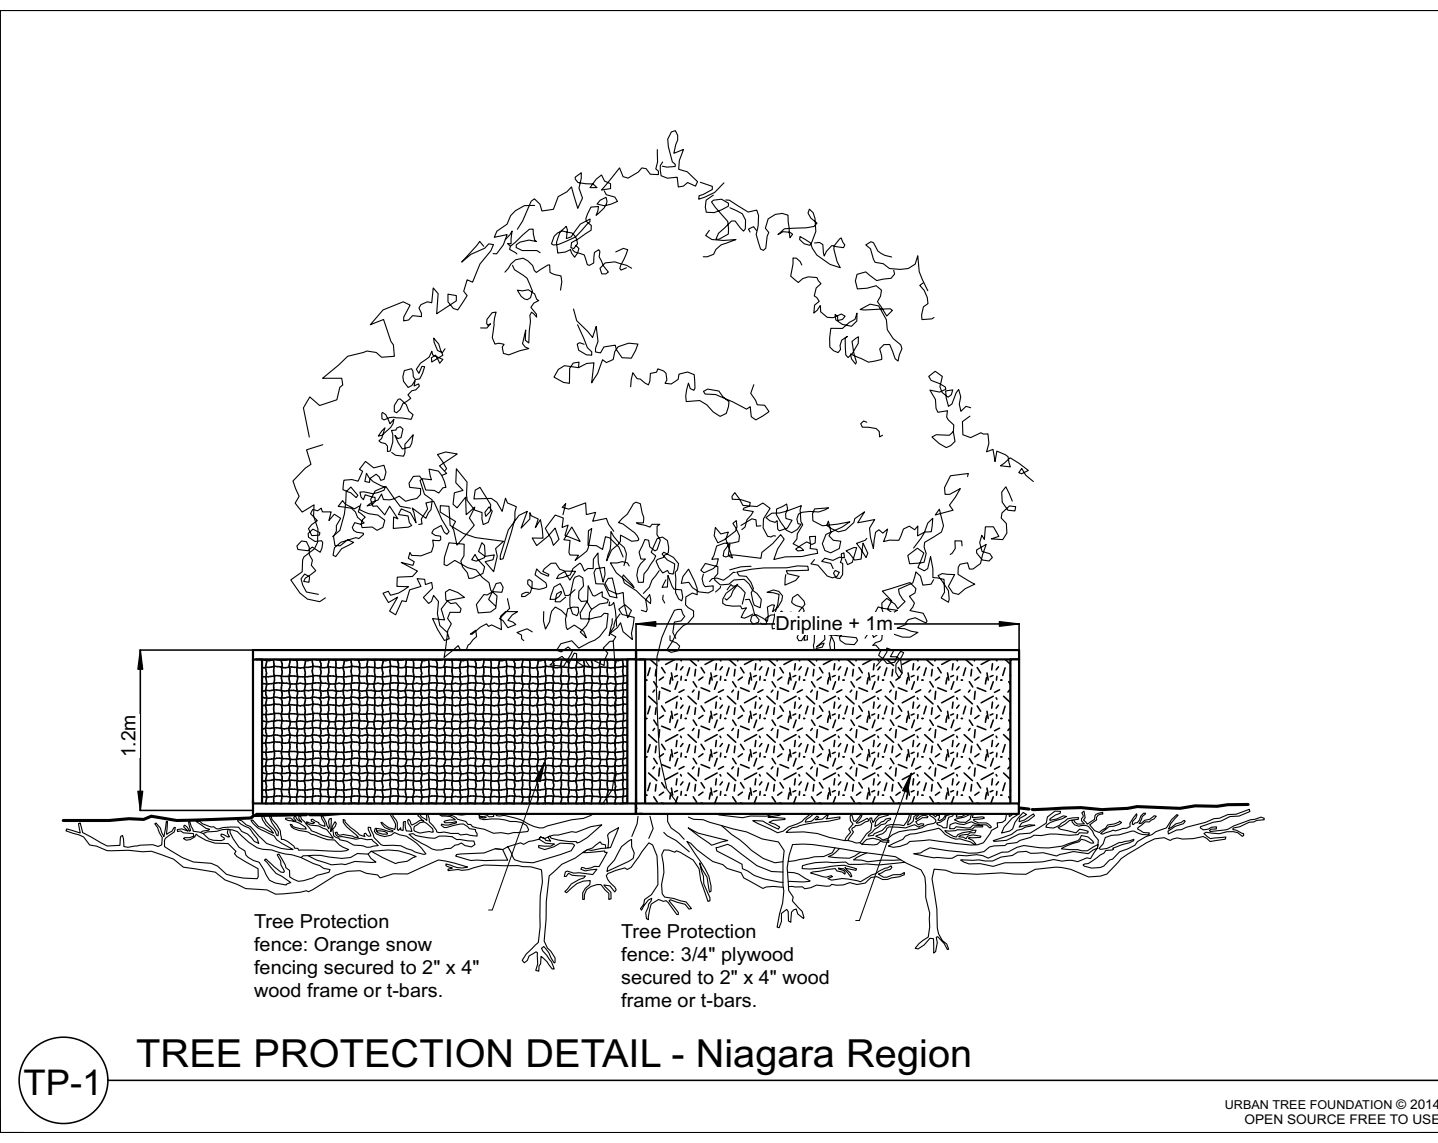
Drawing No.
TPP1

- Tree protection comments were added by the arborist to a site plan created by Peter J. Lesdow Architect dated April 8, 2023 drawing # A-1 project # 23-05.

- It is the responsibility of the site supervisor to inspect the condition of the tree protection measures outlined on the tree protection plan each morning. If disturbance to the barriers is observed, it is to be repaired prior to work commencing on site that day.

- Tree protection barriers must remain in place and in good condition during demolition, construction and/or site disturbance, including landscaping, and must not be altered, moved or removed until authorized by Urban Forestry.

- Tree Protection Zones (TPZ) distances must be measured from the outside edge at the base of the tree.
- During construction, if any tree roots are exposed or disturbed outside the tree protection zone (TPZ), care is to be taken to minimize their disturbance. If roots must be removed outside the TPZ, they are to be cleanly pruned. Tearing roots hinders wound closure and can increase risk of disease and root rot.

- All landscape and gravel removal work within the Minimum Tree Protection Zones (MTPZs) of affected trees must be completed using hand tools only.
- At the completion of the project, the Forestry Department is to be notified prior to removal of the tree protection fencing on the site. With approval, the fencing may be dismantled.
