**Tree Inventory and Preservation Plan Report
175 Portage Road
Niagara Falls, Ontario**

27 May 2022, Revised 01 June 2022

KUNTZ FORESTRY CONSULTING Inc. Project P3132

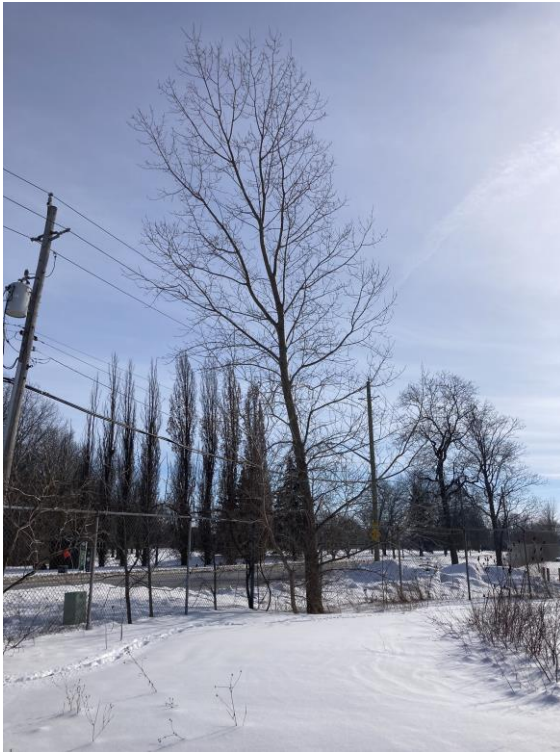
Tree 299

299	Eastern Cottonwood	<i>Populus deltoides</i>	37.5	5	G	G	G	2.4		Private	Remove
300	Basswood	<i>Tilia americana</i>	15.5	3	G	F	G	1.8	Union @ ~0.5m and ~1.5m	Private	Remove
980	Basswood	<i>Tilia americana</i>	16, 9	4	G	G	G	1.8	Union @ ground	Private	Remove
981	White Ash	<i>Fraxinus americana</i>	12.5	3	P	F-G	F	1.8	Stem wound (H)	Private	Remove
982	Black Walnut	<i>Juglans nigra</i>	29	4	P	P	P	1.8	Moribund tree, Massive stem wound, Severe dieback	Private	Remove
983	White Ash	<i>Fraxinus americana</i>	18.5	4	F	FP	F	1.8	Union @ ~2.0m, Epicormic branches (M)	Private	Remove
984	White Ash	<i>Fraxinus americana</i>	13	2	F	F	F	1.8		Private	Remove
985	Black Walnut	<i>Juglans nigra</i>	36	5	P	P	P	2.4	Moribund tree, Stem wound (H), Crown dieback (H)	Private	Remove
986	White Ash	<i>Fraxinus americana</i>	13, 8	3	P	P	P	1.8	Union @ ground, Dying from Emerald ash borer	Private	Remove
987	Eastern Cottonwood	<i>Populus deltoides</i>	11.5	2	F	F	G	1.8	Lean (M)	Private	Remove

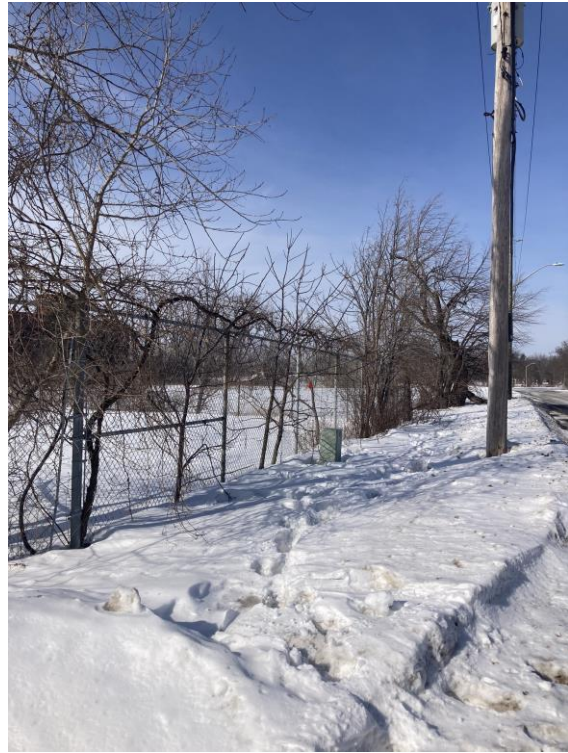
Trees A- C (left to right)

991	Black Walnut	<i>Juglans nigra</i>	28.5	5	G	F	F	1.8	Vine competition (H)	Private	Preserve
A	Black Walnut	<i>Juglans nigra</i>	4	1	G	G	G	1.2		Private	Remove
B	Black Walnut	<i>Juglans nigra</i>	4.5	2	G	G	G	1.2		Private	Remove
C	Black Walnut	<i>Juglans nigra</i>	5.5	2	G	G	G	1.2		Private	Remove

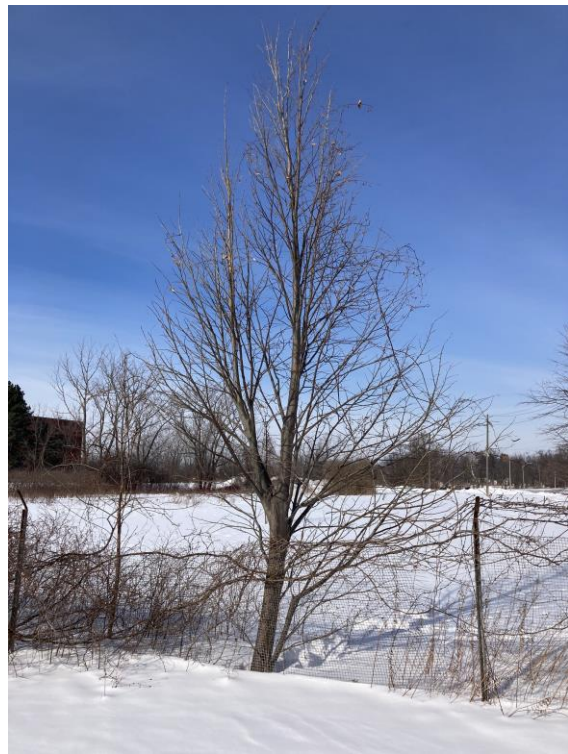
Tree #	Common Name	Scientific Name	DBH	DL	TI	CS	CV	TPZ	Comments	Owner	Action
290	Black Walnut	<i>Juglans nigra</i>	13	3	G	G	G	1.8	Growing against chain link fence	Private	Remove
291	White Ash	<i>Fraxinus americana</i>	16.5, 11	3	P	P	P	1.8	Dying from Emerald ash borer	Private	Remove
292	White Ash	<i>Fraxinus americana</i>	15	3	P	F	P	1.8	Dying from Emerald ash borer	Private	Remove
293	White Ash	<i>Fraxinus americana</i>	12	2	F	G	F	1.8	Dying from Emerald ash borer	Private	Remove
294	White Ash	<i>Fraxinus americana</i>	11	1	P	F	P	1.8	Dying from Emerald ash borer	Private	Remove
295	White Ash	<i>Fraxinus americana</i>	10	4	F	F	F	1.8	Stem wound (L), Sweep (M)	Private	Remove
296	Shagbark Hickory	<i>Carya ovata</i>	49	6	G	G	G	3	Large branch union @ ~1.5m and ~6m, Deadwood (L)	Private	Remove
297	Shagbark Hickory	<i>Carya ovata</i>	41.5	6	F-G	F	F-G	3	Sweep (L), Union @ ~6.0m, Deadwood (M)	Private	Remove
298	Basswood	<i>Tilia americana</i>	18	3	G	G	G	1.8		Neighbour (Northern)	Remove

The removal of 25 trees is required to accommodate the proposed development and associated landscaping works. The required tree removals include Trees 290 – 300, 980 – 990, and Trees A – C. With one exception, all trees identified for removal are located on the subject property. Tree 298 is located on the neighbouring property to the north, and as such, will require written consent from the landowner prior to its removal. Refer to Figure 1 for the location of required tree removals.

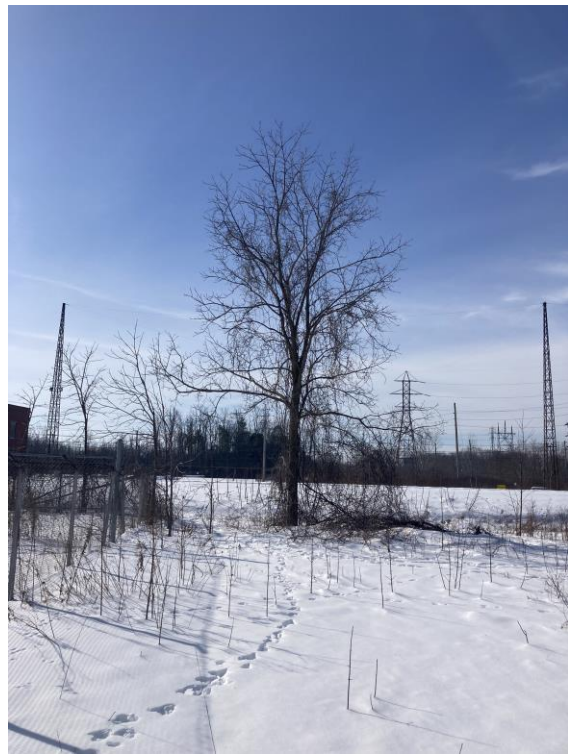
Tree 991 is afforded more than 3m of protection from its base, which is more than sufficient for a tree of its diameter (28.5cm DBH). This level of protection is expected to successfully protect Tree 991 during construction. Nevertheless, where excavation is required within its dripline, special mitigation measures (as discussed below) are recommended.

Minor encroachment into the dripline of Tree 991 is required to facilitate the excavation required for the construction of a proposed underground parking. The tree protection fencing must be installed prior to the commencement of earthworks. If the following mitigation measures are followed, long-term adverse effects are not anticipated for this tree.

1. The protection fencing as shown on Figure 1 should be installed and maintained throughout construction.
2. Where the proposed excavation encroaches into the driplines of Trees 300, 980, and 991, air-spading technology should be used to perform the excavation under the supervision of a Certified Arborist.
3. Any significant roots encountered are to be pruned by a Certified Arborist in accordance with Good Arboricultural Standards.
4. Branches that extend into the proposed development and require pruning must be pruned by a Certified Arborist or other tree professional in accordance with Good Arboricultural Standards.

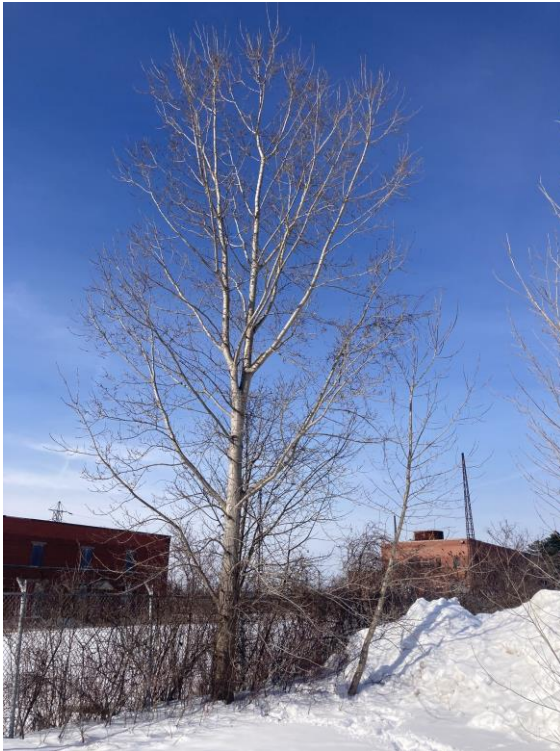
Trees 986 – 988 (left to right)

988	Eastern Cottonwood	<i>Populus deltoides</i>	32.5	5	G	F-G	G	2.4	Union @ ~10.0m	Private	Remove
989	Black Walnut	<i>Juglans nigra</i>	17	4	F-G	F-G	G	1.8	Included fence (M)	Private	Remove
990	Black Walnut	<i>Juglans nigra</i>	11.5	3	G	G	G	1.8		Private	Remove
