**Tree Inventory and Preservation Plan
5969 and 5981 Dunn Street
Niagara Falls, Ontario**

6 December 2024

KUNTZ FORESTRY CONSULTING INC. Project P4318

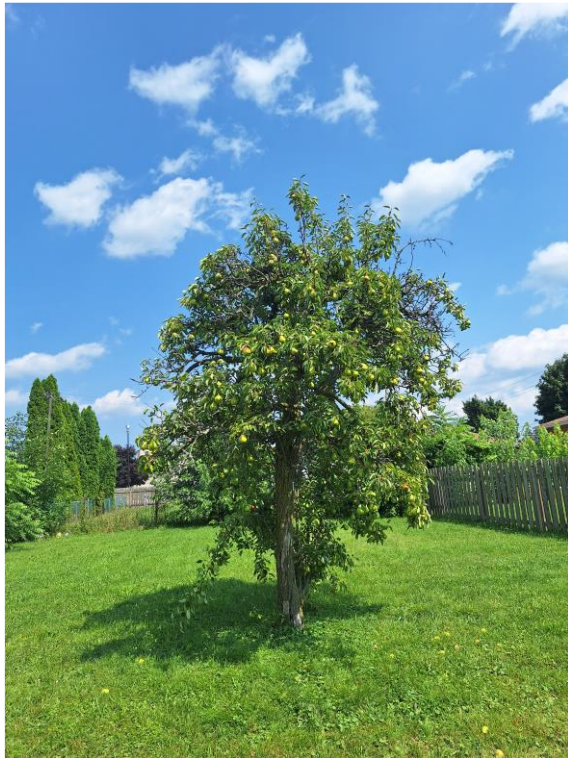
Image 1. Tree 624

The removal of one tree, identified as Tree 624, will be required to accommodate the proposed development. Tree 624 conflicts directly with the footprint of the proposed townhouse building. Tree 624 is located fully within the boundaries of the subject site.

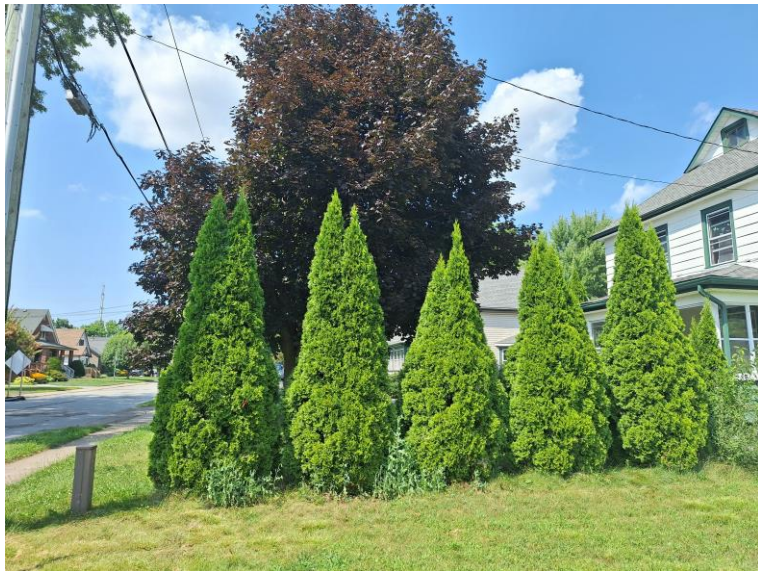
Image 3. Tree A (far left) and four undersized Emerald Cedars (centre and right)

The preservation of the remaining three trees, identified as Trees 625, A, and B, will be possible with the use of appropriate tree protection measures as indicated on Figure 1. Tree protection measures must be implemented prior to the commencement of the proposed works to ensure tree resources designated for preservation are not impacted.
