ARBORIST REPORT

3777, 3791 & 3851 Portage Rd.
Niagara Falls, ON
L2J 2L1

Urban Arboretum Inc. (the arborist) was retained by Arborwood Tree Service Inc. (the client) to complete an arborist report pertaining to 3777, 3791 & 3815 Portage Road, Niagara Falls (the subject site). The report was requested relative to tree impacts and removals to facilitate a new 12-storey Apartment building and proposed parking lot upgrades (the scope).

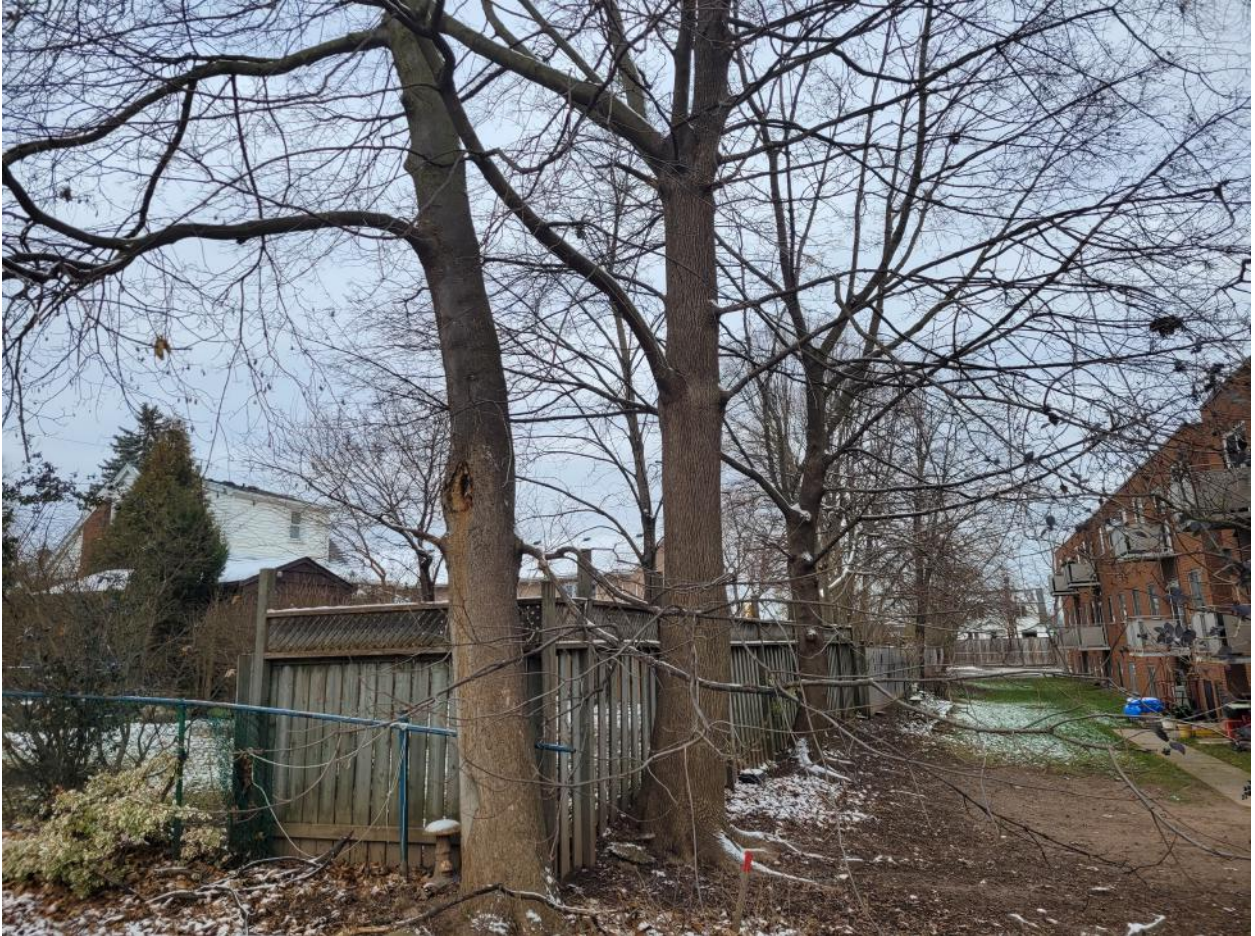
Photo 1. Trees 1-3, 41 & 42.

Tree #	Species	DBH (cm)	Crown Radius (m)	Biological Condition	Structural Condition	Condition Comments	Min TPZ (m)	Ownership Category	Recommended Action & Details
1	<i>Acer platanoides</i> (Norway maple)	36	4	Fair	Fair	Decurrent habit; fair shoot extension.	5	Private	Preserve - tree protection fence.
2	<i>Acer platanoides</i> (Norway maple)	54	4	Fair	Fair	Decurrent habit; fair shoot extension.	5	Private	Injure - due to proposed parking lot.

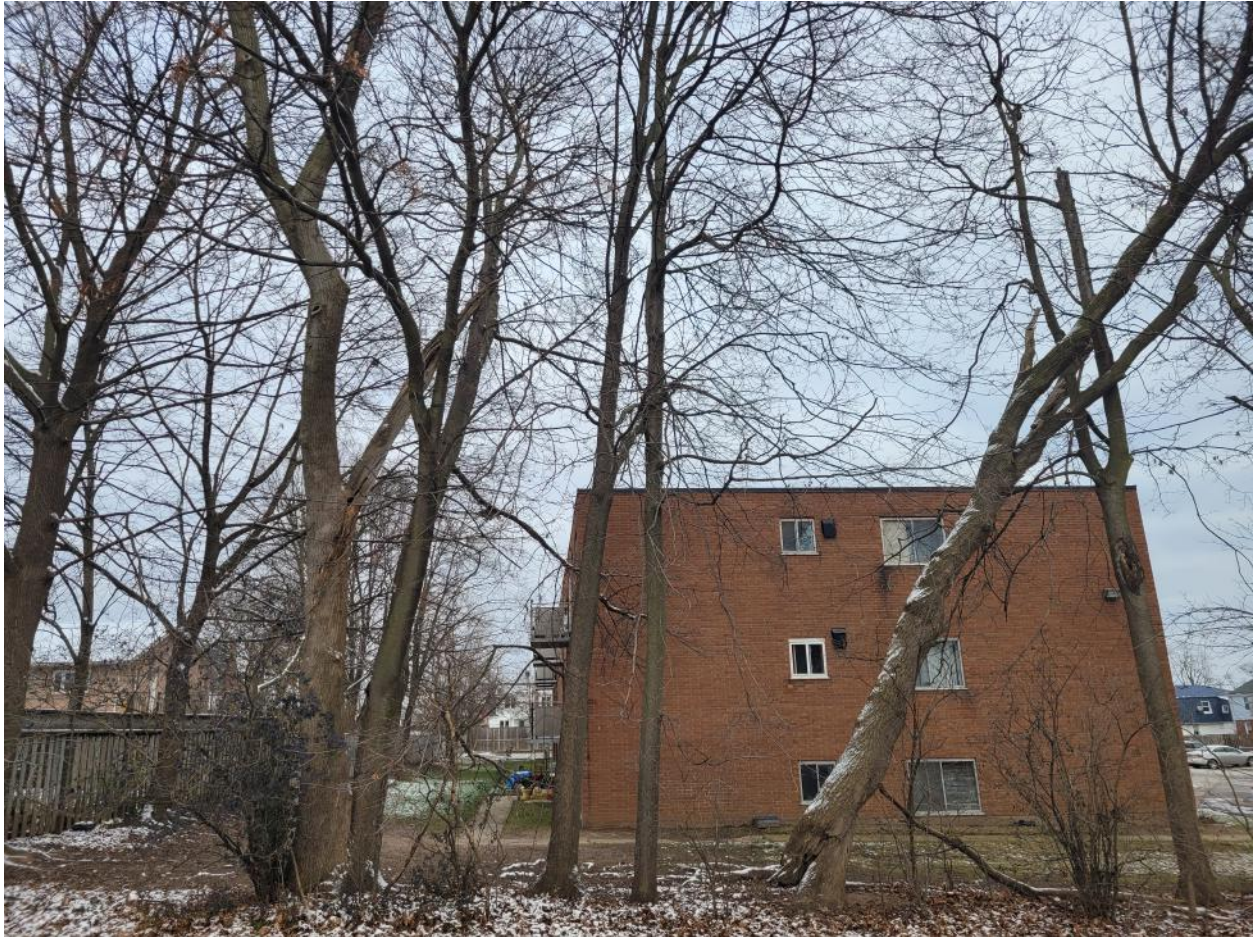
Photo 2. Trees 4-9.

Tree #	Species	DBH (cm)	Crown Radius (m)	Biological Condition	Structural Condition	Condition Comments	Min TPZ (m)	Ownership Category	Recommended Action & Details
3	<i>Acer pseudoplatanus</i> (sycamore maple)	46	4	Good	Fair	Asymmetrical due to Tree 2; good shoot extension; large canker in main trunk ~25% of circumference.	5	Neighbor	Remove - due to proposed parking lot.
4	<i>Acer negundo</i> (Manitoba maple)	48	4	Fair	Poor	Significant deadwood up to ~30cm in diameter; fair shoot extension; cohort base with Tree 5.	5	Private	Remove - due to proposed parking lot.
5	<i>Acer platanoides</i> (Norway maple)	44	5	Fair	Fair	Cohort at base with Tree 4; asymmetrical crown; fair shoot extension.	6	Private	Remove - due to proposed parking lot.
6	<i>Acer platanoides</i> (Norway maple)	33.5	4	Fair	Fair	Cohort with adjacent trees; fair central leader; fair shoot extension.	5	Private	Remove - due to proposed parking lot.

7	<i>Acer platanoides</i> (Norway maple)	24.5	3.5	Fair	Fair	Cohort with adjacent trees; fair central leader; fair shoot extension.	4.5	Private	Remove - due to proposed parking lot.

Tree #	Species	DBH (cm)	Crown Radius (m)	Biological Condition	Structural Condition	Condition Comments	Min TPZ (m)	Ownership Category	Recommended Action & Details
8	<i>Acer negundo</i> (Manitoba maple)	57	4	Poor	Poor	Major lean; caught up in adjacent trees; decay at base; exposed surface roots with decay large diameter deadwood.	5	Private	Remove - due to proposed parking lot.
9	<i>Acer platanoides</i> (Norway maple)	30	3	Fair	Poor	Tree 8 caught up in crown; codominant leader with one leader broken off; good shoot extension; large Eutypella canker in trunk.	4	Private	Remove - due to proposed parking lot.
10	<i>Acer platanoides</i> (Norway maple)	47	5	Fair	Fair	Asymmetrical due to adjacent trees; Tree 8 caught up in crown; Decurrent habit; fair shoot extension.	6	Private	Remove - due to proposed parking lot.
11	<i>Acer pseudoplatanus</i> (sycamore maple)	35	2	Poor	Poor	Majority of crown lost in past failure with significant decay in remaining stem; large diameter deadwood up to ~25cm.	3	Private	Remove - due to proposed parking lot.

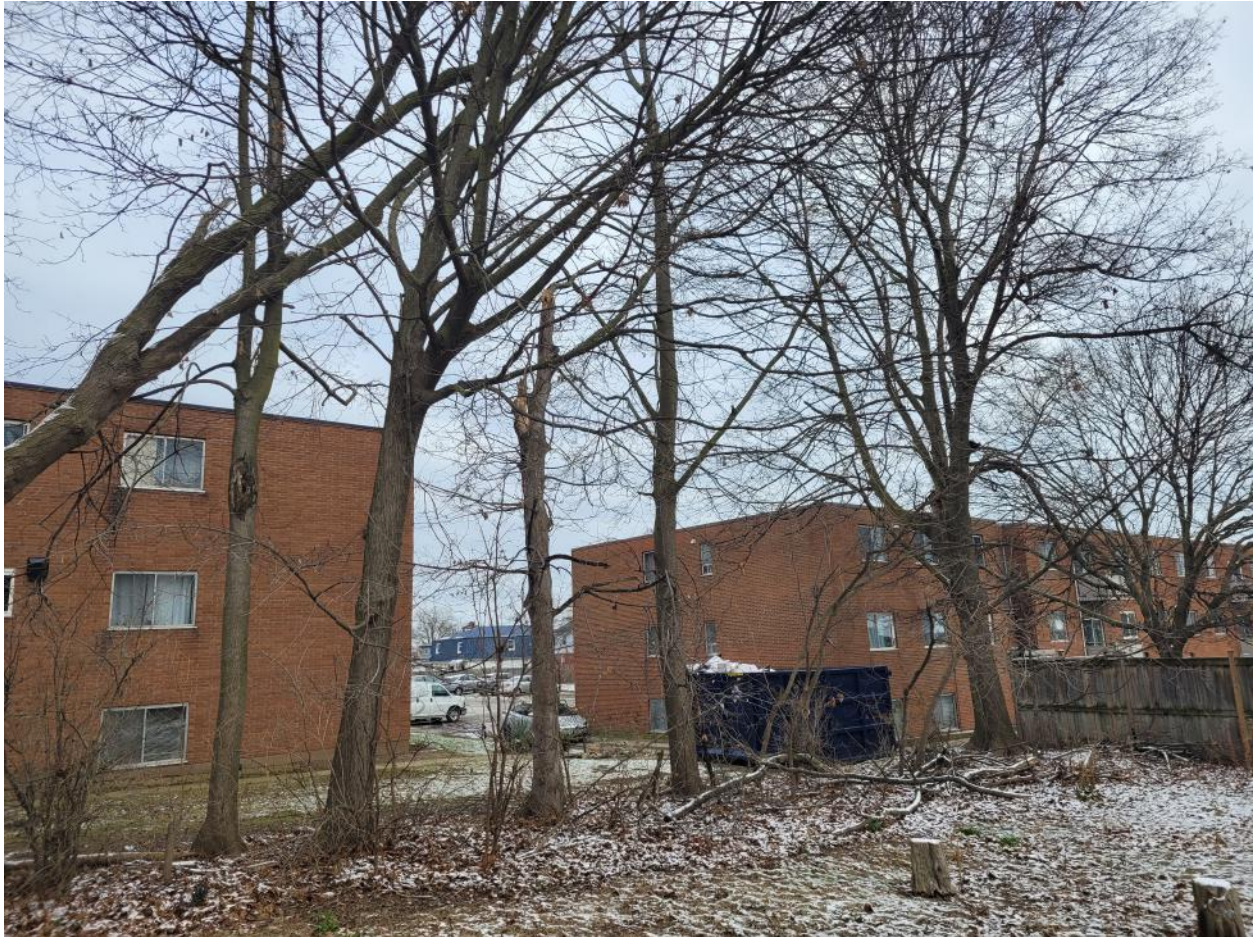
Photo 3. Trees 9-14.

Tree #	Species	DBH (cm)	Crown Radius (m)	Biological Condition	Structural Condition	Condition Comments	Min TPZ (m)	Ownership Category	Recommended Action & Details
12	<i>Acer platanoides</i> (Norway maple)	39	5	Fair	Fair	Fair central leader; fair shoot extension; cohort with adjacent trees.	6	Private	Remove - due to proposed parking lot.
13	<i>Acer platanoides</i> (Norway maple)	63	7	Fair	Poor	Bifurcates at ~5m with a fair union; large diameter deadwood; fair shoot extension; moderate storm damage; evidence of internal decay in scaffold limbs; dead central crown.	8	Private	Remove - due to proposed parking lot.
14	<i>Acer platanoides</i> (Norway maple)	35	5	Fair	Fair	Decurrent habit; fair shoot extension; moderate deadwood.	6	Neighbor	Preserve
15	<i>Juglans nigra</i> (black walnut)	50	8	Fair	Fair	Decurrent habit; fair shoot extension; minor deadwood.	9	Neighbor	Injure - due to proposed parking lot. Tree protection fence with an air spade and root prune is recommended.

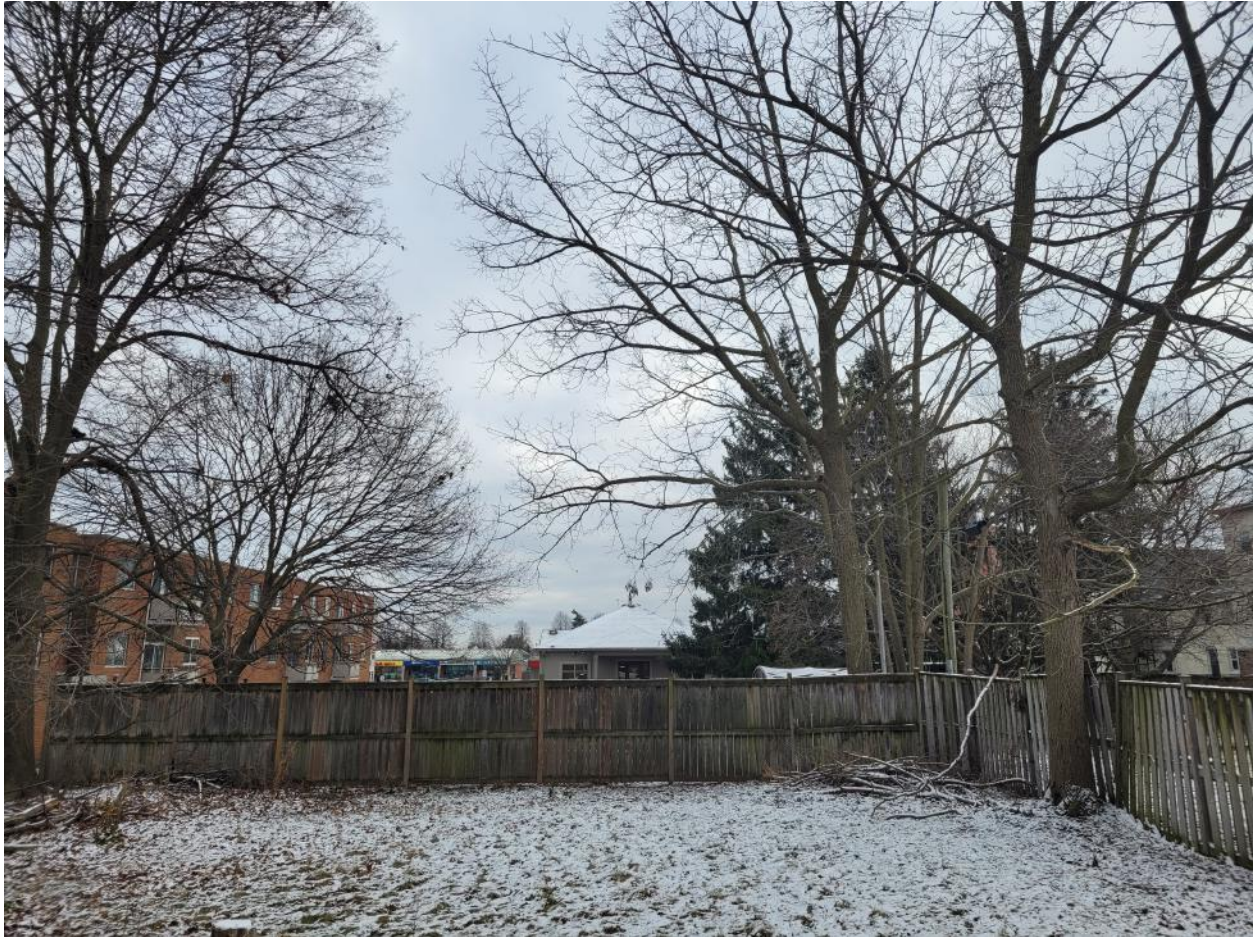
Photo 4. Trees 14-16.

Tree #	Species	DBH (cm)	Crown Radius (m)	Biological Condition	Structural Condition	Condition Comments	Min TPZ (m)	Ownership Category	Recommended Action & Details
16	<i>Juglans nigra</i> (black walnut)	48	7	Fair	Fair	Minor deadwood and past storm damage; utility lines through crown; fair shoot extension.	8	Private	Remove - due to proposed parking lot.
17	<i>Juglans nigra</i> (black walnut)	30	5	Good	Fair	Decurrent habit; good shoot extension; utility lines through crown.	6	Neighbor	Injure - due to proposed parking lot. Tree protection fence with an air spade and root prune is recommended.
18	<i>Morus alba</i> (white mulberry)	23	2.5	Fair	Poor	Multi-stem (13, 16 & 11 cm DBH); growing in fence; under utility lines; past major heading cuts.	3.5	Boundary	Remove - due to proposed parking lot.
19	<i>Juglans nigra</i> (black walnut)	18	2.5	Good	Good	Good central leader; good shoot extension.	3.5	Neighbor	Injure - due to proposed parking lot.

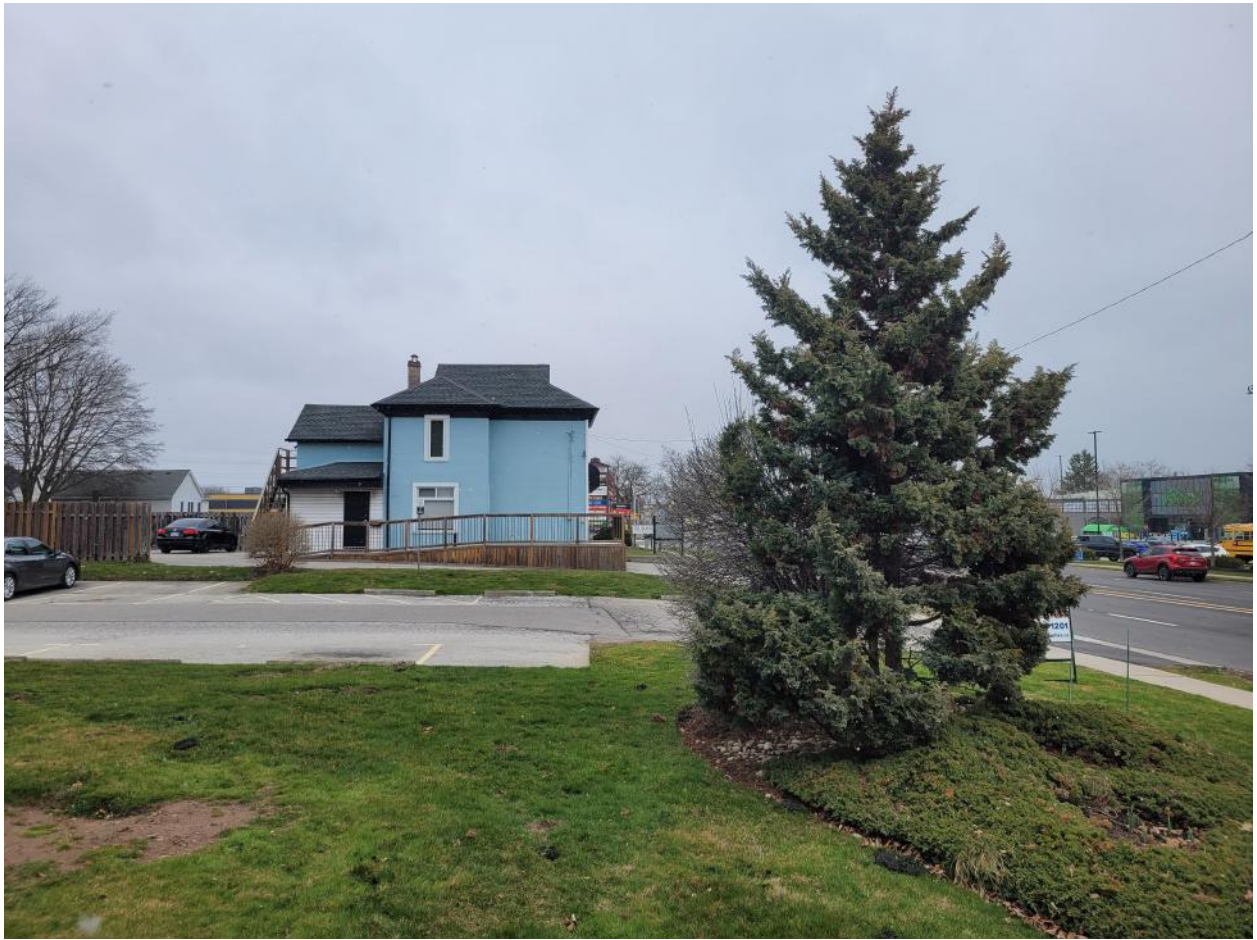
Photo 7. Tree 20

20	<i>Chamaecyparis pisifera</i> (Sawara cypress)	11	1	Good	Good	Good central leader; good new growth.	2	Private	Injure - due to proposed concrete walkway.

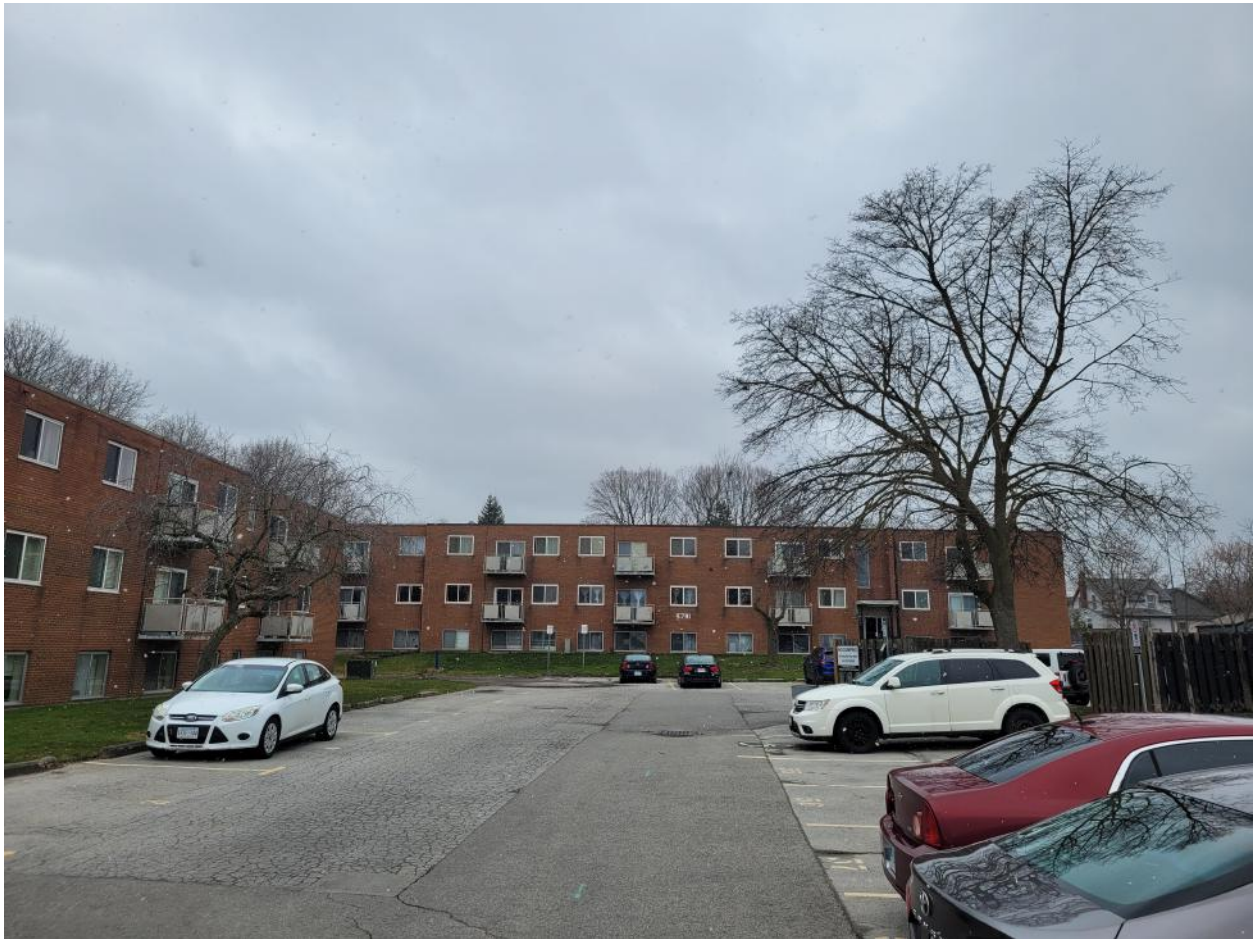
Photo 8. Trees 21-23.

Tree #	Species	DBH (cm)	Crown Radius (m)	Biological Condition	Structural Condition	Condition Comments	Min TPZ (m)	Ownership Category	Recommended Action & Details
21	<i>Acer platanoides</i> (Norway maple)	48	4	Fair	Fair	Decurrent habit; stunted new growth.	5	Private	Remove - due to proposed parking lot.
22	<i>Malus sp.</i> (crabapple)	29.5	3	Fair	Fair	Significant deadwood; fire blight; fair shoot extension.	4	Private	Remove - due to proposed parking lot.
23	<i>Prunus serrulata</i> (flowering cherry)	49	2.5	Poor	Poor	Exposed surface roots with decay; basal decay and sapwood rot in trunk; major past dieback.	3.5	Private	Remove - due to proposed parking lot.
24	<i>Thuja occidentalis</i> 'smaragd' (Emerald cedar)	14	1	Good	Fair	Limbed up 1 m; codominant leaders; good new growth.	2	Private	Remove - due to proposed 1/2 storey parking structure.
25	<i>Quercus rubra</i> (red oak)	120	8	Fair	Fair	Decurrent habit; moderate deadwood; fair shoot extension.	9	Neighbor	Injure - due to proposed 1/2 storey parking structure. Significant impacts expected. Air spade and root pruning recommended.

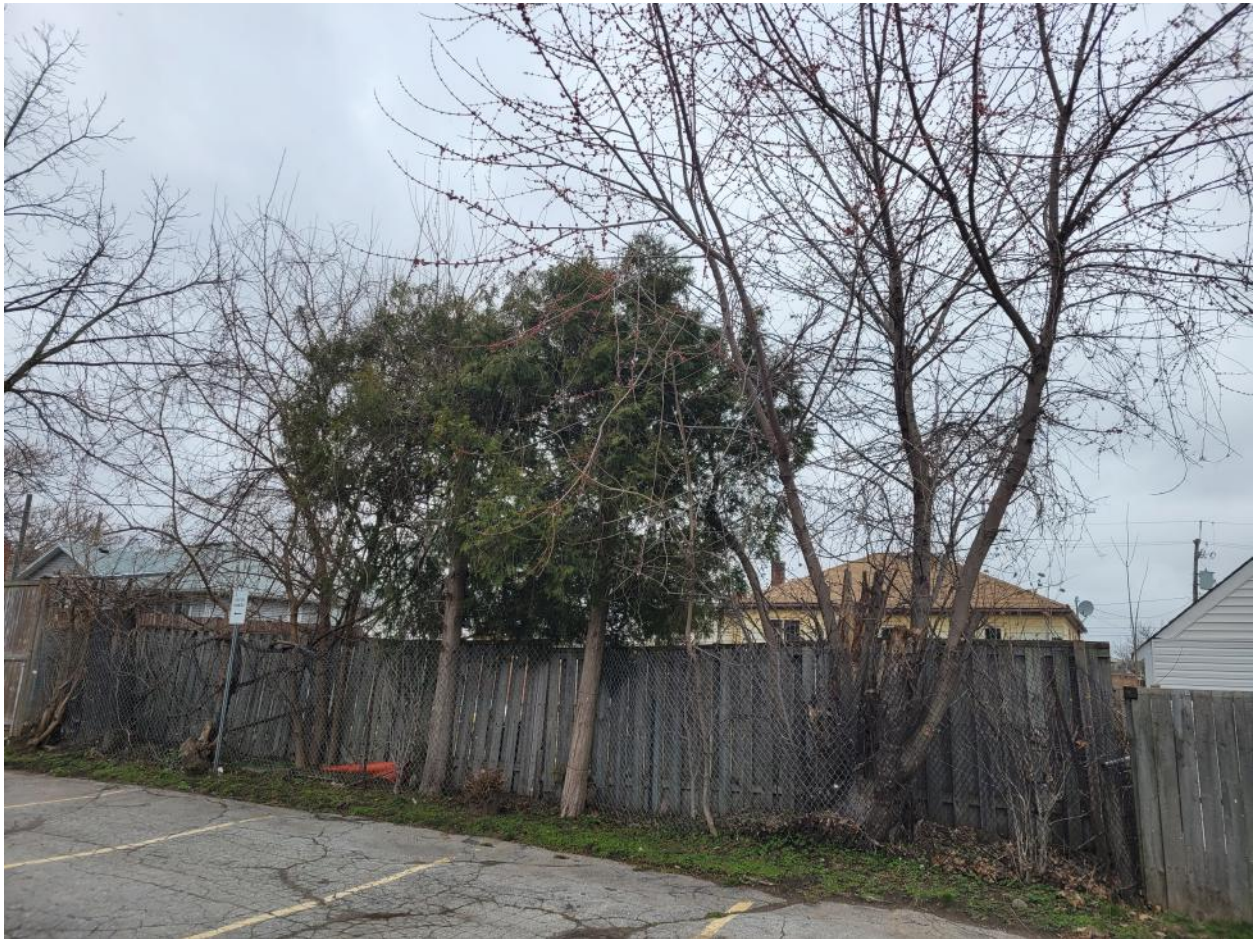
Photo 10. Trees 26-29.

Tree #	Species	DBH (cm)	Crown Radius (m)	Biological Condition	Structural Condition	Condition Comments	Min TPZ (m)	Ownership Category	Recommended Action & Details
26	<i>Acer saccharinum</i> (silver maple)	28	3.5	Good	Poor	Epicormics from stump of past failed tree with rot in existing stump; ~20 & 20cm DBH stems; good new growth.	4.5	Boundary	Remove - due to proposed 1/2 storey parking structure.
27	<i>Thuja occidentalis</i> (white cedar)	20	1.5	Fair	Fair	Limbed up ~2m; fair new growth.	2.5	Boundary	Remove - due to proposed 1/2 storey parking structure.
28	<i>Thuja occidentalis</i> (white cedar)	23	1.5	Fair	Fair	Limbed up ~2m; fair new growth.	2.5	Boundary	Remove - due to proposed 1/2 storey parking structure.
29	<i>Morus alba</i> (white mulberry)	19	1.5	Good	Fair	Multi-stem (~12, 10 & 10cm DBH); good new growth.	2.5	Potential Boundary	Remove - due to proposed 1/2 storey parking structure.
30	<i>Juglans nigra</i> (black walnut)	40	4	Fair	Poor	Multi-stem (33 * 23cm DBH); one main stem failed in past with large dead stub; fair new growth.	5	Private	Remove - due to proposed 1/2 storey parking structure.

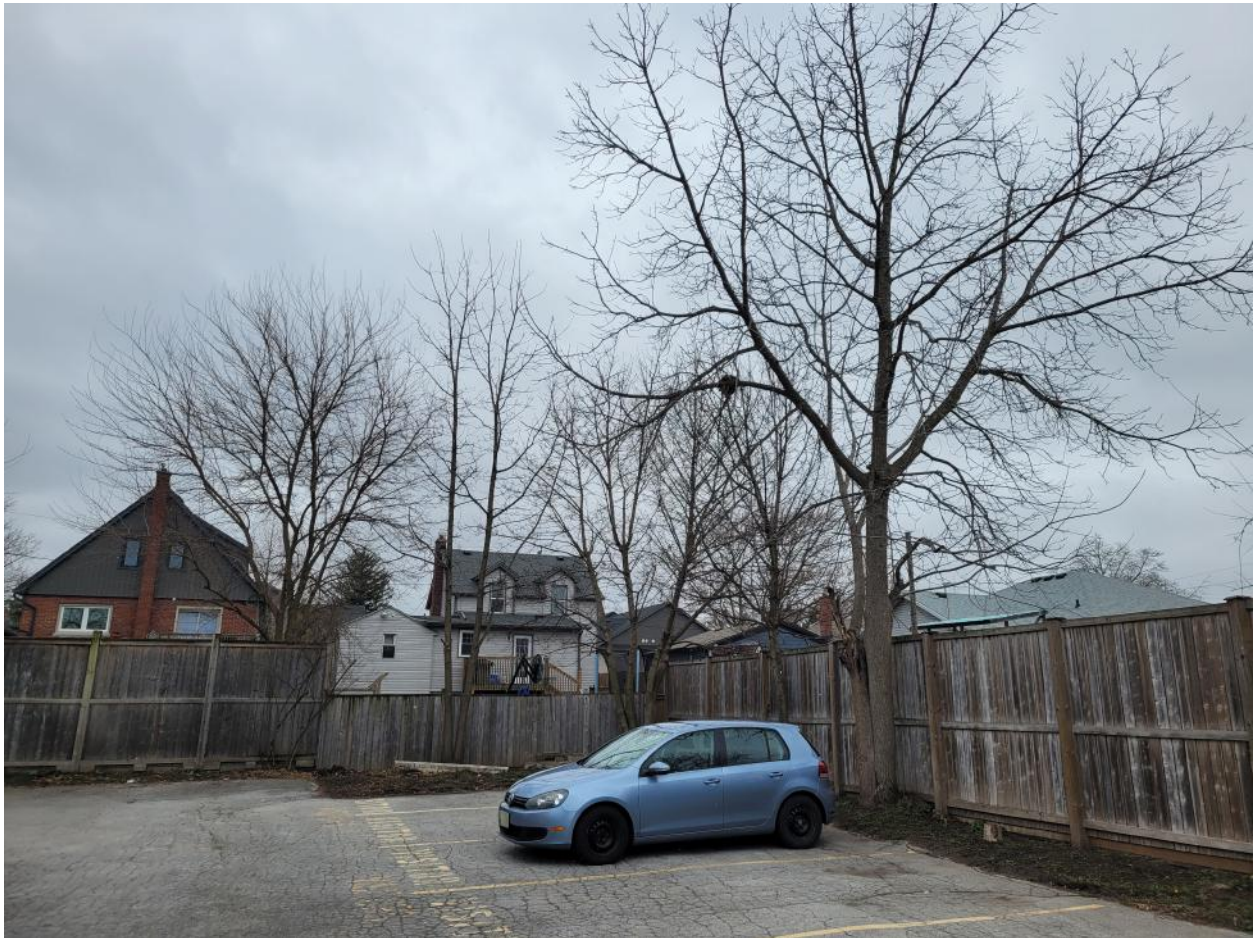
Photo 11. Trees 30-33.

Tree #	Species	DBH (cm)	Crown Radius (m)	Biological Condition	Structural Condition	Condition Comments	Min TPZ (m)	Ownership Category	Recommended Action & Details
31	<i>Acer platanoides</i> (Norway maple)	18	2	Good	Fair	Decurrent habit; good shoot extension.	3	Private	Remove - due to proposed 1/2 storey parking structure.
32	<i>Acer platanoides</i> (Norway maple)	37	4	Fair	Poor	Multi-stem (26.5, 19 & 18.5cm DBH); Fair shoot extension.	5	Private	Remove - due to proposed 1/2 storey parking structure.
33	<i>Juglans nigra</i> (black walnut)	24	3	Good	Fair	Two stems from base (17 & 17cm DBH); good shoot extension.	4	Private	Remove - due to proposed 1/2 storey parking structure.
34	<i>Thuja occidentalis</i> (white cedar)	13.5	1.5	Fair	Fair	Good central leader; dead top.	2.5	Boundary	Remove - due to proposed 1/2 storey parking structure.
35	<i>Morus alba</i> (white mulberry)	25	4	Fair	Fair	Decurrent habit; asymmetrical crown due to Tree 36; fair shoot extension.	5	Boundary	Remove - due to proposed 1/2 storey parking structure.

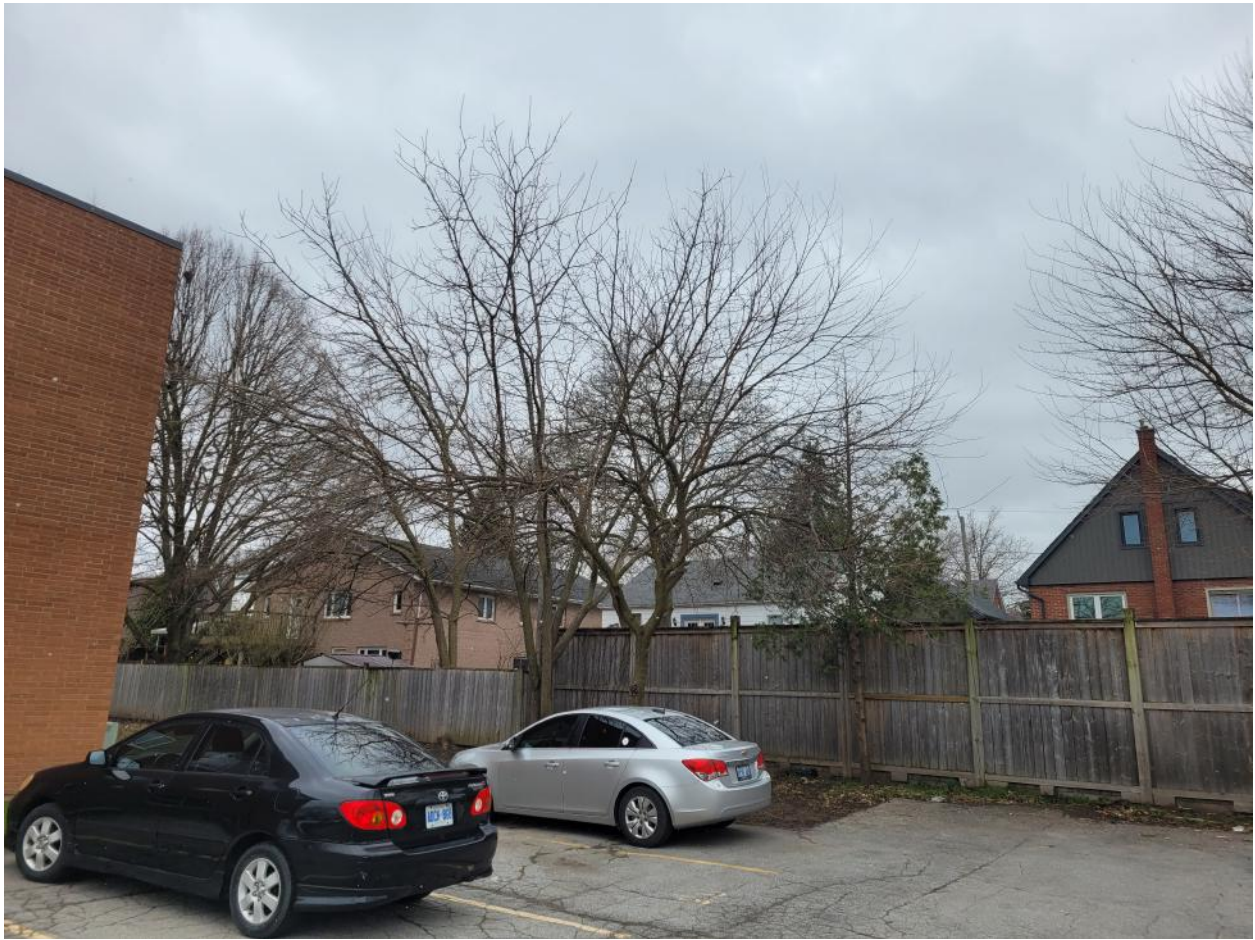
Photo 12. Trees 34-37.

Tree #	Species	DBH (cm)	Crown Radius (m)	Biological Condition	Structural Condition	Condition Comments	Min TPZ (m)	Ownership Category	Recommended Action & Details
36	<i>Juglans nigra</i> (black walnut)	36	4	Fair	Poor	Two stems from base (22 & 28cm DBH); fair shoot extension.	5	Boundary	Remove - due to proposed 1/2 storey parking structure.
37	<i>Morus alba</i> (white mulberry)	25	4	Fair	Fair	Multi-stem (~18 & 17cm DBH); fair shoot extension.	5	Potential Boundary	Preserve - tree protection fence.
38	<i>Tilia americana</i> (basswood)	75	6	Fair	Fair	Decurrent habit; heavy sap sucker feeding; fair shoot extension; minor deadwood.	7	Neighbor	Preserve - tree protection fence.
39	<i>Prunus serotina</i> (black cherry)	41	5	Fair	Fair	Decurrent habit; moderate deadwood; fair shoot extension.	6	Boundary	Preserve - tree protection fence.
40	<i>Tilia americana</i> (basswood)	75	6	Fair	Fair	Decurrent habit; heavy sap sucker feeding; fair shoot extension; minor deadwood.	7	Neighbor	Preserve - tree protection fence.

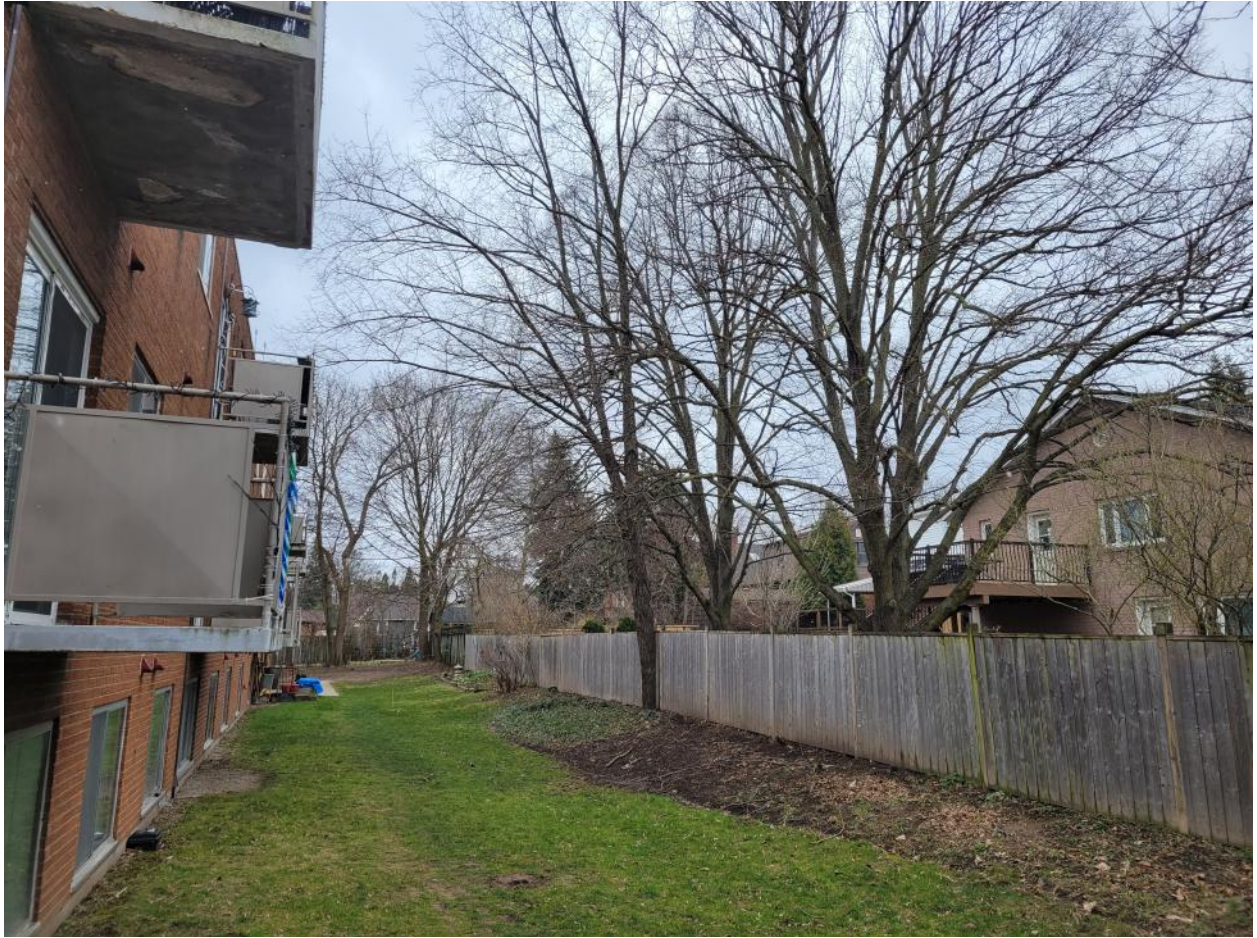
Photo 13. Trees 38-42.

Tree #	Species	DBH (cm)	Crown Radius (m)	Biological Condition	Structural Condition	Condition Comments	Min TPZ (m)	Ownership Category	Recommended Action & Details
41	<i>Acer platanoides</i> (Norway maple)	17	3.5	Fair	Poor	Leader failed in past; lowest scaffold with poor aspect ratio to main trunk.	4.5	Neighbor	Preserve - tree protection fence.
42	<i>Acer platanoides</i> (Norway maple)	30	4	Fair	Good	Good central leader; fair new growth.	5	Neighbor	Preserve - tree protection fence.
