ARBORIST REPORT

3828 Saint Peter Ave.
Niagara Falls, ON
L2J 2N6

Created: January 3, 2024
Last revised: January 3, 2024

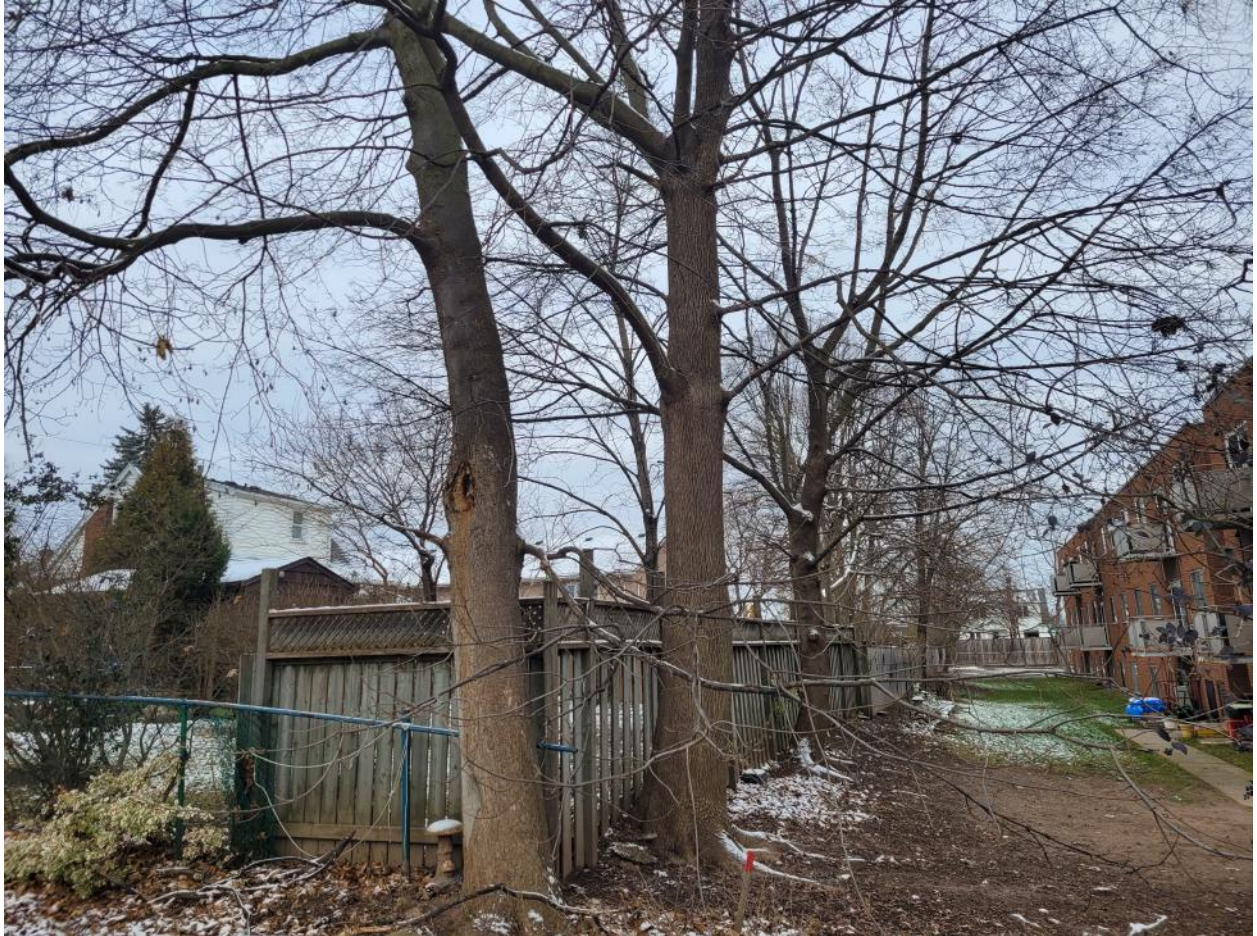
Photo 1. Trees 1-3.

Tree #	Species	DBH (cm)	Crown Radius (m)	Biological Condition	Structural Condition	Condition Comments	Min TPZ (m)	Ownership Category	Recommended Action & Details
1	<i>Acer platanoides</i> (Norway maple)	36	4	Fair	Fair	Decurrent habit; fair shoot extension.	5	Neighbor	Preserve
2	<i>Acer platanoides</i> (Norway maple)	54	4	Fair	Fair	Decurrent habit; fair shoot extension.	5	Neighbor	Injure - due to proposed parking lot.

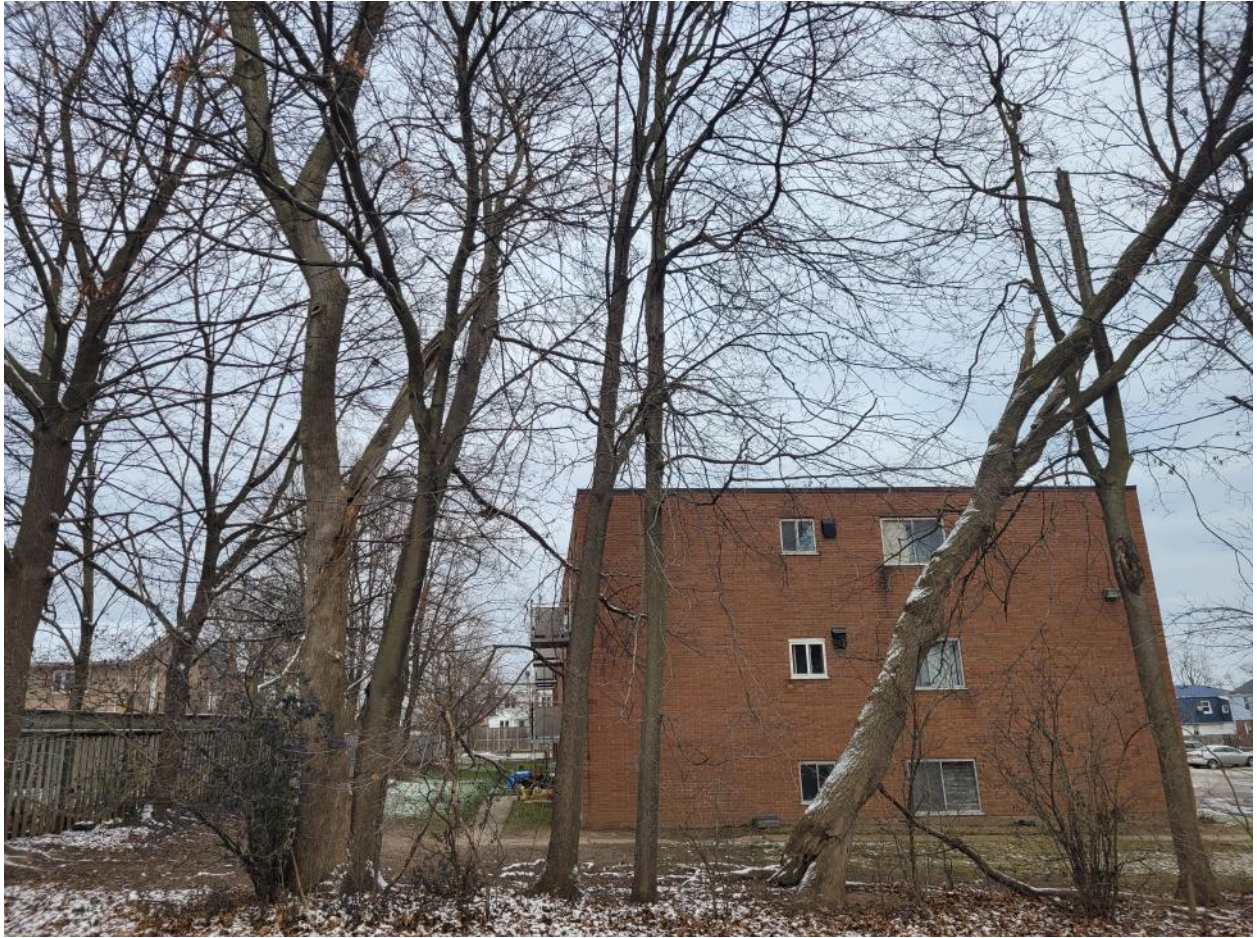
Photo 2. Trees 4-9.

Tree #	Species	DBH (cm)	Crown Radius (m)	Biological Condition	Structural Condition	Condition Comments	Min TPZ (m)	Ownership Category	Recommended Action & Details
3	<i>Acer pseudoplatanus</i> (sycamore maple)	46	4	Good	Fair	Asymmetrical due to Tree 2; good shoot extension; large canker in main trunk ~25% of circumference.	5	Private	Remove - due to proposed parking lot.
4	<i>Acer negundo</i> (Manitoba maple)	48	4	Fair	Poor	Significant deadwood up to ~30cm in diameter; fair shoot extension; cohort base with Tree 5.	5	Potential Boundary	Remove - due to proposed parking lot.
5	<i>Acer platanoides</i> (Norway maple)	44	5	Fair	Fair	Cohort at base with Tree 4; asymmetrical crown; fair shoot extension.	6	Potential Boundary	Remove - due to proposed parking lot.
6	<i>Acer platanoides</i> (Norway maple)	33.5	4	Fair	Fair	Cohort with adjacent trees; fair central leader; fair shoot extension.	5	Potential Boundary	Remove - due to proposed parking lot.

7	<i>Acer platanoides</i> (Norway maple)	24.5	3.5	Fair	Fair	Cohort with adjacent trees; fair central leader; fair shoot extension.	4.5	Private	Remove - due to proposed parking lot.

Tree #	Species	DBH (cm)	Crown Radius (m)	Biological Condition	Structural Condition	Condition Comments	Min TPZ (m)	Ownership Category	Recommended Action & Details
8	<i>Acer negundo</i> (Manitoba maple)	57	4	Poor	Poor	Major lean; caught up in adjacent trees; decay at base; exposed surface roots with decay large diameter deadwood.	5	Potential Boundary	Remove - due to proposed parking lot.
9	<i>Acer platanoides</i> (Norway maple)	30	3	Fair	Poor	Tree 8 caught up in crown; codominant leader with one leader broken off; good shoot extension; large Eutypella canker in trunk.	4	Potential Boundary	Remove - due to proposed parking lot.
10	<i>Acer platanoides</i> (Norway maple)	47	5	Fair	Fair	Asymmetrical due to adjacent trees; Tree 8 caught up in crown; Decurrent habit; fair shoot extension.	6	Private	Remove - due to proposed parking lot.
11	<i>Acer pseudoplatanus</i> (sycamore maple)	35	2	Poor	Poor	Majority of crown lost in past failure with significant decay in remaining stem; large diameter deadwood up to ~25cm.	3	Potential Boundary	Remove - due to proposed parking lot.
