**Tree Inventory and Preservation Plan
3770 and 3940 Montrose Road
Niagara Falls, Ontario**

6 January 2022; revised 29 August 2023, 27 November 2023, 14 February 2024,
and 8 April 2024

KUNTZ FORESTRY CONSULTING INC. Project P2940

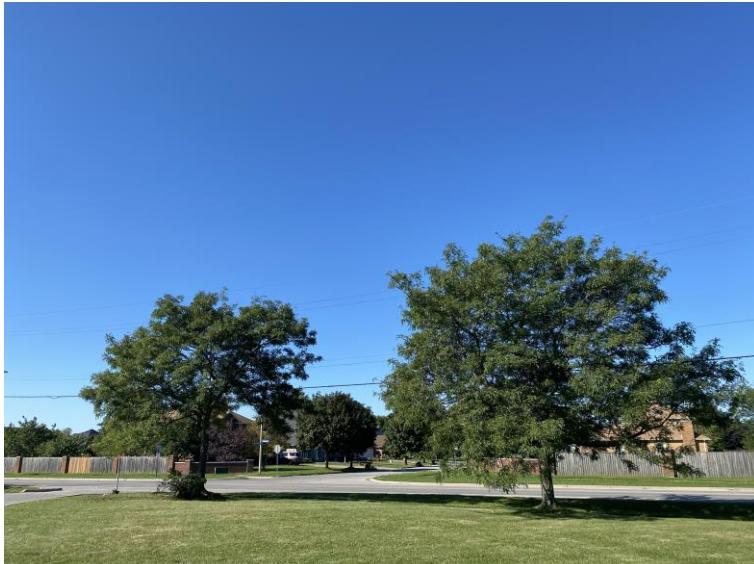
Image 1. Trees 658 (left) and 658 (right)

Tree #	Common Name	Scientific Name	DBH	TI	CS	CV	CDB	DL	Comments	Action
657	Honey Locust (Shademaster)	<i>Gleditsia triacanthos inermis</i>	31.5	G	G	G		4.5	Exposed roots (L), deadwood (L), union at 3m	Remove
658	Honey Locust (Shademaster)	<i>Gleditsia triacanthos inermis</i>	38.0	G	G	G		5.0	Union at 2m, pruning wounds (L)	Remove
659	Austrian Pine	<i>Pinus nigra</i>	43.0	FG	G	G		4.0	Pruning wounds (L), lean (L), exposed roots (VL)	Remove
660	White Spruce	<i>Picea glauca</i>	40.0	FG	G	G		3.0	Sweep (L), pruning wounds (L)	Remove
661	Austrian Pine	<i>Pinus nigra</i>	43.0	G	G	G		3.5	Pruning wounds (L)	Remove
662	White Birch	<i>Betula papyrifera</i>	19.5, 8	P	PF	F	10	3.5	Poor form (M), bow (M), crack (M) with decay in larger leader, decay along larger leader to base, deadwood (L)	Remove
663	Austrian Pine	<i>Pinus nigra</i>	~48	FG	G	FG		3.5	Lean (L), pruning wounds (L)	Remove
664	White Spruce	<i>Picea glauca</i>	40.0	G	G	G		2.5	Lean (VL), pruning wounds (L)	Remove

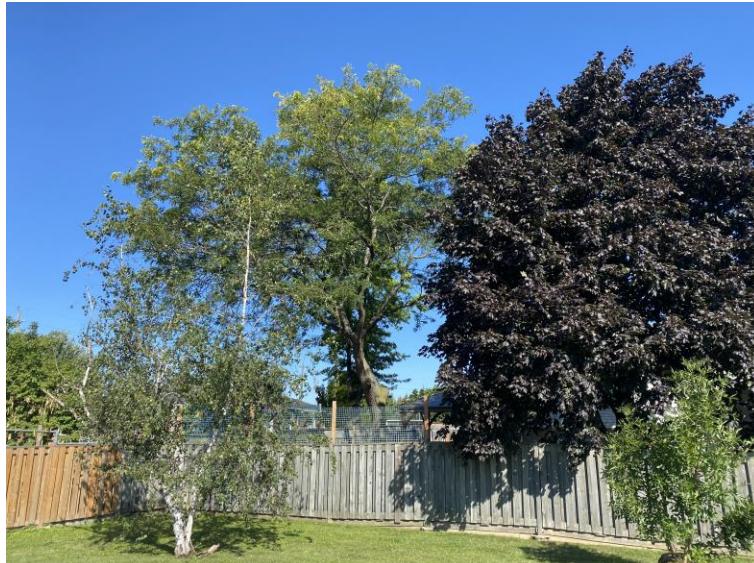
Image 3. From left to right, Trees 662, A, and B

Encroachment into the driplines of Trees A and B will be required to facilitate the installation of a proposed retaining wall. If the following mitigation measures are employed, long-term adverse effects are not anticipated for these trees.

A	Honey Locust (Shademaster)	<i>Gleditsia triacanthos inermis</i>	~55	G	G	G		8.0	Union at 3m, pruning wounds (L)	Preserve
B	Norway Maple (Crimson King)	<i>Acer platanoides 'Crimson King'</i>	~50	FG	G	G		4.0	Girdling roots (M)	Preserve

1. The preservation fencing, as shown on Figure 1, should be installed as required and maintained throughout construction.
2. Air-spade or low-pressure hydro-vacuum technology should be used to excavate a trench at the limit of excavation for the proposed retaining wall, under the supervision of a Certified Arborist.
3. The depth of the trench will depend on the depth of excavation required to install the proposed retaining wall.
4. The roots of Trees A and B are to be pruned inside the trench by a Certified Arborist in accordance with Good Arboricultural Standards.
5. The trench is to be backfilled with clean topsoil.

Given that Trees A and B are located on a neighbouring property, the respective neighbouring property owner should be engaged prior to the commencement of the proposed works to discuss the anticipated injury to their trees.

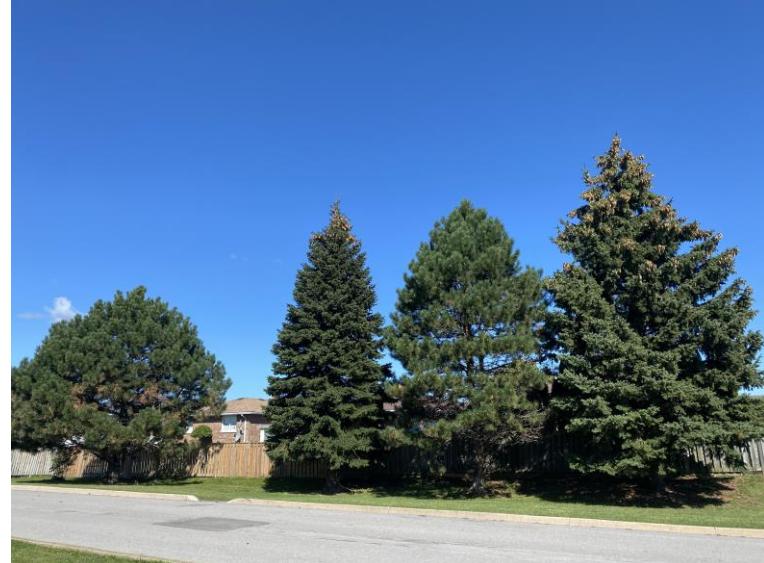
Image 4. From left to right, Trees 663 - 666

665	Austrian Pine	<i>Pinus nigra</i>	39.0	F	FG	FG		4.0	Lean (L), V-union at 2m (co-dominance) with 3 leaders, pruning wounds (L)	Remove
666	White Spruce	<i>Picea glauca</i>	38.0	FG	G	FG		4.0	Sweep (L), epicormic branching (L)	Remove
667	Green Ash	<i>Fraxinus pennsylvanica</i>	37.5	P	P	PF	70	3.0	Emerald Ash Borer, main leader dead with decay, epicormic branching (H), bark sloughing	Remove (Condition)
668	Austrian Pine	<i>Pinus nigra</i>	41.0	F	G	FG		4.0	Pruning wounds (L), girdling roots (L), sweep (L), bow (L)	Remove
669	Austrian Pine	<i>Pinus nigra</i>	~28	FG	G	FG		4.0	Lean (L), pruning wounds (L)	Remove
670	Austrian Pine	<i>Pinus nigra</i>	38.0	F	G	G		4.0	Lean (M), pruning wounds (L), girdling roots (L)	Remove
671	White Spruce	<i>Picea glauca</i>	41.0	FG	G	G		3.0	Epicormic branching (L), pruning wounds (L), lean (L)	Remove
672	Austrian Pine	<i>Pinus nigra</i>	48.0	G	G	G		4.0	Pruning wounds (L)	Remove

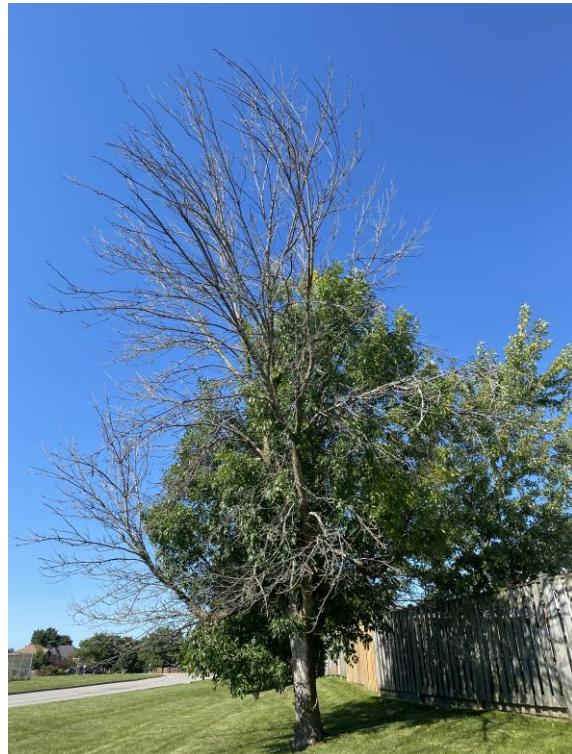
Image 5. Tree 667

The removal of 32 trees is required to accommodate the proposed development. The required tree removals include Trees 657 – 666 and 668 – 689. All trees identified for removal directly either conflict directly with the proposed development or the level of encroachment into their driplines resulting from the proposed work would be at an intolerable level such that we would not expect the trees to overcome the injury. It should be noted that Tree 680 is identified for removal as a result of the re-grading proposed within the buffer area. The removal of one additional tree, Tree 667, is recommended due to its poor condition.

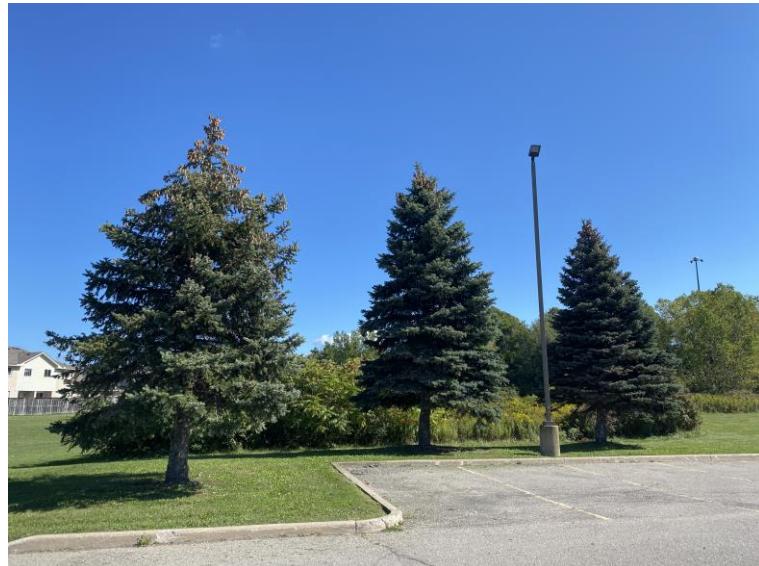
Image 9. From left to right, Trees 676 – 678

676	Blue Spruce	<i>Picea pungens</i>	28.0	FG	G	FG		2.5	Exposed roots (L), pruning wounds (L) with sap, stem wounds (L) with sap, lean (VL), epicormic branching (VL)	Remove
677	Blue Spruce	<i>Picea pungens</i>	28.0	G	G	G		2.5	Pruning wounds (L) with sap	Remove
678	Blue Spruce	<i>Picea pungens</i>	28.0	FG	G	FG		2.5	Pruning wounds (L) with sap, lean (L), epicormic branching (VL)	Remove
679	Manitoba Maple	<i>Acer negundo</i>	33.0	F	FG	FG		4.0	V-union at 1.5m with included bark, epicormic branching (M), exposed roots (M), vine competition (M)	Remove
680	Blue Spruce	<i>Picea pungens</i>	19.5	G	G	G		2.0	Pruning wounds (L), exposed roots (VL)	Remove
681	Honey Locust (Shademaster)	<i>Gleditsia triacanthos inermis</i>	23.5	FG	FG	F	10	4.0	Bow (L), pruning wounds (L), sparse crown (L), deadwood (L), epicormic branching (L)	Remove
682	Honey Locust (Shademaster)	<i>Gleditsia triacanthos inermis</i>	16.0	G	F	PF	25	3.0	Union at 2m, epicormic branching (H), sparse crown (M), deadwood (L)	Remove

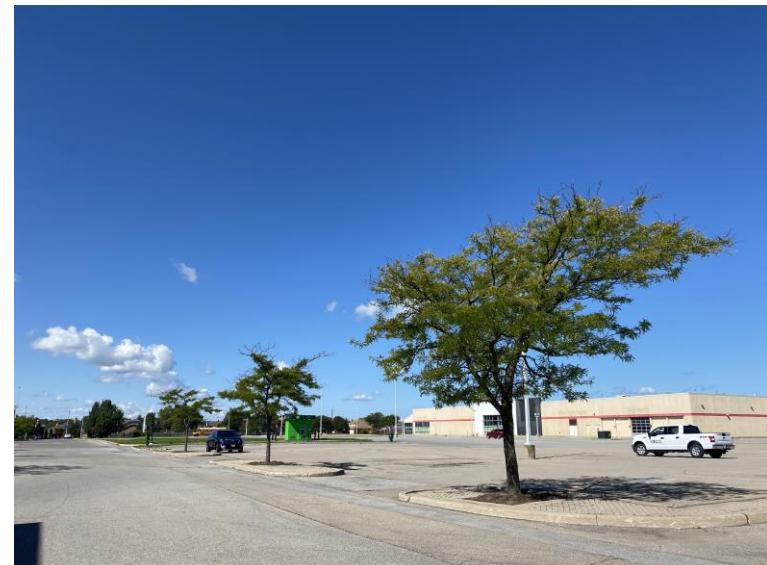
Image 14. From right to left, Trees 681 - 683

Trees 681 – 683 are located on a neighbouring property and as such, written permission from the respective neighbouring property owner will be required prior to the removal of these trees. All other trees identified for removal are located within the boundaries of the subject property.

683	Honey Locust (Shademaster)	<i>Gleditsia triacanthos inermis</i>	13.5	G	F	PF	35	2.5	Union at 2m, epicormic branching (H), sparse crown (M), deadwood (M)	Remove
684	English Oak (Pyramidal)	<i>Quercus robur 'Fastigiata'</i>	32, 18	FG	FG	G		4.5	Union at 0.2m, asymmetrical crown (L)	Remove
685	English Oak (Pyramidal)	<i>Quercus robur 'Fastigiata'</i>	30.0	G	FG	G		3.5	Union at 0.2m, asymmetrical crown (L)	Remove
686	English Oak (Pyramidal)	<i>Quercus robur 'Fastigiata'</i>	24, 28, 24	FG	FG	G		5.0	Union at 0.1m and 0.2m, asymmetrical crown (L)	Remove
687	Honey Locust (Shademaster)	<i>Gleditsia triacanthos inermis</i>	39.0	FG	G	G		5.5	Lean (L), union at 2m, pruning wounds (L)	Remove
688	Honey Locust (Shademaster)	<i>Gleditsia triacanthos inermis</i>	37.5	G	G	G		5.5	Union at 1.5m, pruning wounds (L)	Remove
689	Honey Locust (Shademaster)	<i>Gleditsia triacanthos inermis</i>	33.0	G	G	G		5.5	Pruning wounds (L), included branching in trunk, exposed roots (L)	Remove
