APPENDIX C GRAND NIAGARA SECONDARY PLAN BACKGROUND ANALYSIS REPORT APRIL 2016

# REPORT VIBRATION IMPACT STUDY

GRAND NIAGARA SECONDARY PLAN

14-15039-001-N02 | April 2016

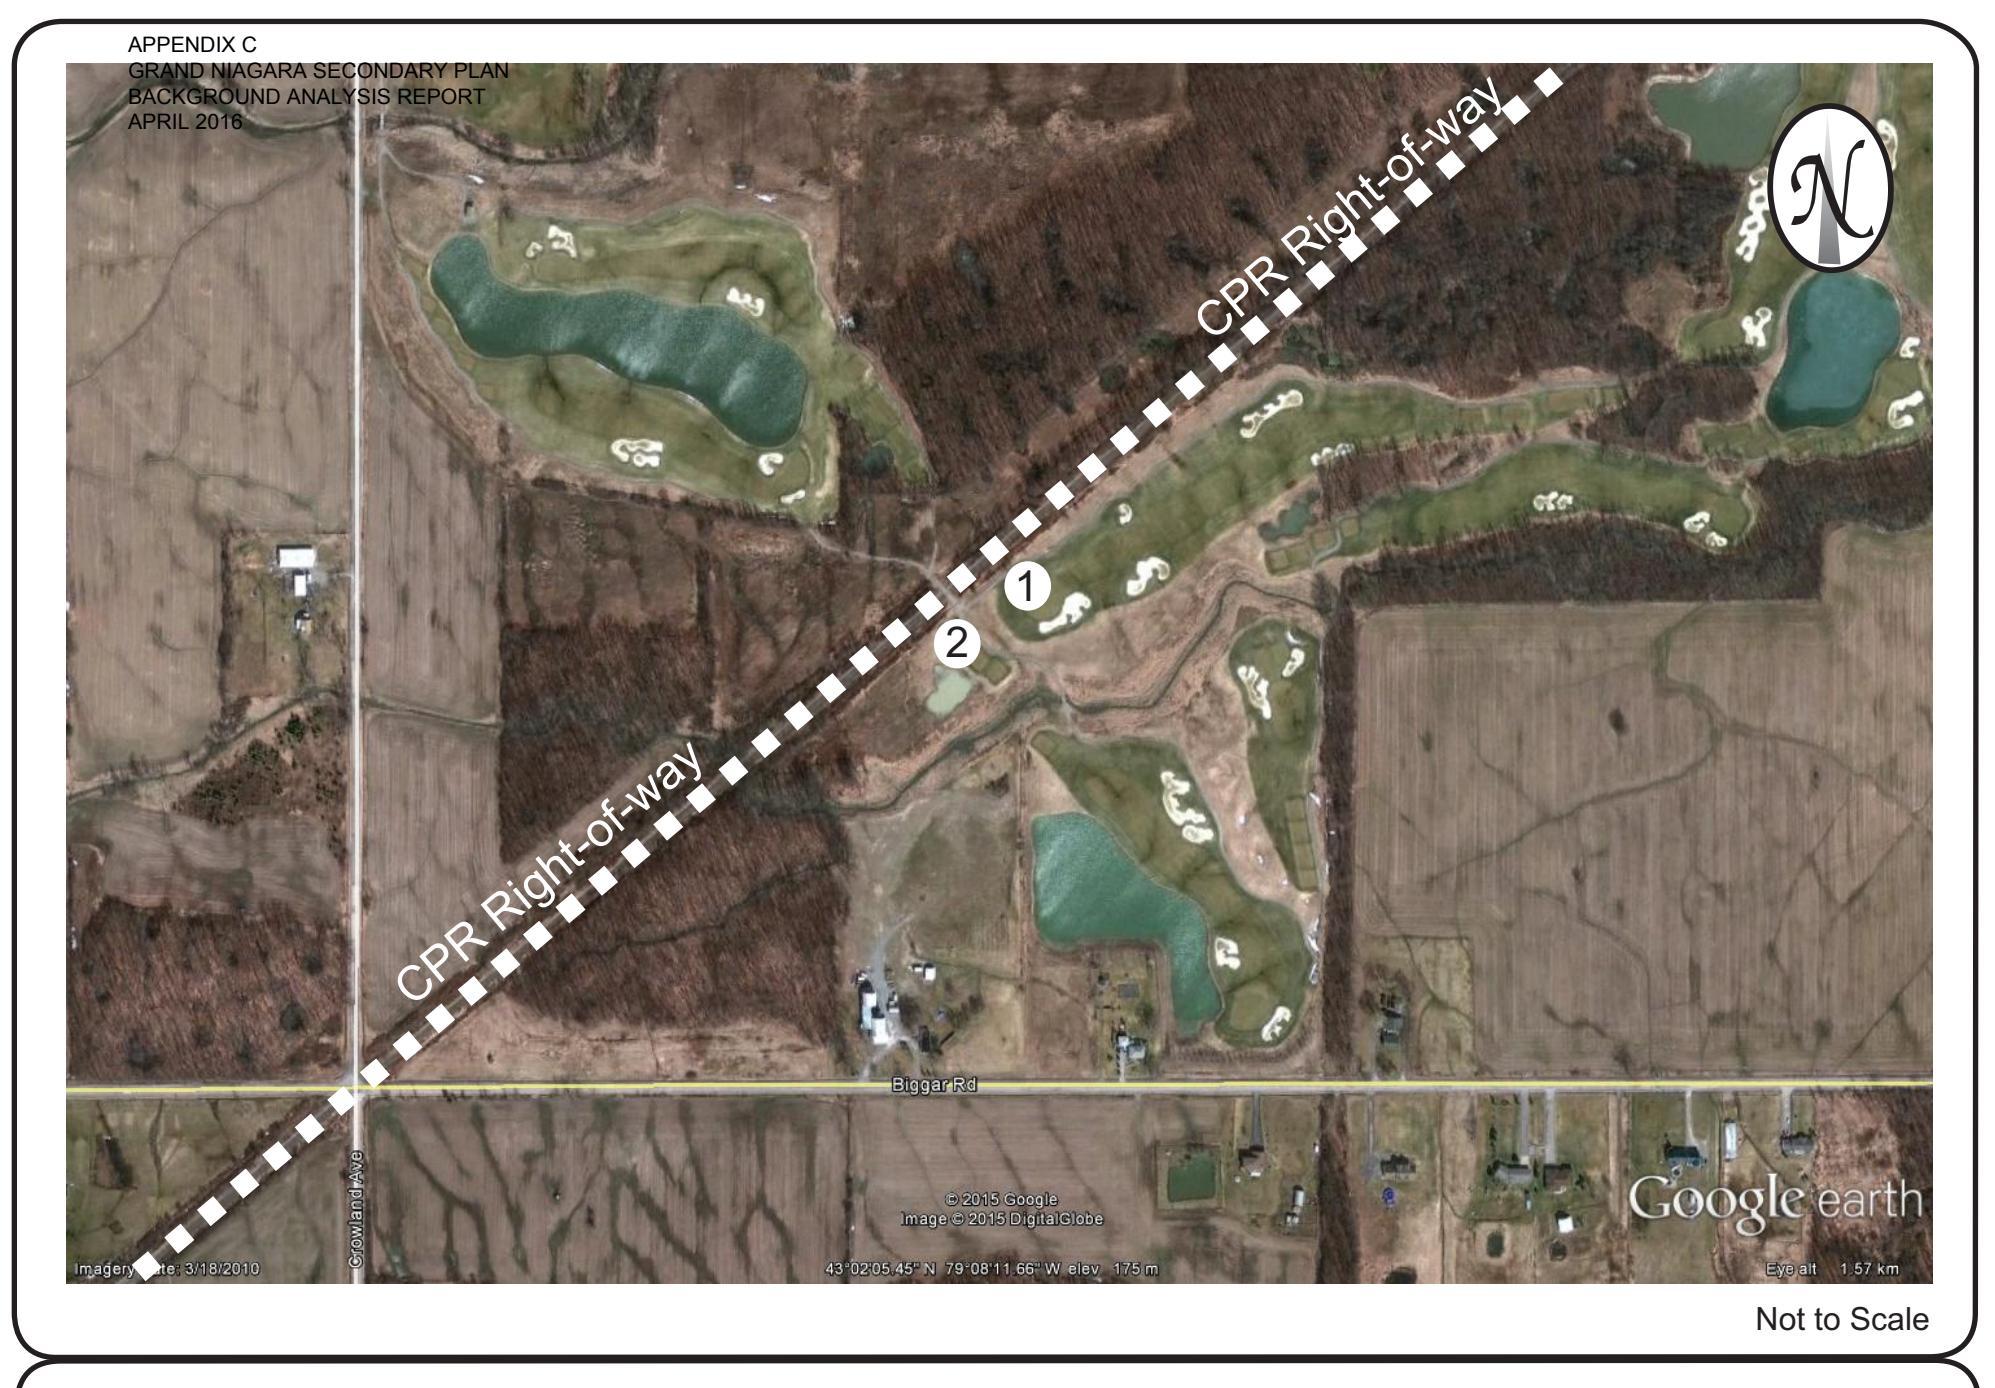
FIGURE 1 CPR Freight Train Pass-by Vibration Measurement Locations Grand Niagara Secondary Plan

Vibration measurements were undertaken at two locations as shown in **Figure 1**. The resulting measurement locations' distance to the railway right-of-way is approximately 30 metres. These measurement locations are referred to as Locations 1 and 2.

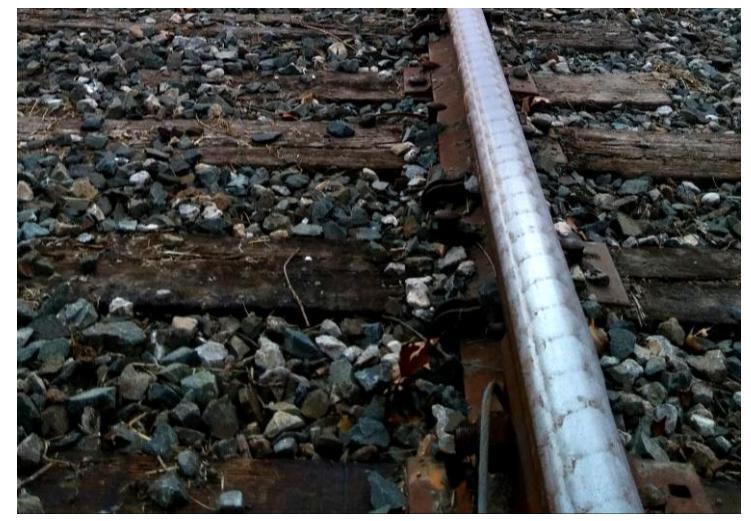
Photograph 1

Rail unevenness, large gaps between rail segments, roughness and corrugation are very important factors causing vibration during train pass-bys. Train maintenance such as proper wheel alignment and well-

maintained wheels (i.e. no flat spots) are very important as well. These factors can increase vibration levels by up to 20 dB in the most extreme cases. We observed large gaps between rails, and based on a consultation with our Senior Rail Inspector, the rail is badly corrugated, as shown in the **Photograph 1** below. As such, the poor state of the tracks is likely to be exacerbating any vibration caused by the trains (see attached correspondence).

- The measurement results indicate that the maximum vibration levels due to the CPR freight train
  pass-bys on the railway line exceed the applicable vibration criteria. The poor state of the railway
  is likely to be exacerbating any vibration caused by the trains. We expect the vibration levels to
  noticeably drop if the observed corrugation, the roughness and the large gaps between rail
  segments are addressed by CPR.

As per the pictures this is getting to the point that it should be addressed.

As per the pictures is this on tangent track Normally occurs on the low rail of curve.

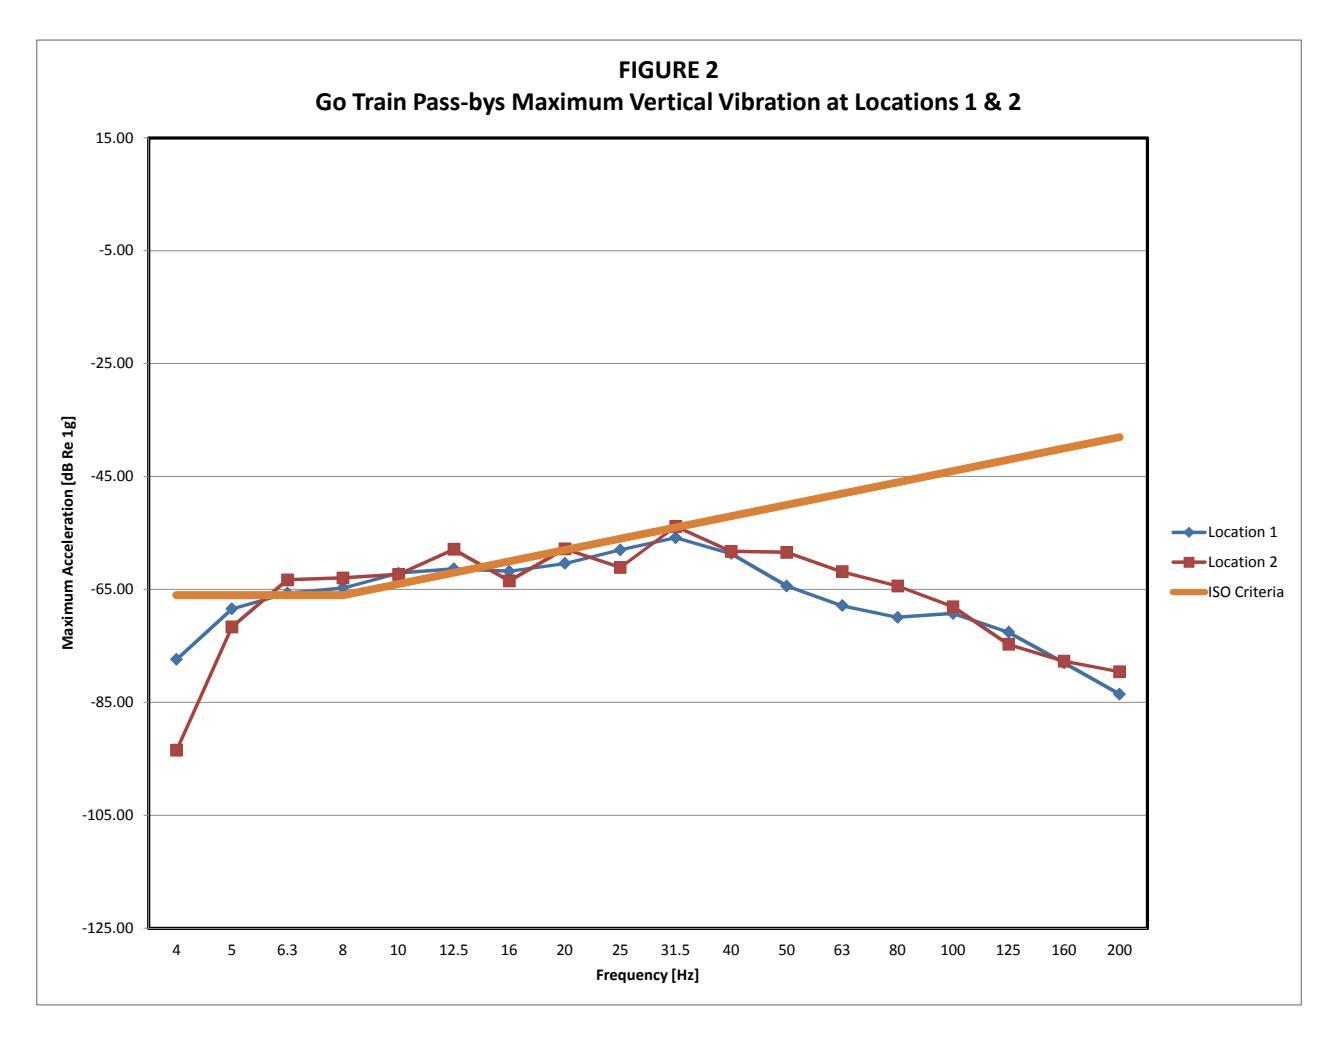
**Figure 2** and **Table 1** in the **Appendix** contain the measured vibration levels taken at Locations 1 and 2. Measured vibration levels are compared to the CPR Vibration Guidelines criteria outlined in Section 2 of this report.

The results illustrated on the graphs and tables show that the **maximum vibration levels** due to the CPR train pass-bys on the railway lines **exceed the applicable vibration criteria**. This is consistent with the findings of Grand Niagara Resort – Noise/Vibration Study prepared by Aercoustics Engineering Limited in December 7, 2006, at locations approximately 150 to 200 metres away. The vibration exceedances were observed in the 6.3 Hz, 8 Hz, 10 Hz and 12.5 Hz third-octave bands. Given the low frequency of vibration, we note that mitigation may not be practical or effective.

These exceedances are considered marginal and range from only 0.5 to 4 decibels above the ISO criteria. In general, these exceedances manifested themselves as short 1-second exceedances totaling 5 and 11 non-consecutive seconds out of the 90-second observed train pass-by duration for locations 1 and 2, respectively.
