**PHASE TWO
ENVIRONMENTAL SITE ASSESSMENT**

5438 Ferry Street, Niagara Falls, ON

**For:
1788618 Ontario Inc.**

January 18, 2023
Project: E-22-33-2

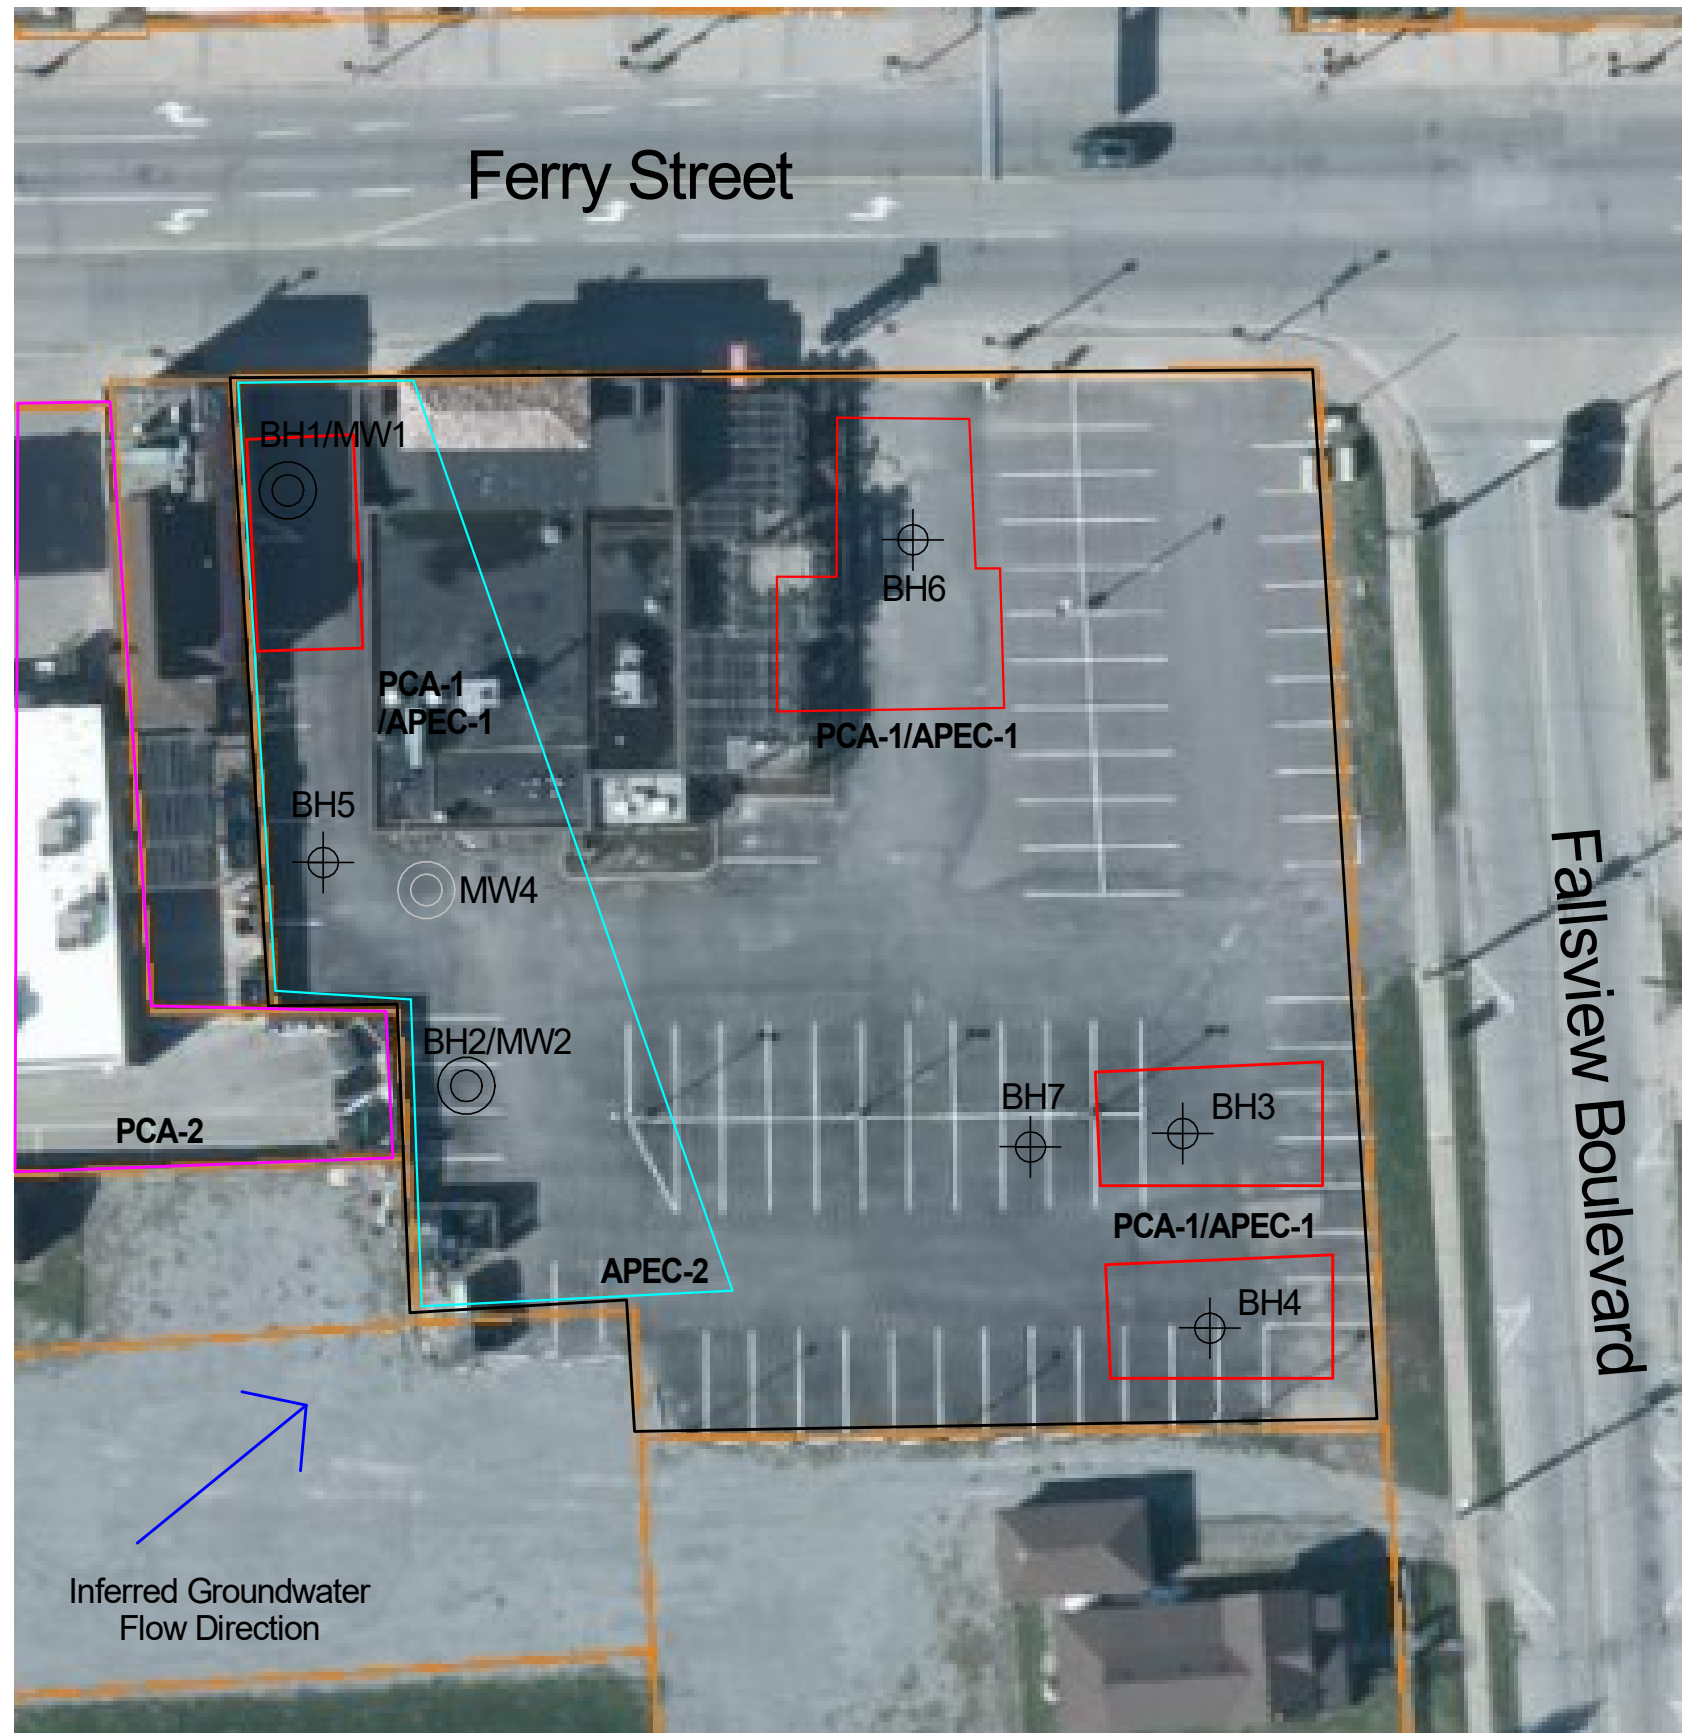
Project E-22-33-2	Figure 1
Date January 2023	
Drafted: M. Calvert	
Reviewed: N. Metz

PCA-1/APEC-1:
 #30 Importation of Fill Material of Unknown Quality
PCA-2/APEC-2:
 #28 Gasoline and Associated Products Storage
 in Fixed Tanks

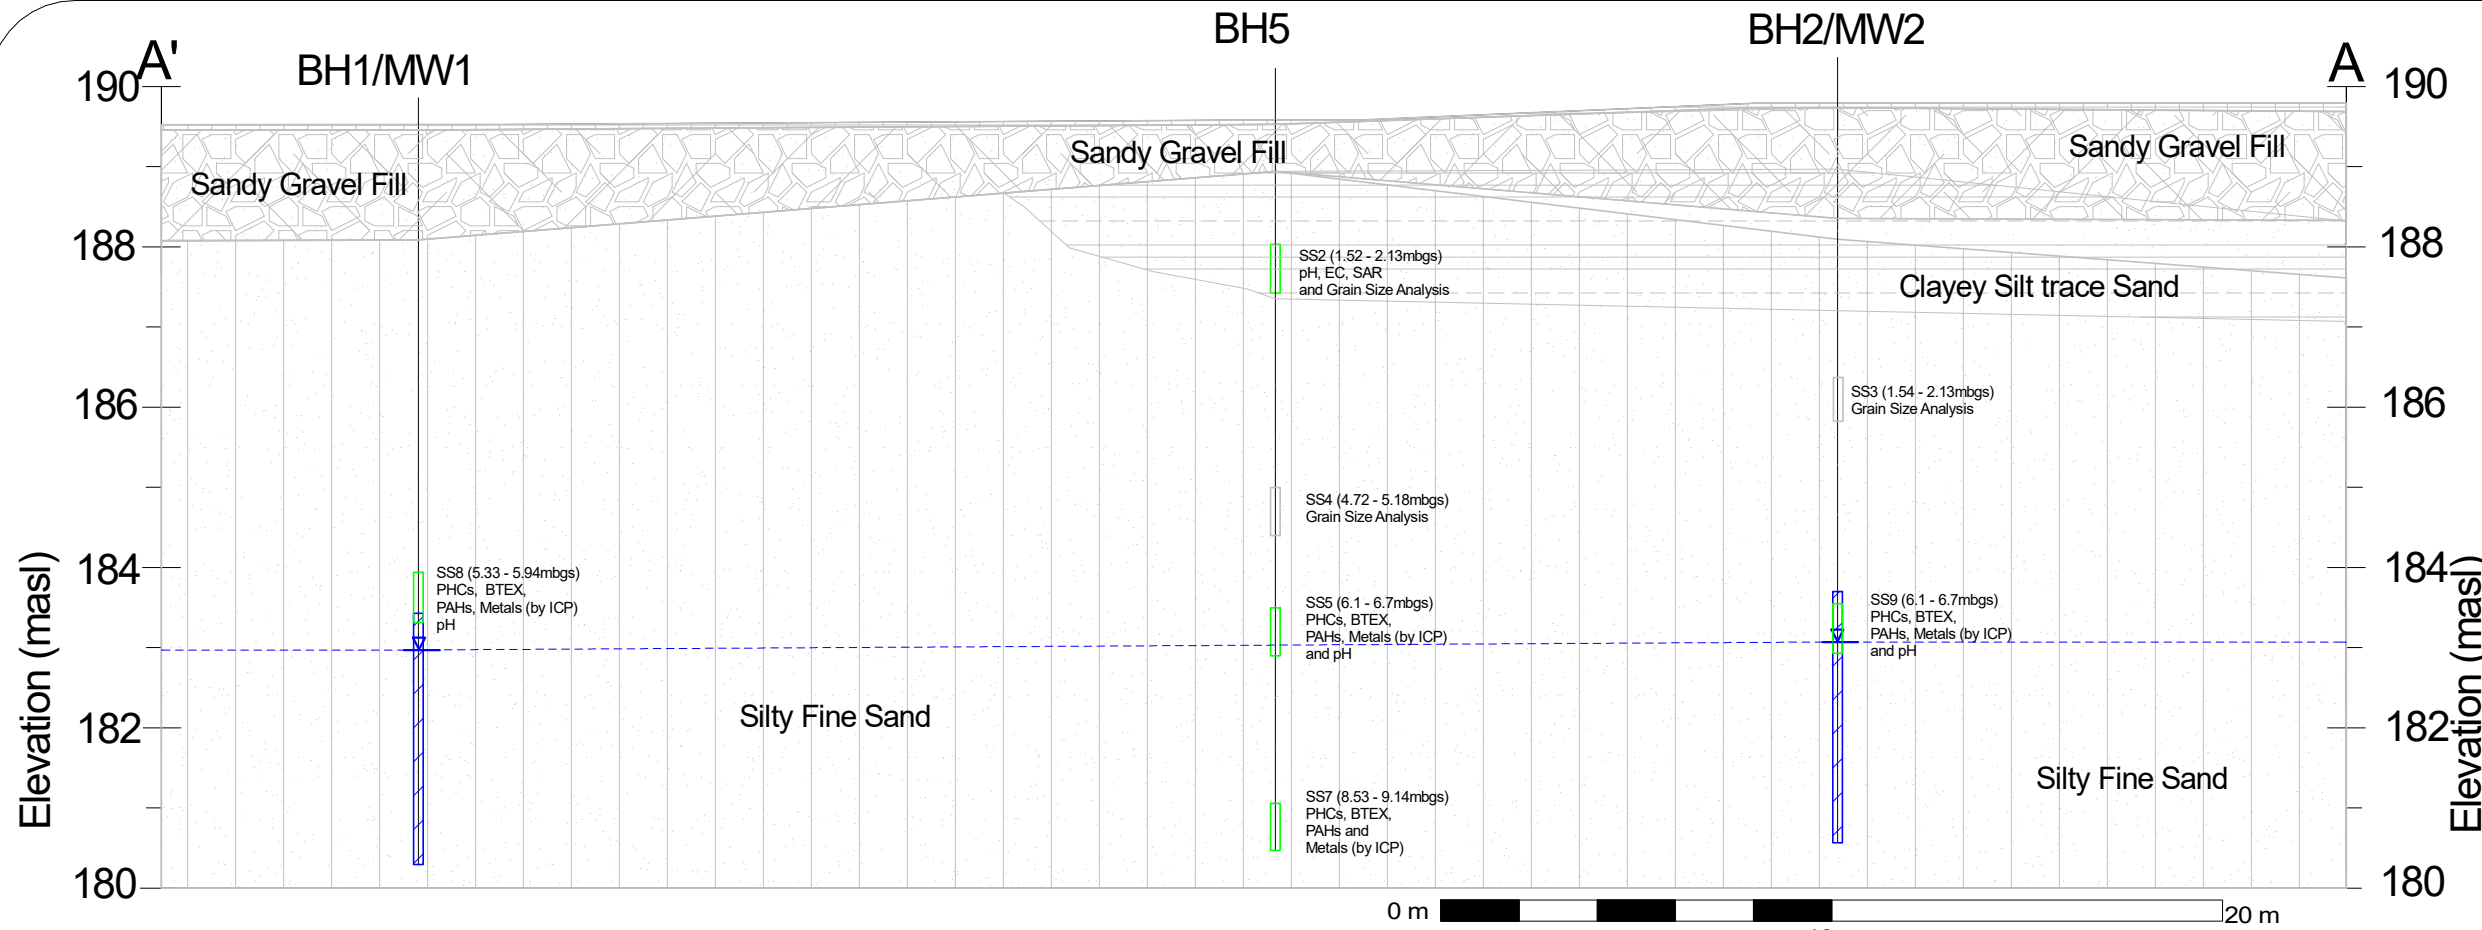
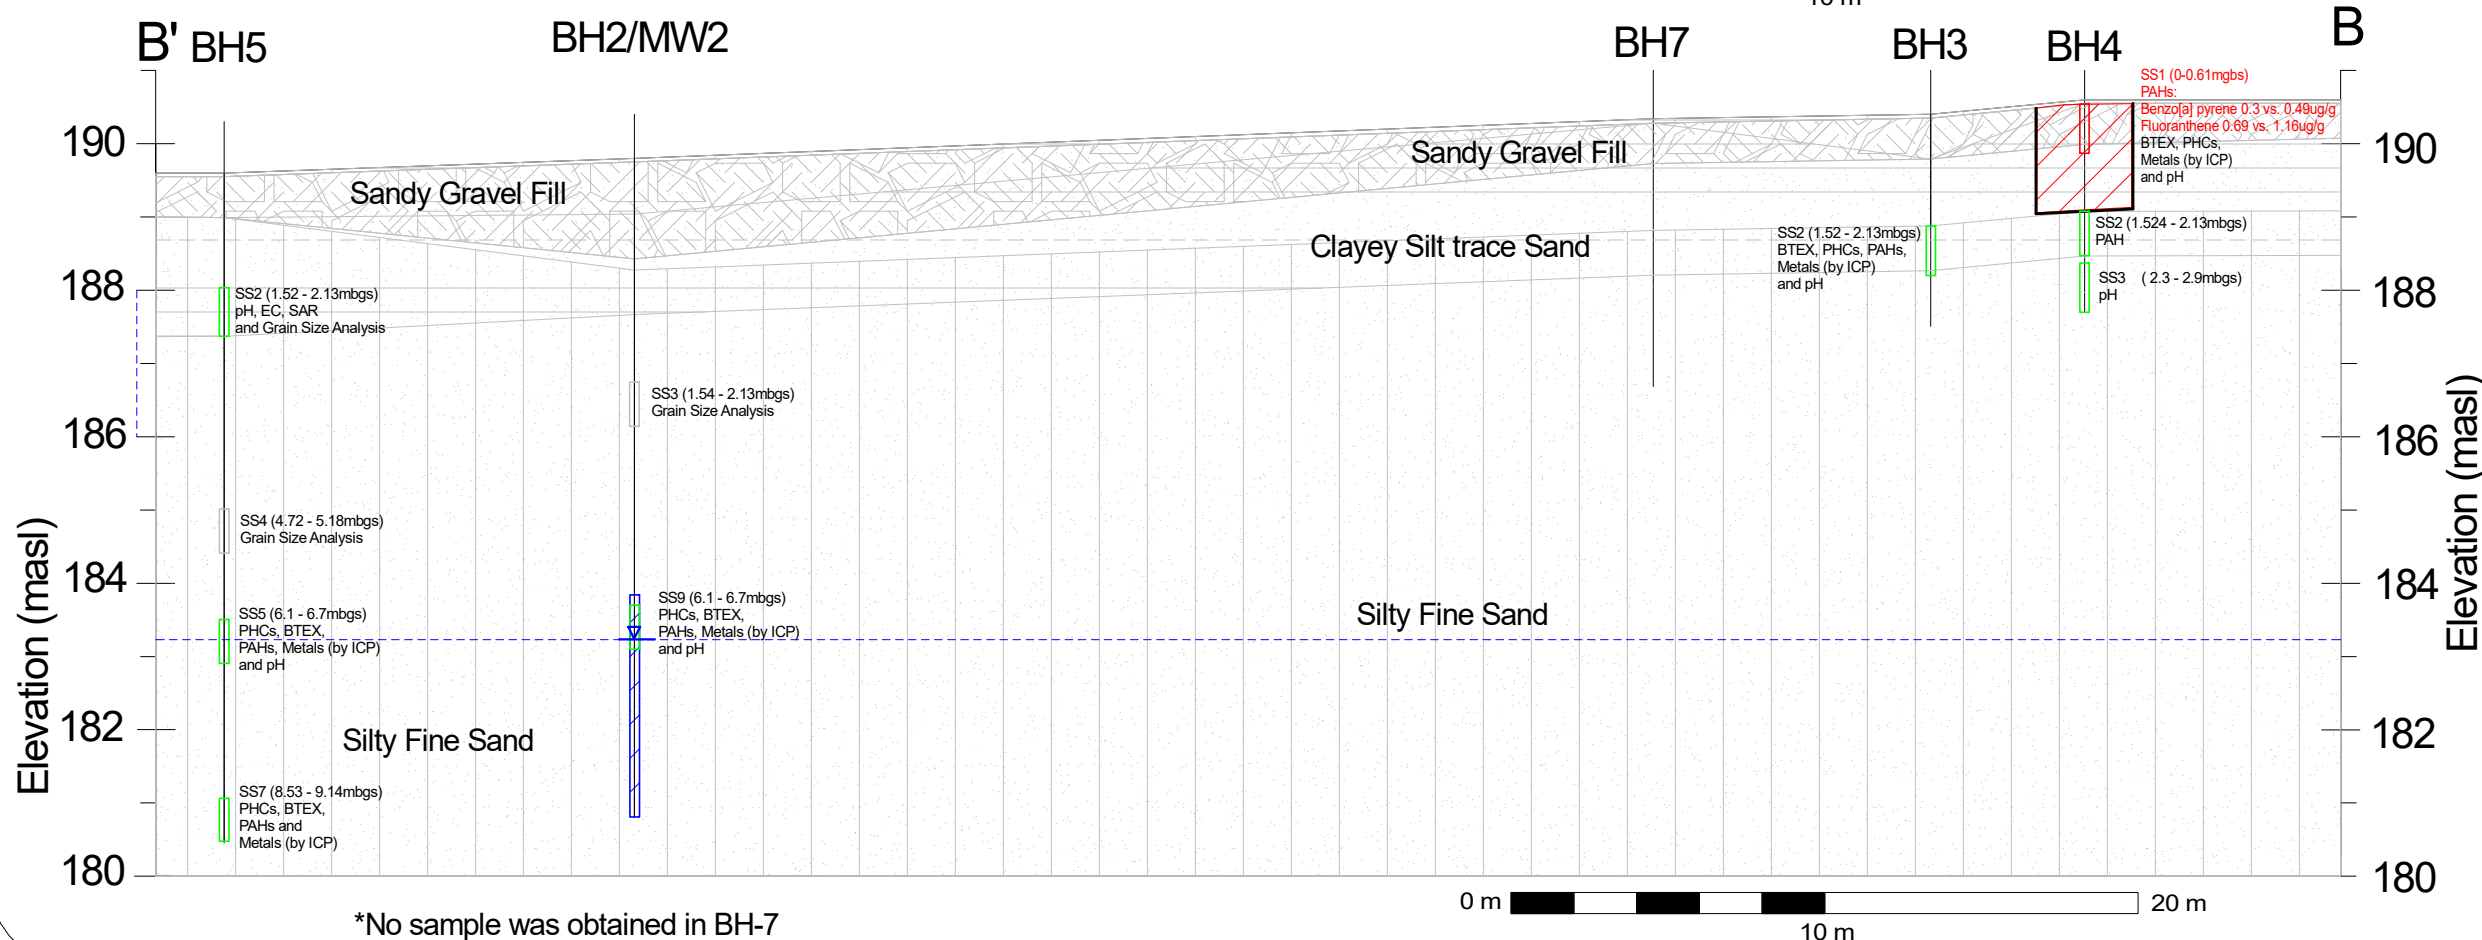
PROJECT: E-22-33-2	FIGURE 4b
DATE: January 2023	
Drafted: M. Calvert Reviewed: N. Metz

*No sample was obtained in BH-7

FIGURE NAME:
Cross Sections:
A - A' and B - B'
