2430 ST. PAUL AVENUE, CITY OF NIAGARA FALLS, ON

PROJECT NO. LA 797-23

PROJECT: 2430 ST. PAUL AVENUE, NIAGARA FALLS

DRAWING: EXISTING CONDITIONS

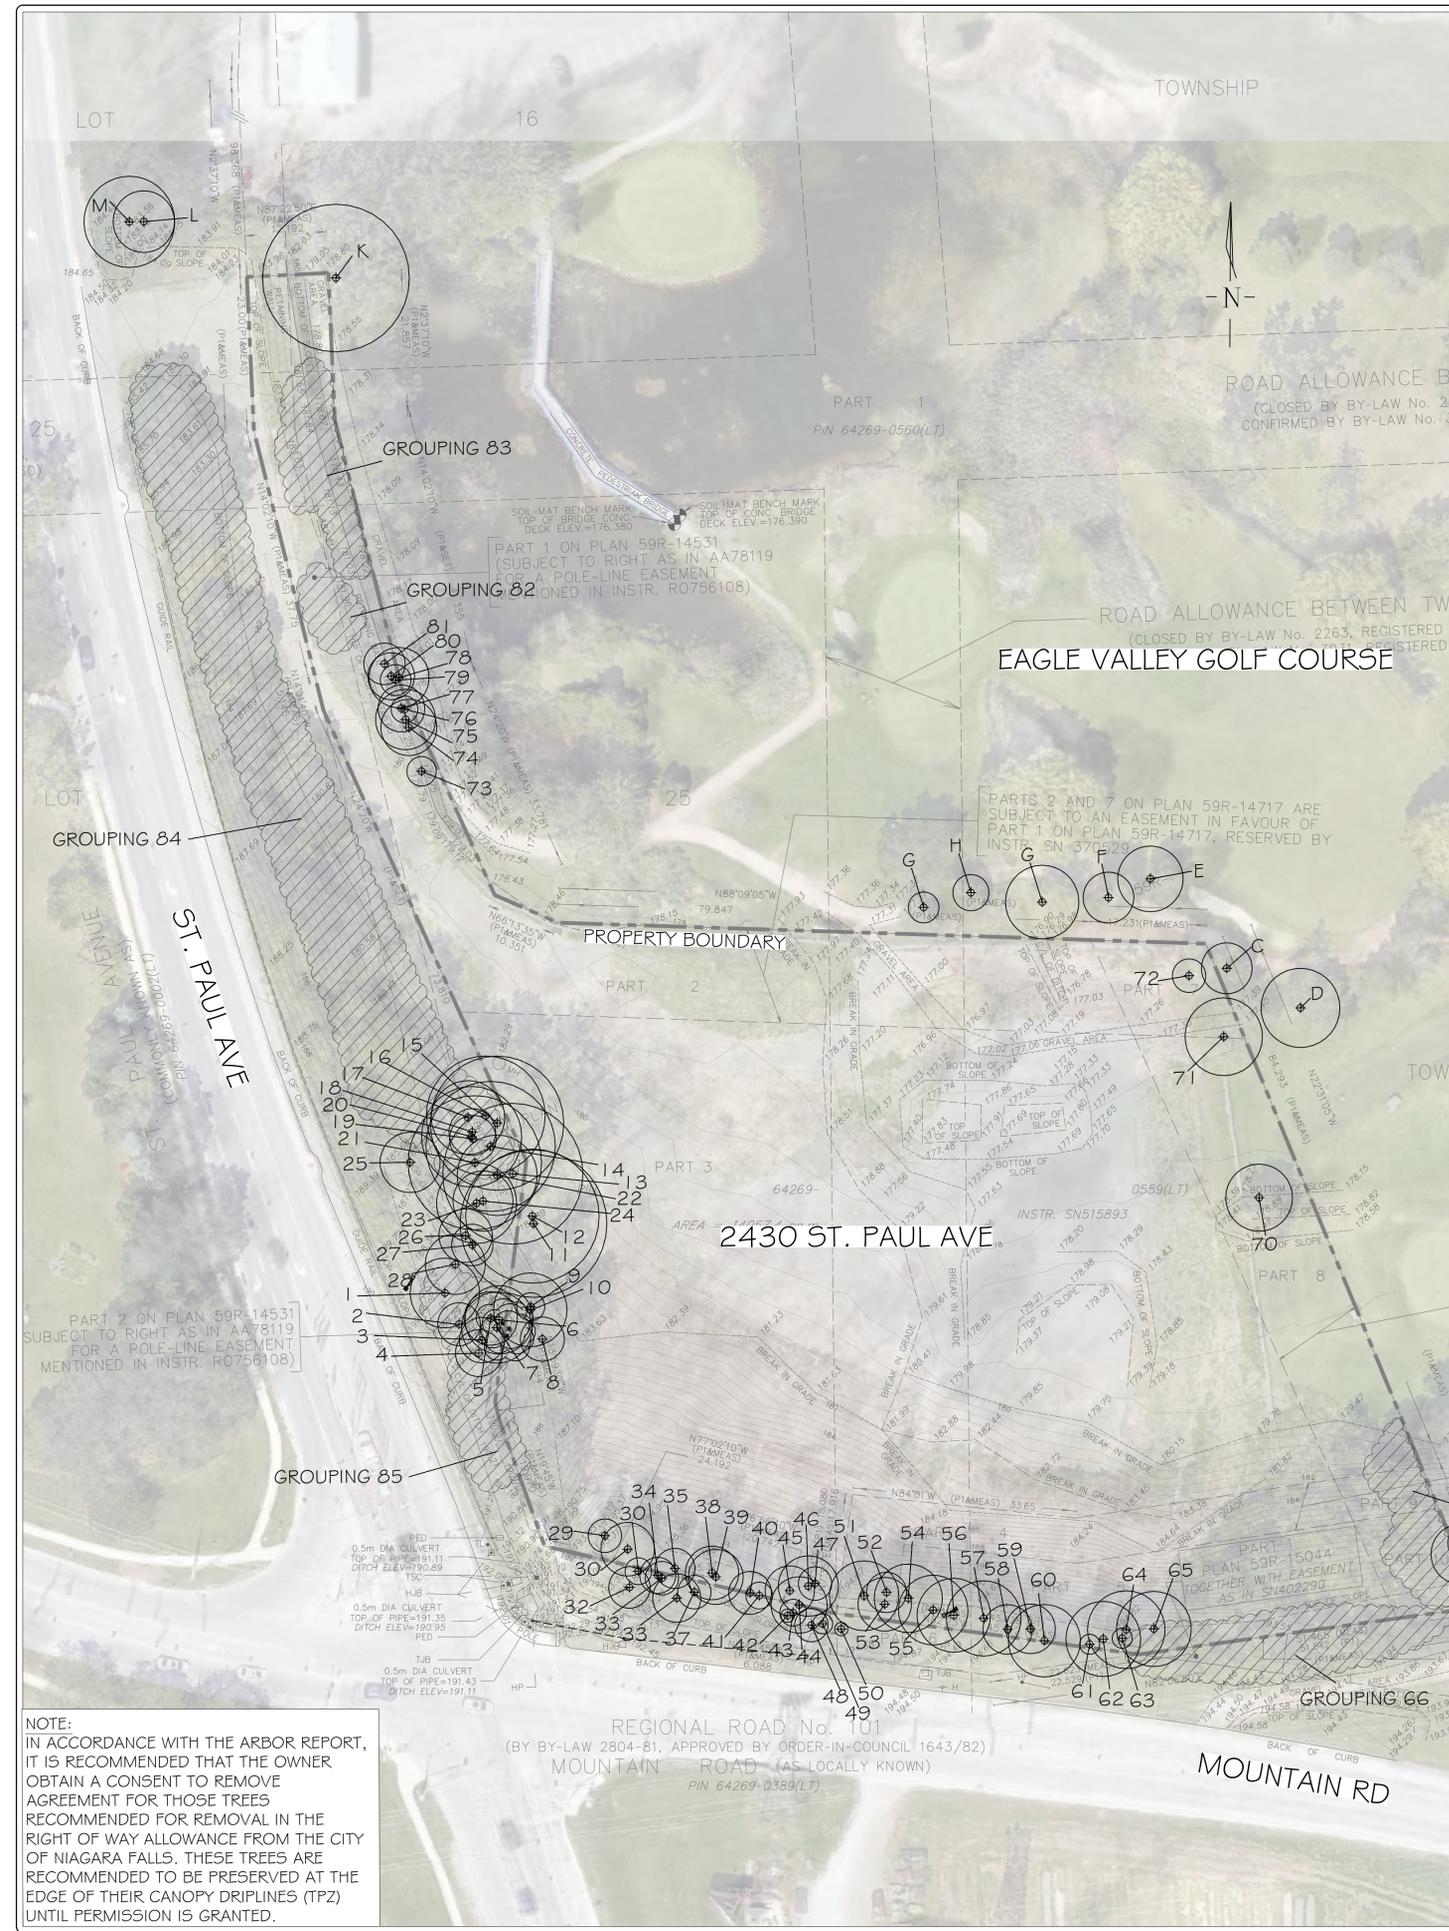
DRAWN BY: B.B. CHECKED BY: J.H. DRAWING No.: EX-1

ONSITE TREE INVENTORY									
KEY	LOCATION	SCIENTIFIC NAME	COMMON NAME	DBH (cm)	COMMENTS	ASSESSMENT	CANOPY RADIUS (m)	REMOVE/PRESERVE	
1	ROWA Tree	<i>Robinia pseudoacacia</i>	Black Locust	28	riverbank grapevine, one sided branching, branch dieback	2 Marginal	5.2	Preserve	
2	ROWA Tree	<i>Robinia pseudoacacia</i>	Black Locust	19.5, 16, 12	multiple leaders included bark, one sided branching, branch dieback	1 Poor	3.2	Preserve	
3	ROWA Tree	<i>Robinia pseudoacacia</i>	Black Locust	20.5	one sided branching, branch dieback,	1 Poor	3.4	Preserve	
4	Onsite Tree	<i>Robinia pseudoacacia</i>	Black Locust	24, 14	branch dieback, oriental bittersweet vine, multiple leaders included	1 Poor	3.5	Preserve	
5	ROWA Tree	<i>Gleditsia triacanthos</i>	Honey Locust	36, 25	multiple leaders included bark, decay at union, grafted leaders branch dieback, epicormic branching, river bank grapevine	1 Poor	4.0	Preserve	
6	ROWA Tree	<i>Gleditsia triacanthos</i>	Honey Locust	25	epicormic branching, lean to south, branch dieback, grapevine	1 Poor	5.1	Preserve

7	Onsite Tree	<i>Gleditsia triacanthos</i>	Honey Locust	45	multiple leaders included bark, branch dieback, epicormic branching	2 Marginal	5.3	Preserve	
8	Onsite Tree	<i>Robinia pseudoacacia</i>	Black Locust	32	river bank grapevine, branch dieback, epicormic branching	2 Marginal	3.3	Remove	
9	Onsite Tree	<i>Robinia pseudoacacia</i>	Black Locust	15	branch dieback, epicormic branching	1 Poor	2.1	Remove	
10	Onsite Tree	<i>Robinia pseudoacacia</i>	Black Locust	26	tree 135one sided branching to south, multiple leaders included bark, branch dieback	2 Marginal	5.5	Remove	
11	Onsite Tree	<i>Populus deltoides</i>	Eastern Cottonwood	70	broken leader, root zone excavated, epicormic branching	1 Poor	11.0	Remove	
12	Onsite Tree	<i>Populus deltoides</i>	Eastern Cottonwood	59	covered root zone, epicormic branching, branch dieback	2 Marginal	10.0	Remove	
13	ROWA Tree	<i>Populus deltoides</i>	Eastern Cottonwood	42	branch dieback, epicormic branching, multiple leaders	2 Marginal	10.5	Remove

14	ROWA Tree	<i>Populus deltoides</i>	Eastern Cottonwood	38	poor trunk form, piled debris at base, epicormic branching	1 Poor	9.7	Remove	
15	ROWA Tree	<i>Populus deltoides</i>	Eastern Cottonwood	45	one sided branching, lean to south, branch dieback	1 Poor	10.0	Remove	
16	ROWA Tree	<i>Populus deltoides</i>	Eastern Cottonwood	40	epicormic branching, riverbank grapevine, one sided branching, lean to south	1 Poor	8.9	Remove	
17	ROWA Tree	<i>Populus deltoides</i>	Eastern Cottonwood	45	epicormic branching, branch dieback, lean to north	2 Marginal	5.5	Preserve	
18	ROWA Tree	<i>Robinia pseudoacacia</i>	Black Locust	24.5	poor trunk form, epicormic branching, branch dieback	1 Poor	3.5	Preserve	
19	Onsite Tree	<i>Populus deltoides</i>	Eastern Cottonwood	35	branch dieback, lean to south, epicormic branching	1 Poor	3.5	Preserve	
20	Onsite Tree	<i>Populus deltoides</i>	Eastern Cottonwood	48	epicormic branching, lean to west	1 Poor	7.5	Preserve

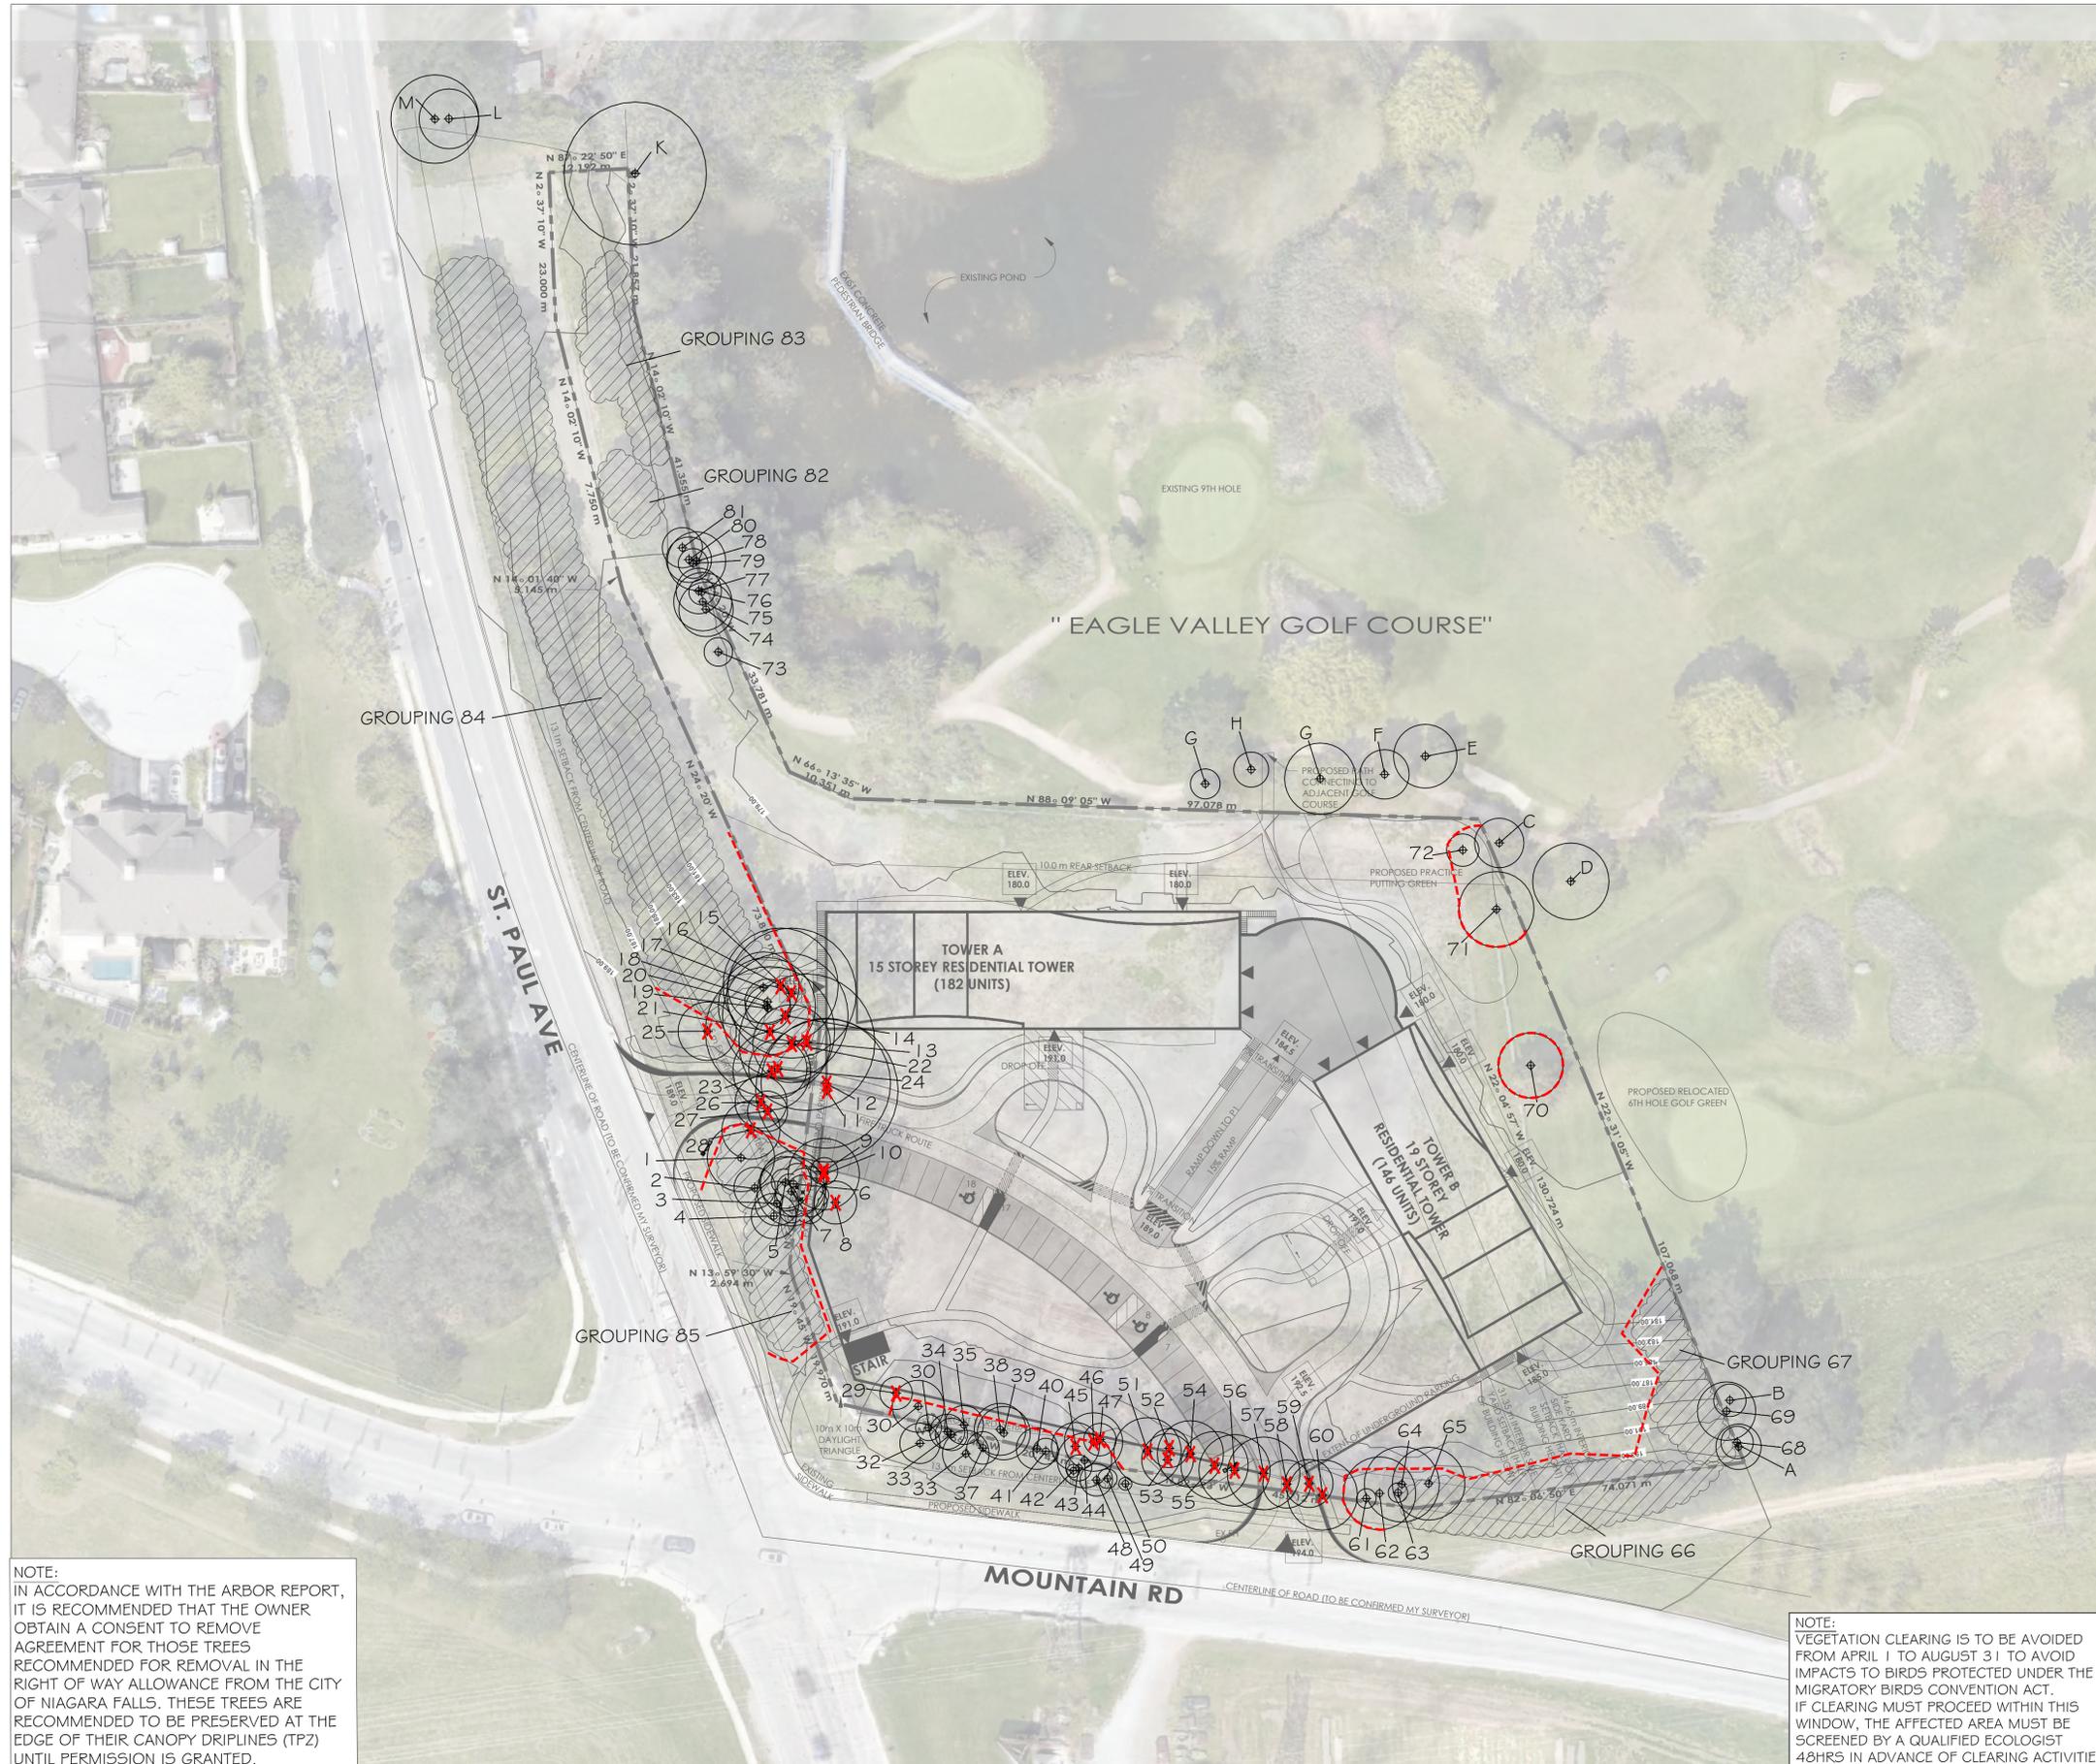
DRAWN BY: B.B. CHECKED BY: J.H. DRAWING No.: TP-1

NOTE:
IN ACCORDANCE WITH THE ARBOR REPORT,
IT IS RECOMMENDED THAT THE OWNER
OBTAIN A CONSENT TO REMOVE
AGREEMENT FOR THOSE TREES
RECOMMENDED FOR REMOVAL IN THE
RIGHT OF WAY ALLOWANCE FROM THE CITY
OF NIAGARA FALLS. THESE TREES ARE
RECOMMENDED TO BE PRESERVED AT THE
EDGE OF THEIR CANOPY DRIPLINES (TPZ)
UNTIL PERMISSION IS GRANTED.

DRAWING: TREE PRESERVATION PLAN I

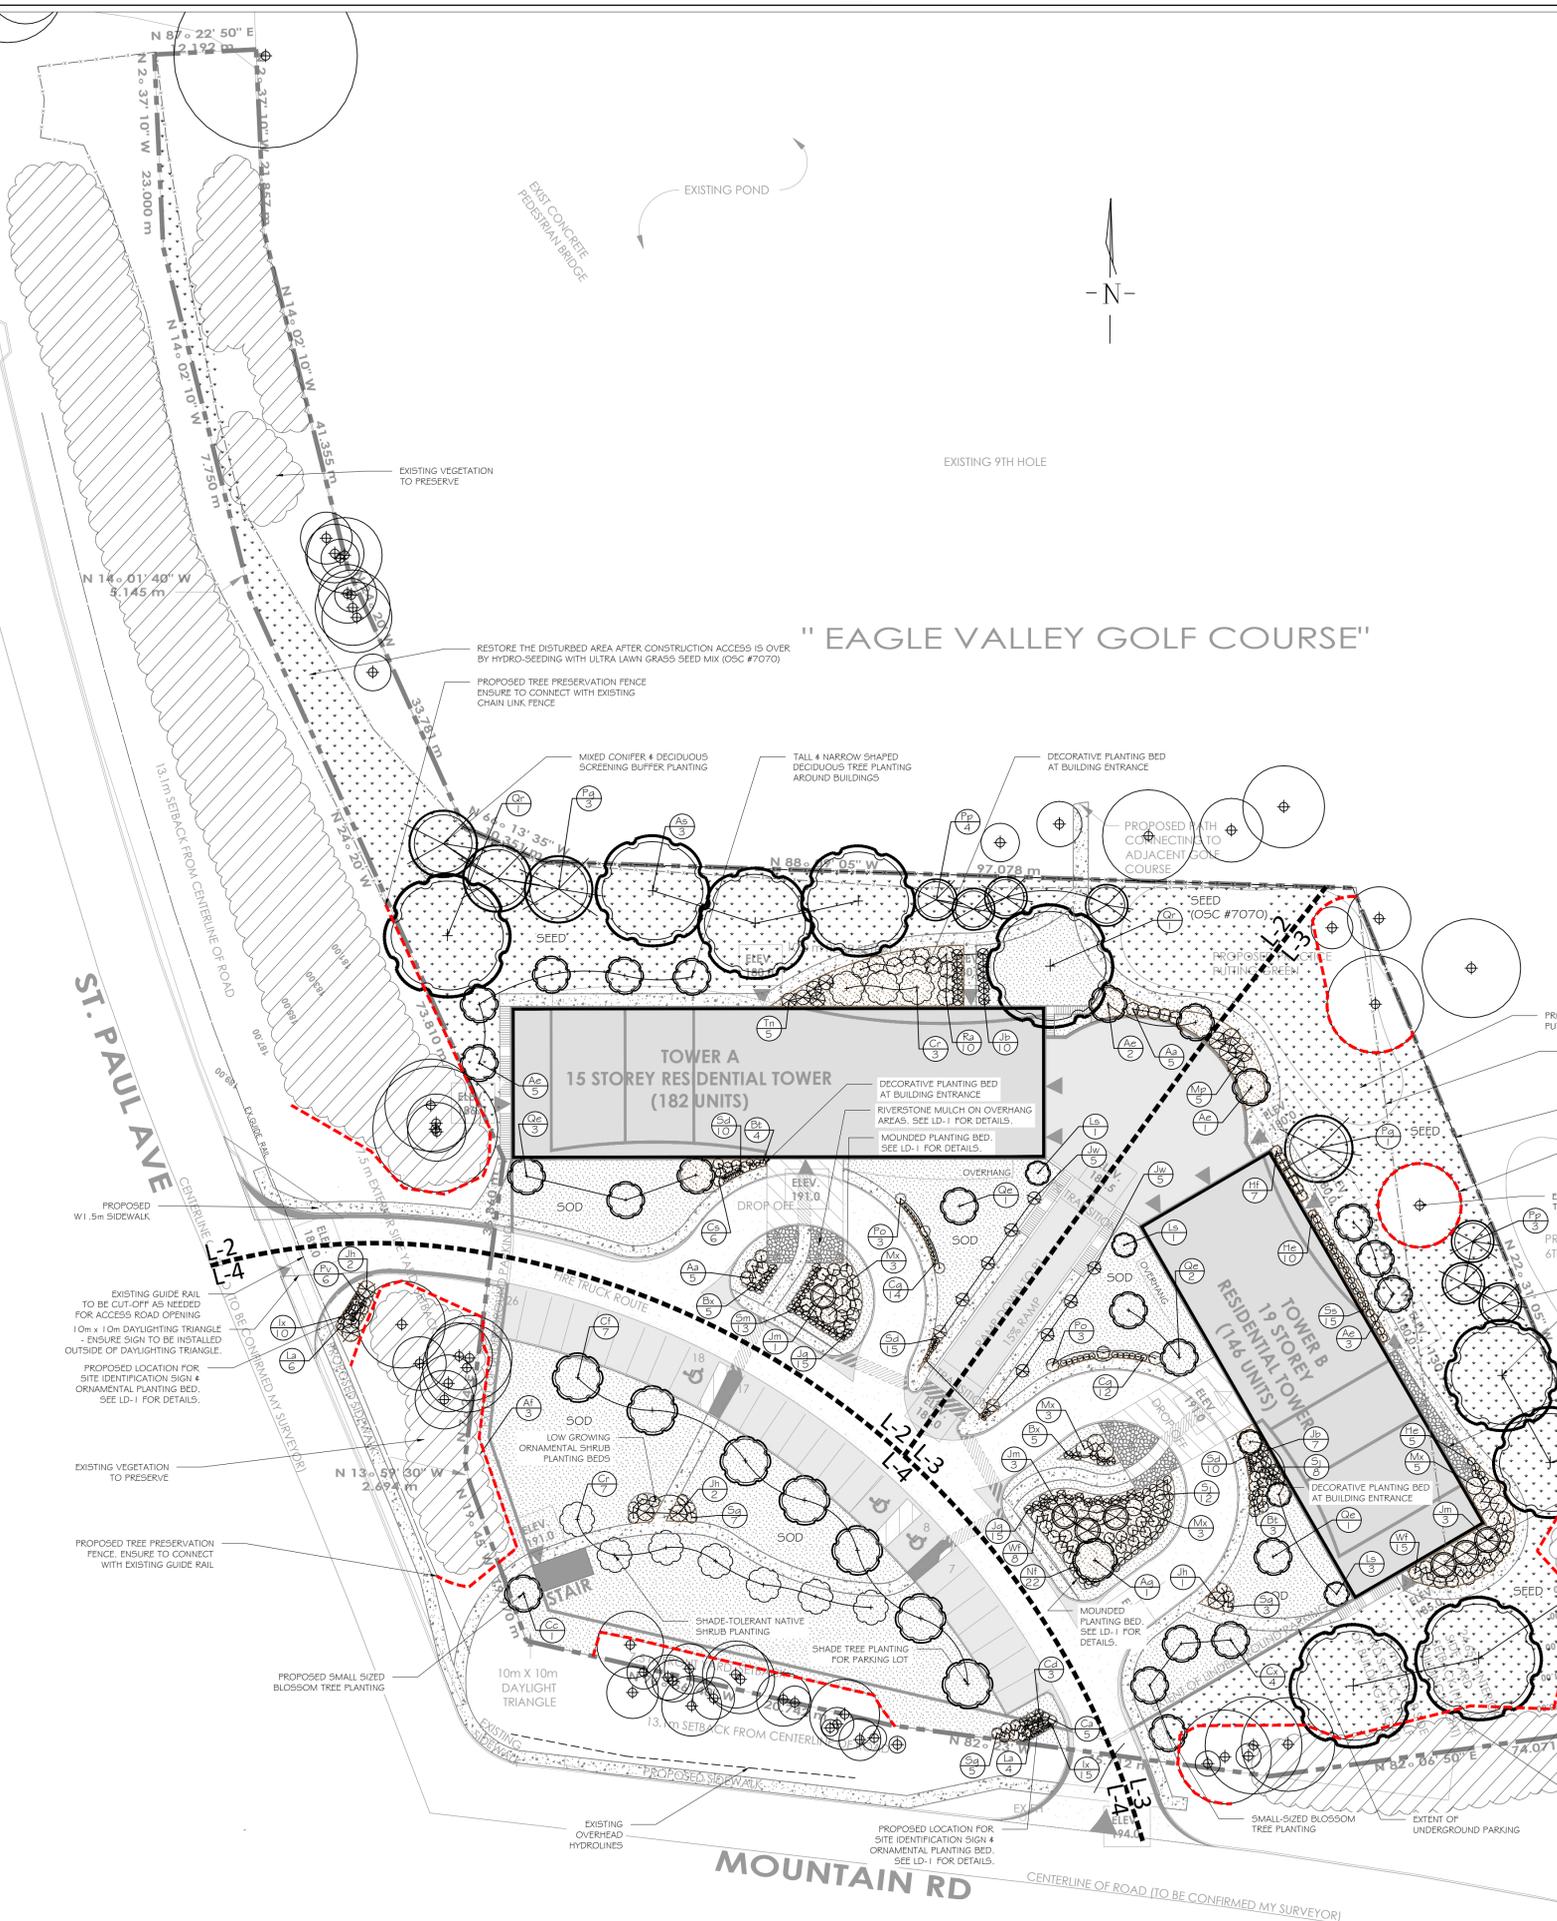
DRAWN BY: S.K. CHECKED BY: J.H. DRAWING No.: L-1

- 1) PLANTING NOTES AND PLANTING DETAILS ARE FOUND ON SHEET LD-2.
- 2) ENTRANCE SIGN AND RIVERSTONE MULCH BED DETAILS ARE SHOWN ON SHEET LD-1.
- 3) TREE PRESERVATION NOTES AND DETAILS ARE FOUND ON SHEET LD-1.

DRAWING: LANDSCAPE PLAN

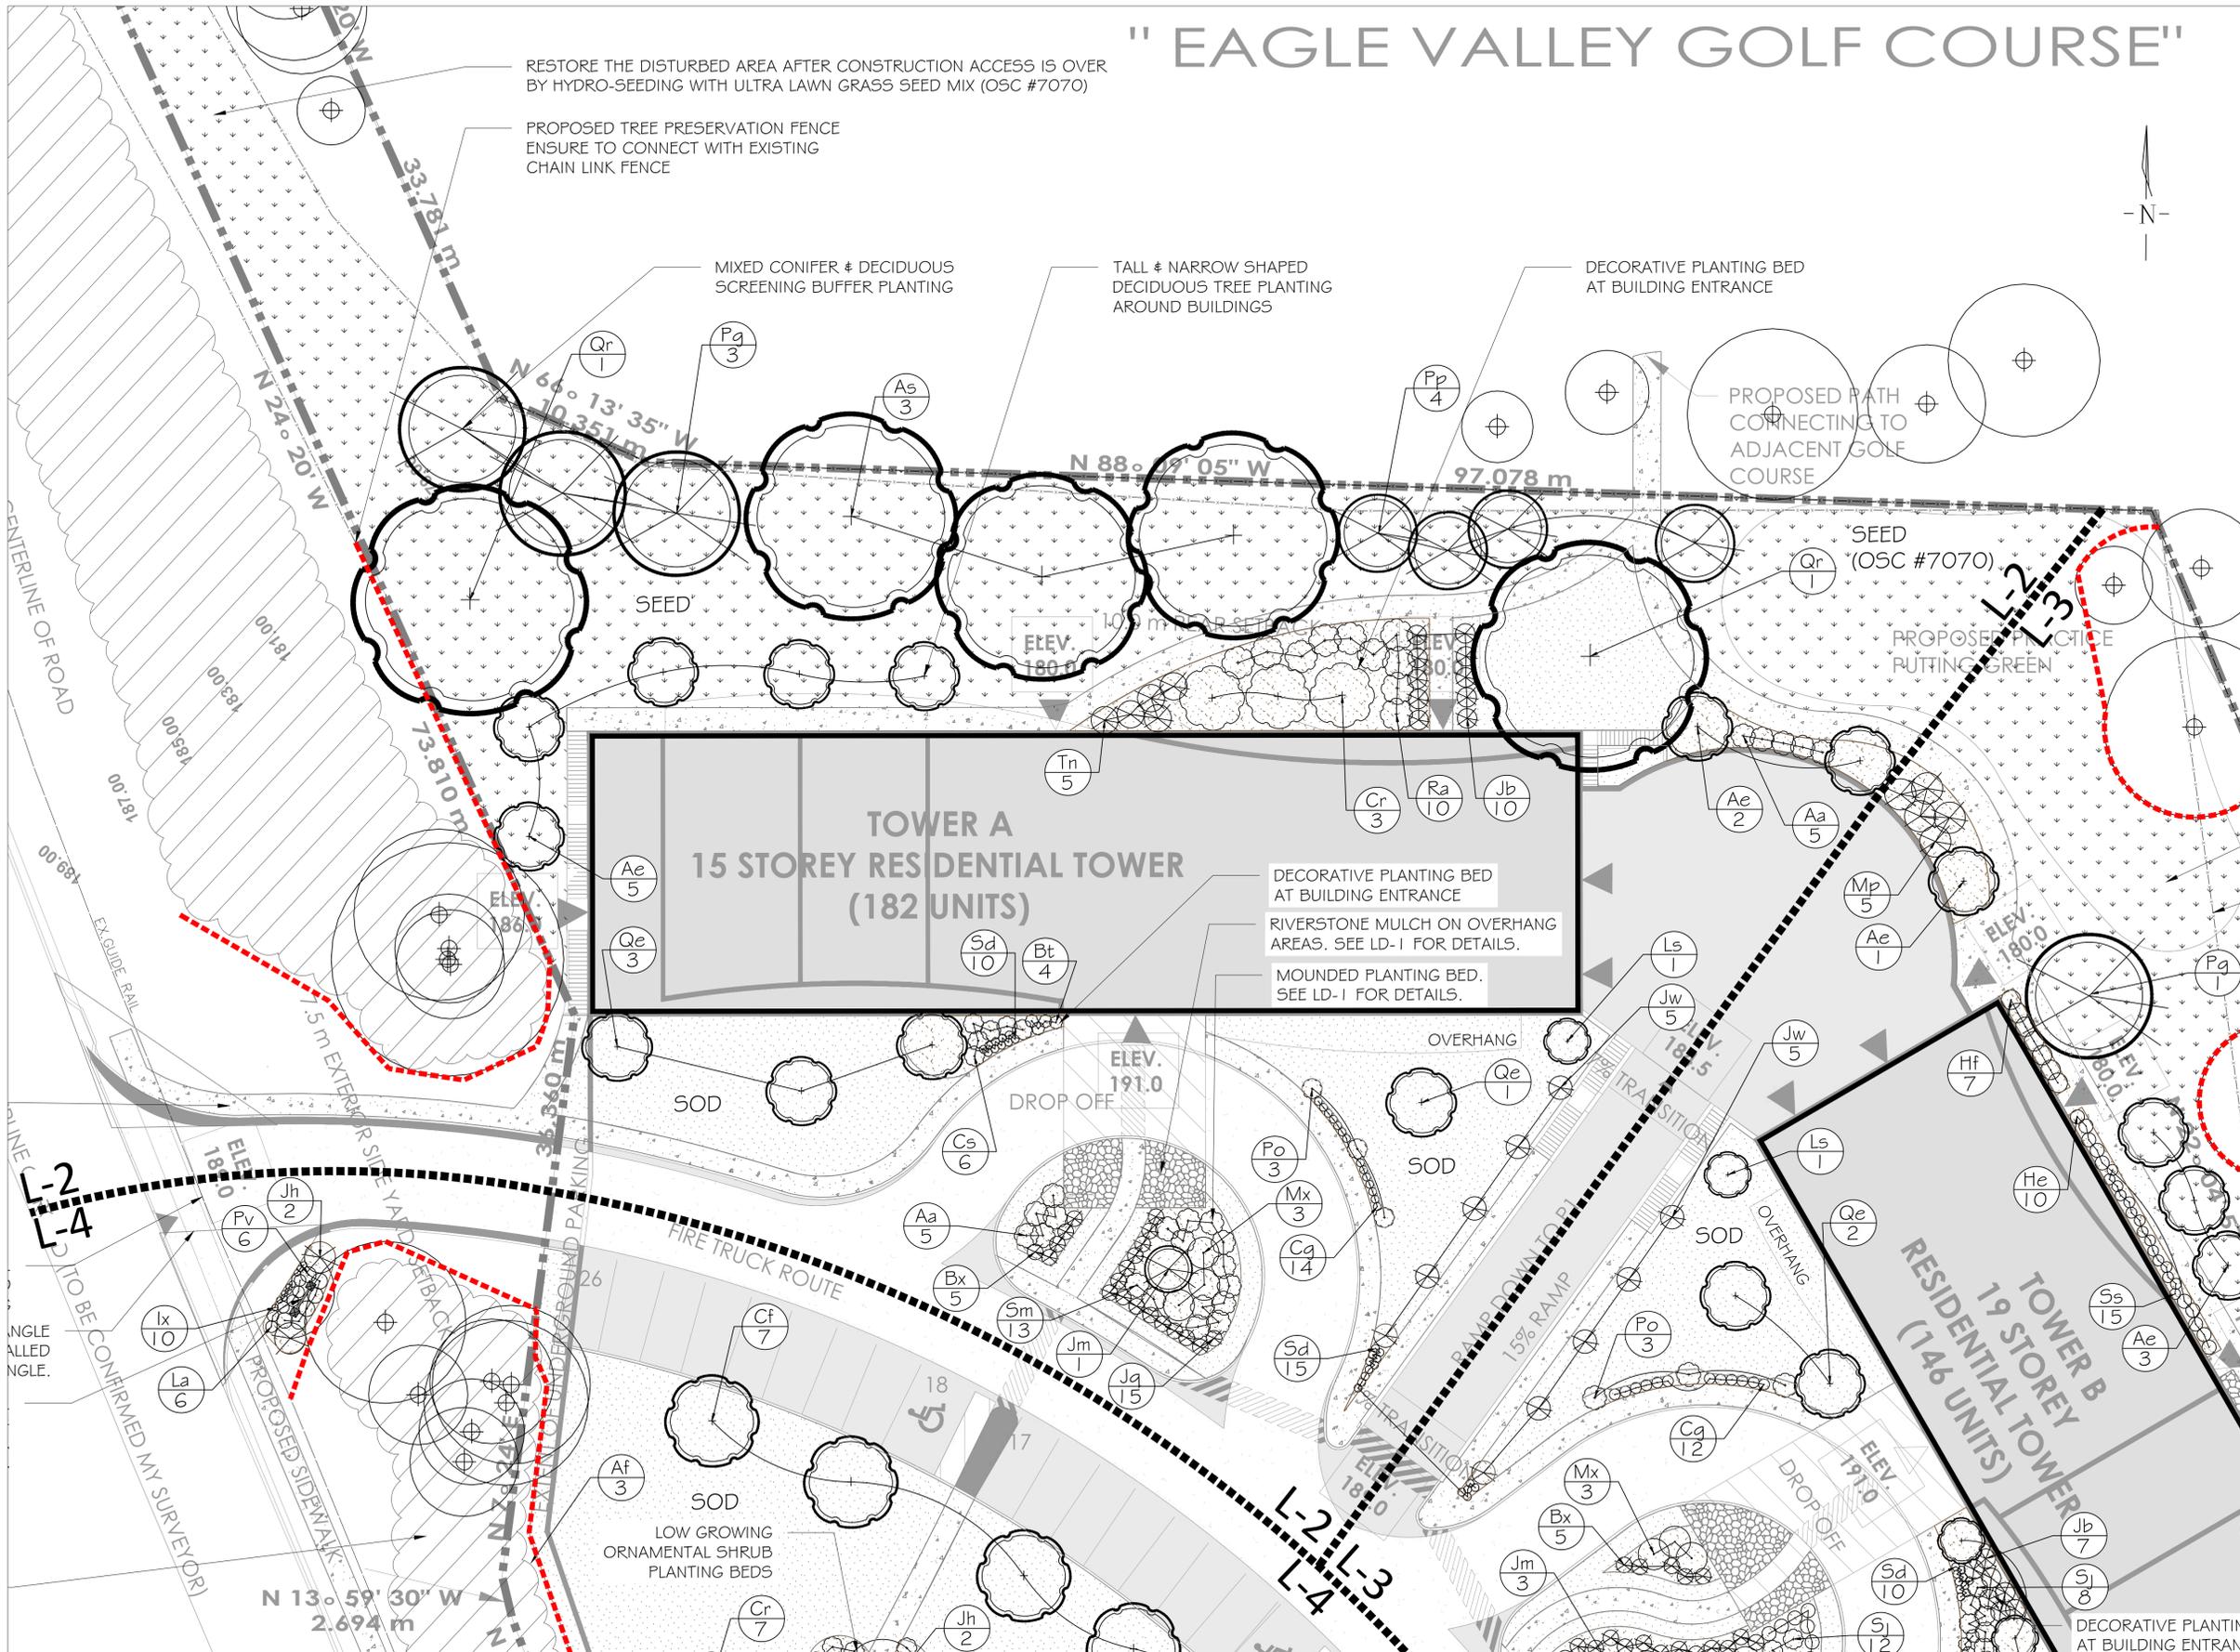
DRAWN BY: S.K CHECKED BY: J.H DRAWING No.: L-2

DRAWING: LANDSCAPE PLAN ENLARGEMENT 1

DECORATIVE PLANTING BED AT BUILDING ENTRANCE
RIVERSTONE MULCH ON OVERHANG AREAS. SEE LD-1 FOR DETAILS.
MOUNDED PLANTING BED. SEE LD-1 FOR DETAILS.

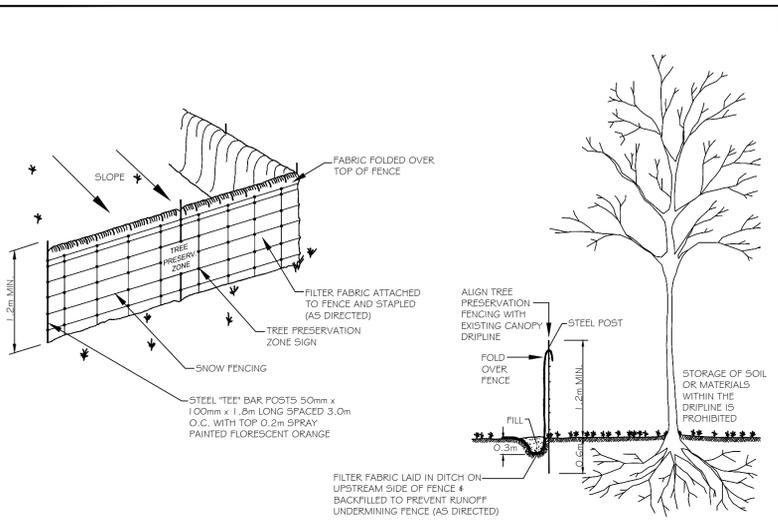
- NOTES :**
- FOR LAYOUT, SEE APPROVED SUBDIVISION/SITEPLAN ENGINEERING/TREE PRESERVATION PLANS.
 - FILTER FABRIC ONLY REQUIRED AS DIRECTED. FENCING IS PART OF EROSION CONTROL PLANS.
 - ALL MEASUREMENTS ARE IN MILLIMETRES UNLESS OTHERWISE INDICATED.

LANDMARK ENVIRONMENTAL GROUP LTD Landscape Architects Consulting Arborists Urban Forestry		TREE PRESERVATION FENCE DETAIL	
APPROVED: J.H.	DATE: 16.11.15	DRAWN: N.H.	SCALE: N.T.S.

TREE PRESERVATION NOTES

- ALL EXISTING TREES WHICH ARE TO REMAIN SHALL BE FULLY PROTECTED WITH HOARDING, I.E. SNOW FENCING, ERECTED BEYOND THEIR 'DRIP LINE' PRIOR TO AND DURING CONSTRUCTION, TO THE SATISFACTION OF THE BUILDING AND INSPECTIONS DEPARTMENT. GROUPS OF TREES AND OTHER EXISTING PLANTINGS TO BE PROTECTED, SHALL BE TREATED IN A LIKE MANNER WITH HOARDING AROUND THE ENTIRE CLUMP(S). AREAS WITHIN THE PROTECTIVE FENCING SHALL REMAIN UNDISTURBED AND SHALL NOT BE USED FOR THE STORAGE OF BUILDING MATERIALS OR EQUIPMENT.

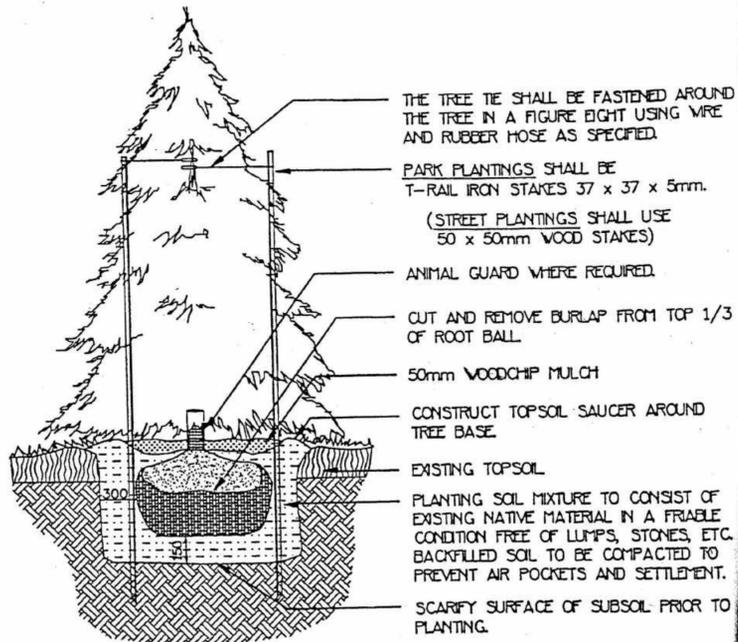
5.5.2 CONIFEROUS TREE PLANTING DETAIL

- THE TREE TIE SHALL BE FASTENED AROUND THE TREE IN A FIGURE EIGHT USING WIRE AND RUBBER HOSE AS SPECIFIED.
- PARK PLANTINGS SHALL BE T-RAIL IRON STAKES 37 x 37 x 5mm. (STREET PLANTINGS SHALL USE 50 x 50mm WOOD STAKES)
- ANIMAL GUARD WHERE REQUIRED.
- CUT AND REMOVE BURLAP FROM TOP 1/3 OF ROOT BALL.
- 50mm WOODCHIP MULCH
- CONSTRUCT TOPSOIL SAUCER AROUND TREE BASE.
- EXISTING TOPSOIL.
- PLANTING SOIL MIXTURE TO CONSIST OF EXISTING NATIVE MATERIAL IN A FRIABLE CONDITION FREE OF LUMPS, STONES, ETC. BACKFILLED SOIL TO BE COMPACTED TO PREVENT AIR POCKETS AND SETTLEMENT.
- SCARIFY SURFACE OF SUBSOIL PRIOR TO PLANTING.

TREES UNDER 1800mm REQUIRE 2 STAKES, TREES OVER 1800mm REQUIRE 3 STAKES. WHEN PLANT MATERIAL IS SUPPLIED IN WIRE BASKETS THE ENTIRE BASKET WILL BE REMOVED FROM THE PIT. SET TREE 50mm HIGHER THAN SURROUNDING GRADE TO ALLOW FOR SETTLEMENT.

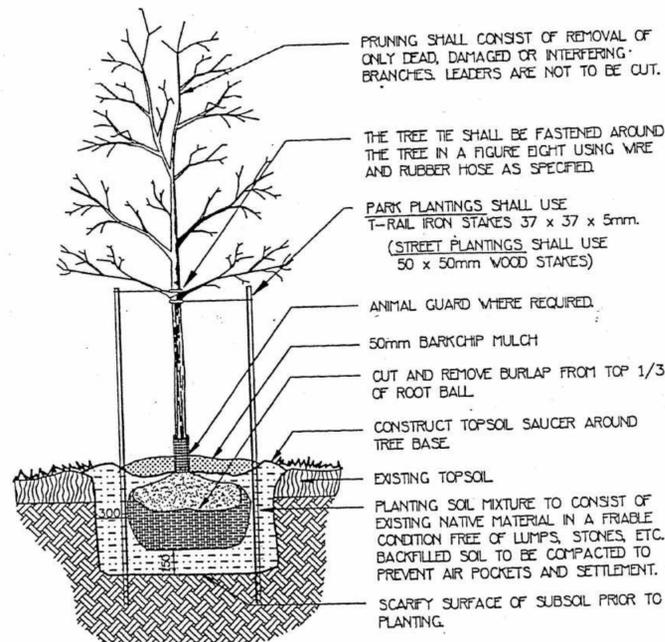
5.5.1 DECIDUOUS TREE PLANTING DETAIL

- PRUNING SHALL CONSIST OF REMOVAL OF ONLY DEAD, DAMAGED OR INTERFERING BRANCHES. LEADERS ARE NOT TO BE CUT.
- THE TREE TIE SHALL BE FASTENED AROUND THE TREE IN A FIGURE EIGHT USING WIRE AND RUBBER HOSE AS SPECIFIED.
- PARK PLANTINGS SHALL USE T-RAIL IRON STAKES 37 x 37 x 5mm. (STREET PLANTINGS SHALL USE 50 x 50mm WOOD STAKES)
- ANIMAL GUARD WHERE REQUIRED.
- 50mm BARKCHIP MULCH
- CUT AND REMOVE BURLAP FROM TOP 1/3 OF ROOT BALL.
- CONSTRUCT TOPSOIL SAUCER AROUND TREE BASE.
- EXISTING TOPSOIL.
- PLANTING SOIL MIXTURE TO CONSIST OF EXISTING NATIVE MATERIAL IN A FRIABLE CONDITION FREE OF LUMPS, STONES, ETC. BACKFILLED SOIL TO BE COMPACTED TO PREVENT AIR POCKETS AND SETTLEMENT.
- SCARIFY SURFACE OF SUBSOIL PRIOR TO PLANTING.

TREES UNDER 70mm CALIPER REQUIRE 2 STAKES, TREES 70mm CALIPER AND OVER REQUIRE 3 STAKES. WHEN PLANT MATERIAL IS SUPPLIED IN WIRE BASKETS THE ENTIRE BASKET WILL BE REMOVED FROM THE PIT. SET TREE 50mm HIGHER THAN SURROUNDING GRADE TO ALLOW FOR SETTLEMENT.

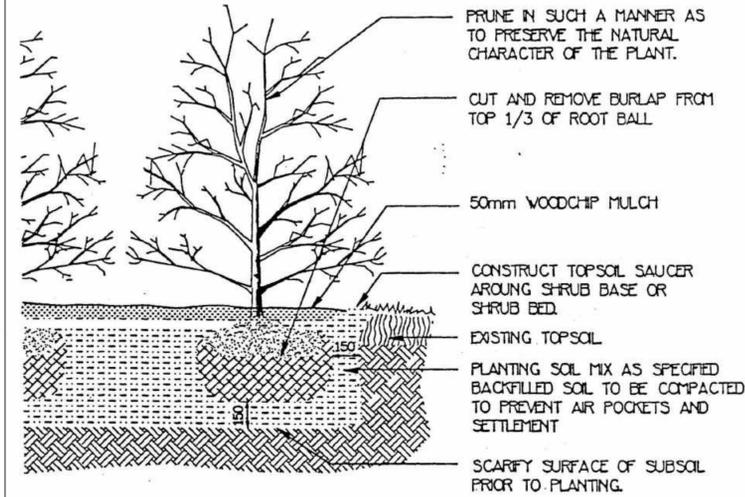
5.5.3 SHRUB PLANTING DETAIL

- PRUNE IN SUCH A MANNER AS TO PRESERVE THE NATURAL CHARACTER OF THE PLANT.
- CUT AND REMOVE BURLAP FROM TOP 1/3 OF ROOT BALL.
- 50mm WOODCHIP MULCH
- CONSTRUCT TOPSOIL SAUCER AROUND SHRUB BASE OR SHRUB BED.
- EXISTING TOPSOIL.
- PLANTING SOIL MIX AS SPECIFIED BACKFILLED SOIL TO BE COMPACTED TO PREVENT AIR POCKETS AND SETTLEMENT.
- SCARIFY SURFACE OF SUBSOIL PRIOR TO PLANTING.

PLANTING METHOD ILLUSTRATED SHALL APPLY EQUALLY TO BARE - ROOT AND BALLED STOCK. SET SHRUBS 50mm HIGHER THAN SURROUNDING GRADE TO ALLOW FOR SETTLEMENT.

NOTES
THE ABOVE DETAIL DOES NOT REPRESENT ANY PARTICULAR SPECIES.
SHRUBS PLANTED IN GROUPS SHALL BE SET IN CONTINUOUS BEDS.
ALL MEASUREMENTS IN MILLIMETERS UNLESS OTHERWISE INDICATED.

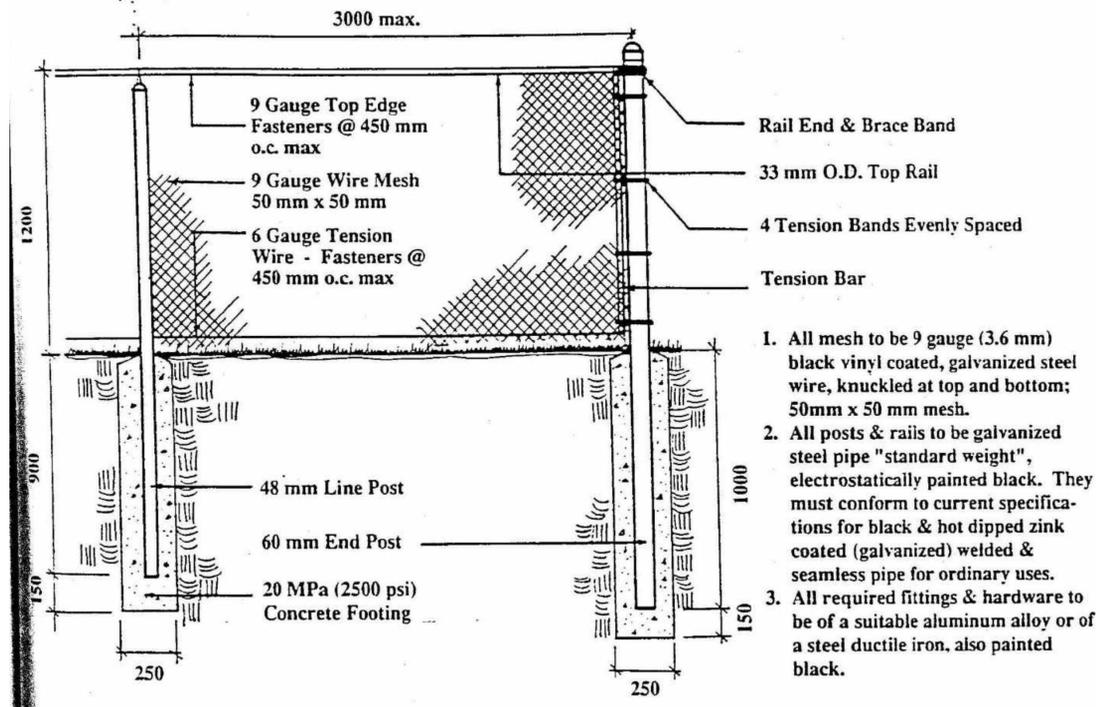
BLACK VINYL COATED CHAIN LINK FENCE
DETAIL SOURCE:
PAGE 27, CITY STANDARDS FOR SITE PLANNING,
THE CITY OF NIAGARA FALLS
