2131595 Ontario Inc.

**RE: Update to the Phase 1 Environmental Site Assessment of 7302 Kalar Road, Niagara Falls, ON
(Letter Report)**

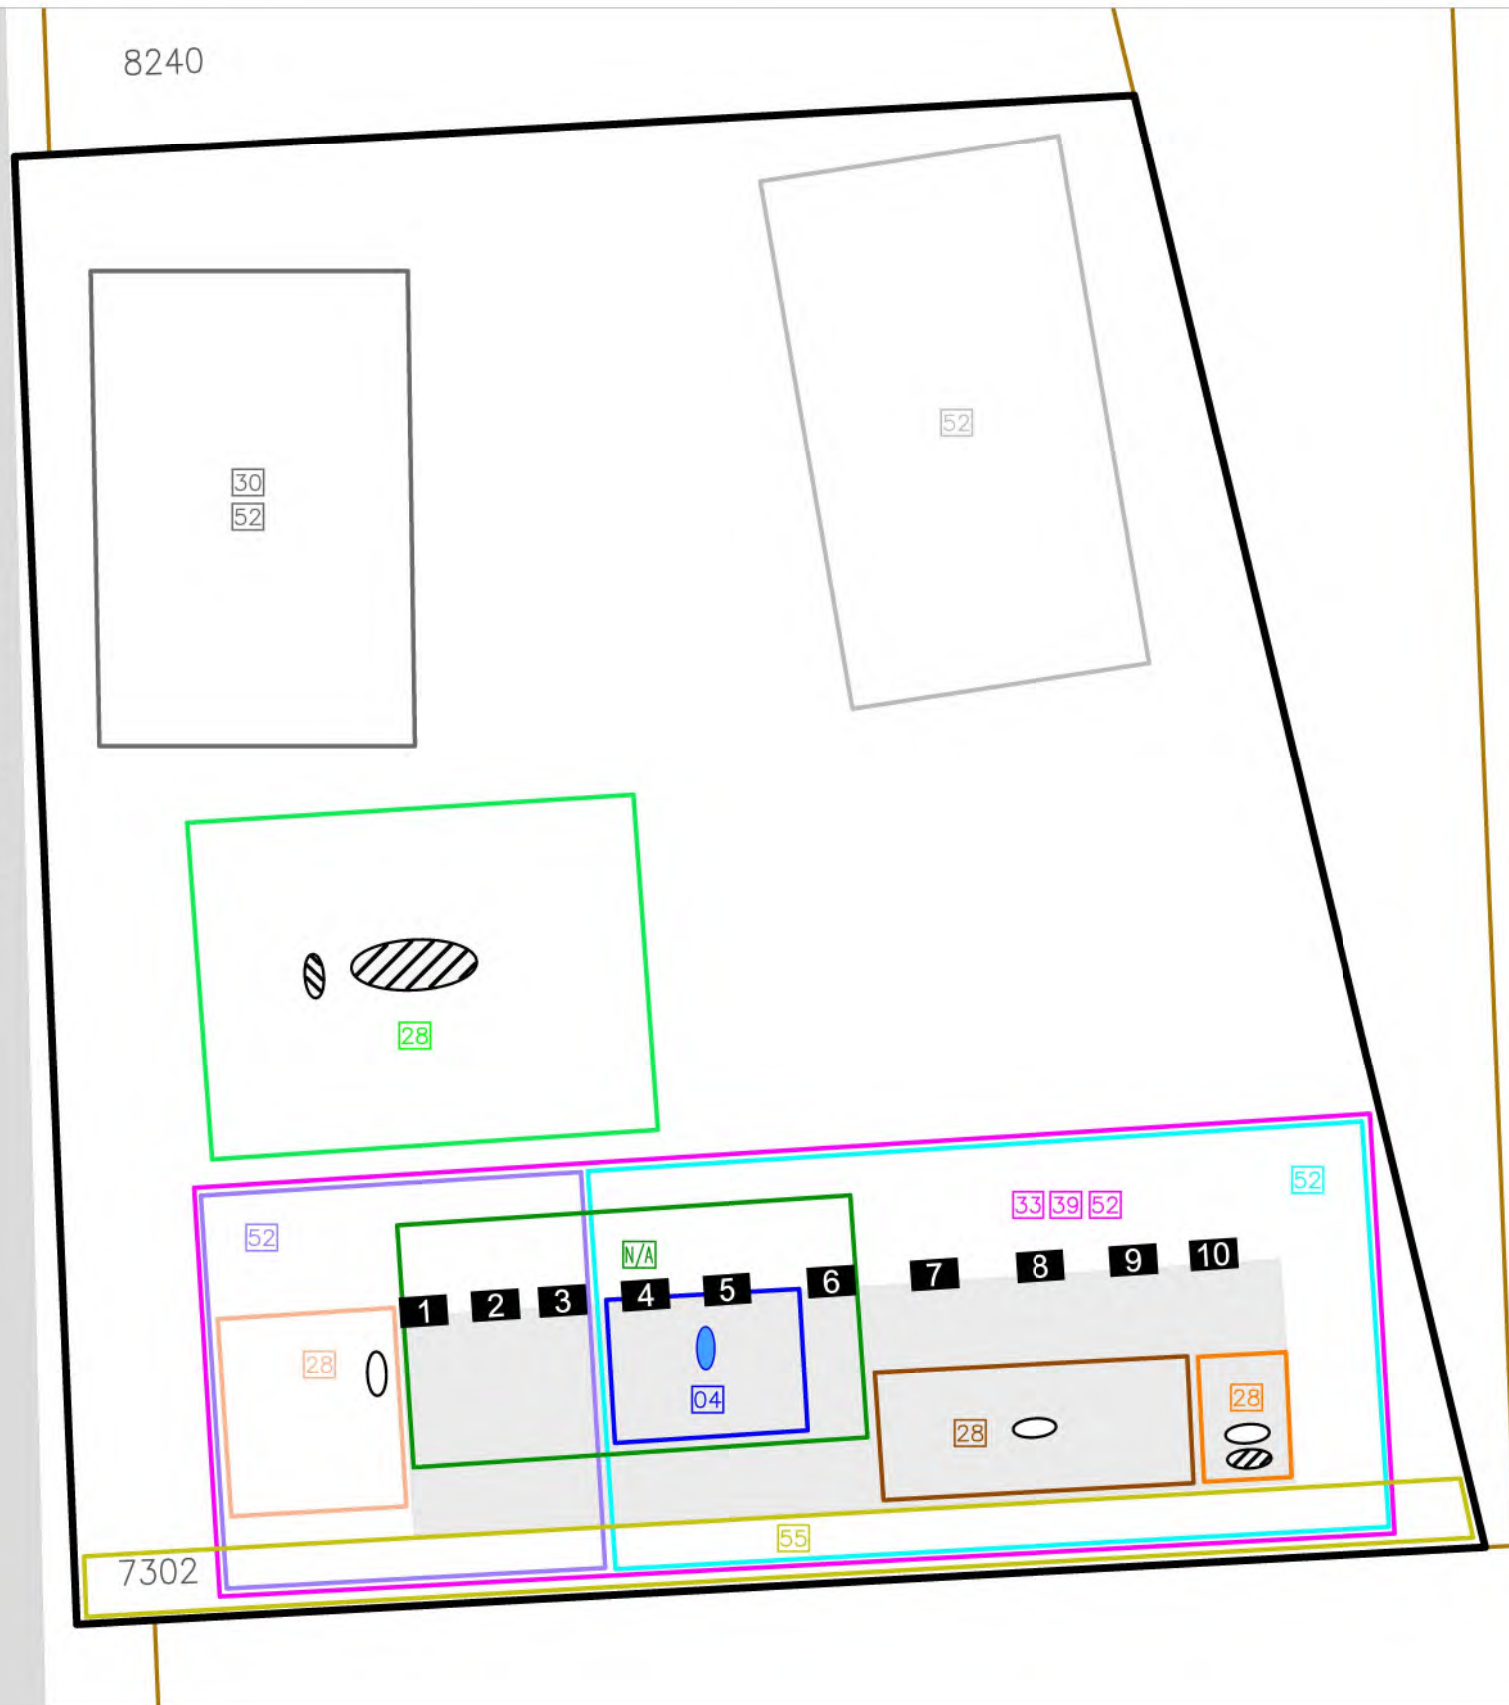
TITLE		PHASE 1 CONCEPTUAL SITE MODEL
PROJECT NO.	PR-23-037A	DATE
		JANUARY 2024
PROJECT		
PHASE 1 ENVIRONMENTAL SITE ASSESSMENT		
CLIENT		
2131595 ONTARIO INC.		
SITE		
7302 KALAR ROAD, NIAGARA FALLS, ON		
SCALE	SCALE BAR (m)	SHEET
		FIGURE 4B

PCA Location	Item	Potentially Contaminating Activity	Description
PCA #1A	33	Metal Treatment, Coating, Plating and Finishing	Trillium Lifestyles Industries was located on-site from 1992 to 1995. Operations included metal furniture manufacturing.
PCA #1B	39	Paints Manufacturing, Processing and Bulk Storage	Trillium Lifestyles Industries generated paint residue waste on site from 1995-2004.
PCA #1C	52	Storage, maintenance, fuelling and repair of equipment, vehicles, and material used to maintain transportation systems	Wajax Power Systems was located on site from 2010 to 2019. Operations included automotive repairs and maintenance.
PCA #2	28	Gasoline and Associated Products Storage in Fixed Tanks	Historical Aboveground Storage Tanks (ASTs) were noted on site when WAJAX owned the property. One 1,100 litre AST was used for waste oil was noted along the west side of the building.
PCA #3	28	Gasoline and Associated Products Storage in Fixed Tanks	A 1,200-litre engine oil AST was historically located in proximity to Bay #6 & #7, while Wajax was in operation.

PCA #4	N/A	Parts and Vehicle Wash Station	A parts wash station was noted in the centre portion of the building on site. There is currently a bus wash station located in Bay #4.
PCA #5	52	Storage, maintenance, fuelling and repair of equipment, vehicles, and material used to maintain transportation systems	Coach Canada currently occupies the spaces associated with Bays #4 through #10 to repair and maintain buses.
PCA #6	52	Storage, maintenance, fuelling and repair of equipment, vehicles, and material used to maintain transportation systems	Arlington Crane and Phoenix Crane currently operate out of Bays #1 through #3. Operations include the maintenance and servicing of cranes.
PCA #7	4	Antifreeze and De-icing Manufacturing and Bulk Storage	Two 900-litre plastic totes of antifreeze was located in Bay #5.
PCA#8	28	Gasoline and Associated Products Storage in Fixed Tanks	A double-walled steel 50,000-litre used diesel fuel AST and 1,100-litre AST was noted near the southern entrance of the property.

PCA#9	28	Gasoline and Associated Products Storage in Fixed Tanks	A 1,100-litre steel waste oil AST was noted in the southeast corner of the building. An additional former 1,100-litre AST associated with Wajax was also located in this area.
PCA#10A	30	Importation of Fill Material of Unknown Quality	According to aerial photographs a building was present along the northwest side of the site which could have been in-filled with materials of unknown quality.
PCA#10B	52	Storage, maintenance, fuelling and repair of equipment, vehicles, and material used to maintain transportation systems	Pilot Trucking Training stores transport trucks along the northwest corner of the site.
PCA#11	52	Storage, maintenance, fuelling and repair of equipment, vehicles, and material used to maintain transportation systems	Coach Canada stores buses along the northeastern portion of the site.
PCA#12	55	Transformer Manufacturing, Processing and Use	The Niagara Falls Hydro Electric Commission (currently known as Niagara Peninsula Energy) was noted at 7447 Pin Oak Drive. This property is listed on the Ontario PCB Registry. Operations also include the use of various oils and chemical wastes.

PCA#13	28	Gasoline and Associated Products Storage in Fixed Tanks	The Niagara Falls Hydro Electric Commission (currently known as Niagara Peninsula Energy) has a private fueling station for its fleet, further to the east of the site.
PCA#14	49	Salvage Yard including automobile wrecking	An automotive junk yard was noted approximately 138m south-southwest of the study site.
PCA#15	58	Waste Disposal and Waste Management, including thermal treatment, landfilling and transfer of waste, other than use of biosolids as soil conditioners	Properties to the north of Kalar Road were historically associated with waste disposal. The land has been remediated and redeveloped.

All APECs are included in **Table 4** and summarized below. APEC locations are depicted in **Figure 2**.
