PHASE ONE ENVIRONMENTAL SITE ASSESSMENT

7302 Kalar Road, Niagara Falls, ON

August 11th, 2023 Project: E-23-35-1

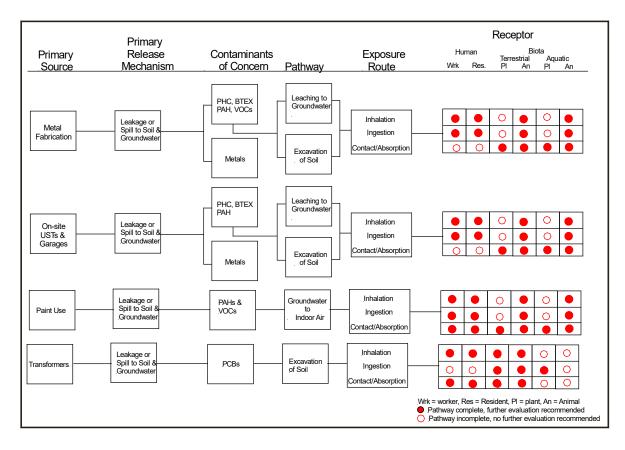
6.4 Phase One Conceptual Site Model

The conceptual site model qualitatively considers the potential interaction of primary sources of environmental concern, with suspected contaminants of concern, and the pathway(s) and exposure route(s) to the receptors. Target contaminants of Metals, PHCs, BTEX, VOCs, PCBs, and PAHs were identified with potential migration pathways to human and/or biota receptors.

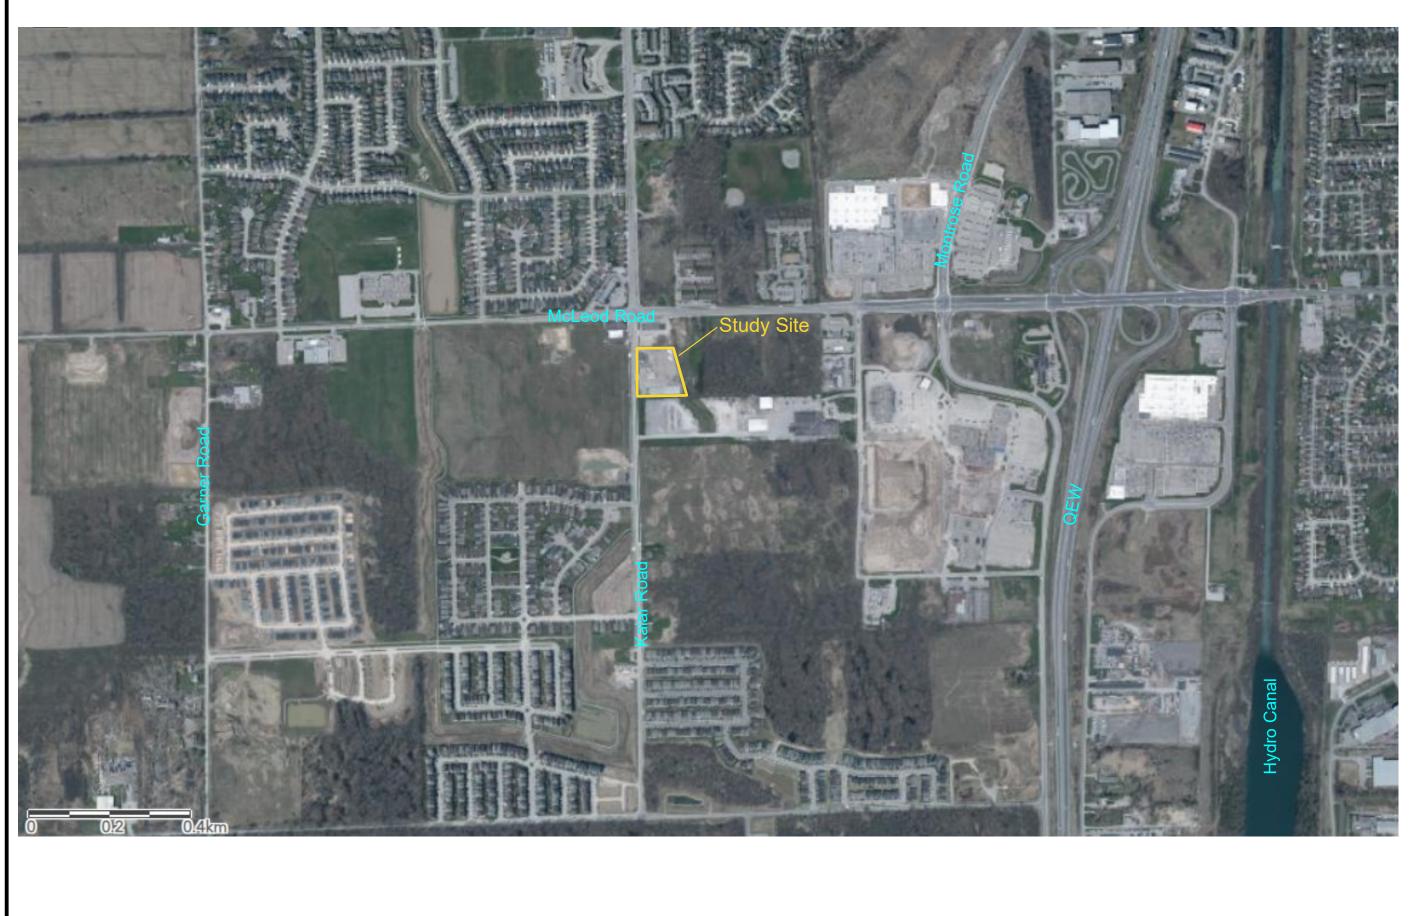
- Figure 2: Adjacent Land Uses
- Figure 3: Site Layout
- Figure 4a: Potentially Contaminating Activities within Study Area
- Figure 4b: Areas of Potential Environmental Concern

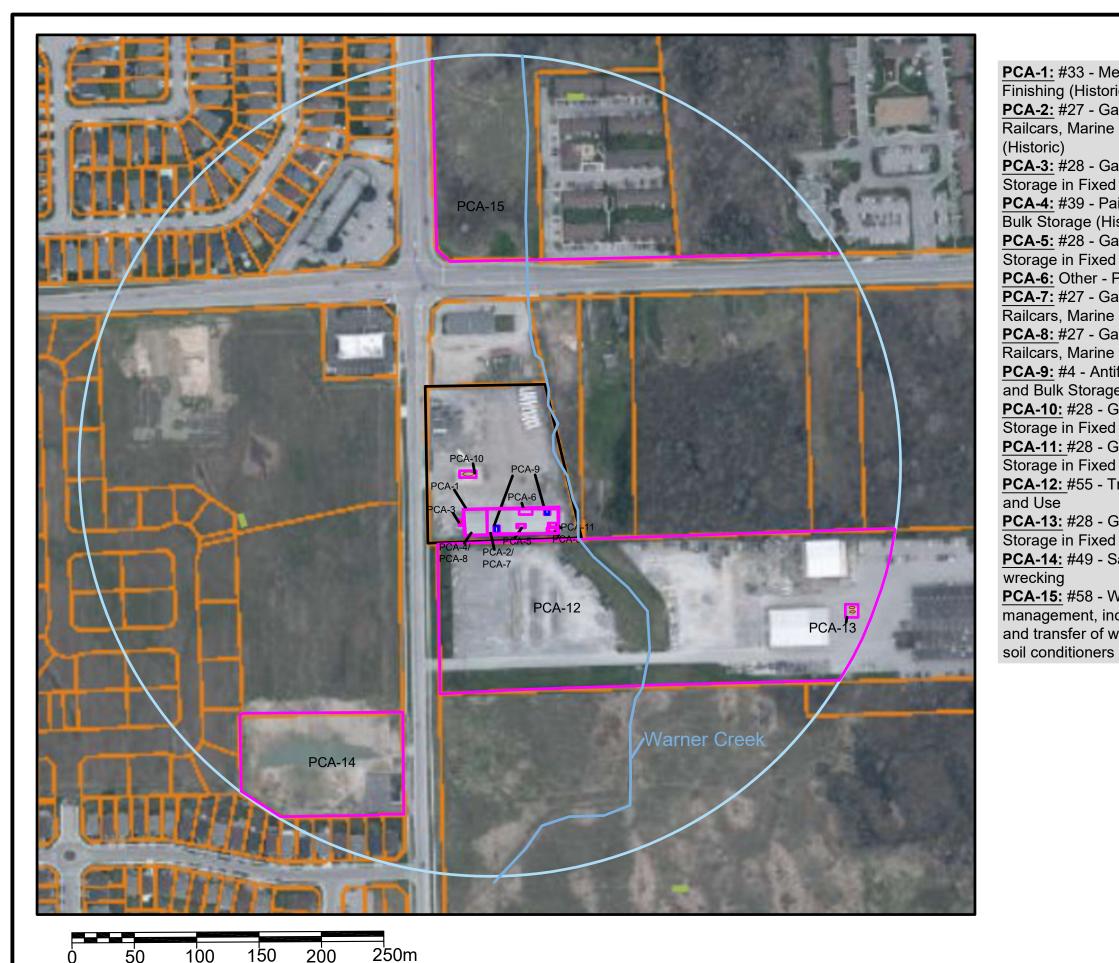
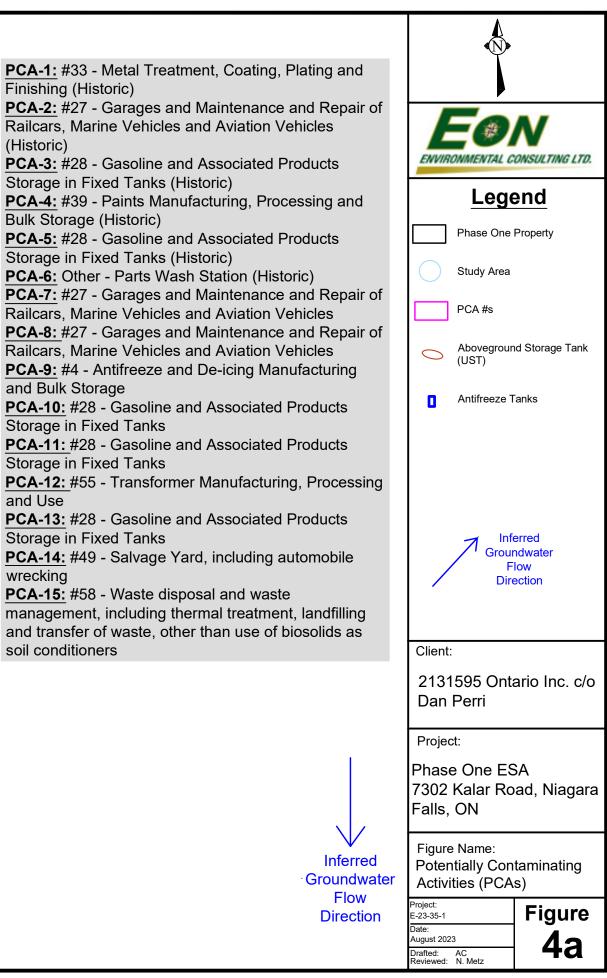
Finishing (Historic) Railcars, Marine Vehicles and Aviation Vehicles (Historic) PCA-3: #28 - Gasoline and Associated Products Storage in Fixed Tanks (Historic) PCA-4: #39 - Paints Manufacturing, Processing and Bulk Storage (Historic) PCA-5: #28 - Gasoline and Associated Products Storage in Fixed Tanks (Historic) PCA-6: Other - Parts Wash Station (Historic) Railcars, Marine Vehicles and Aviation Vehicles Railcars, Marine Vehicles and Aviation Vehicles PCA-9: #4 - Antifreeze and De-icing Manufacturing and Bulk Storage PCA-10: #28 - Gasoline and Associated Products Storage in Fixed Tanks **PCA-11:** #28 - Gasoline and Associated Products Storage in Fixed Tanks and Use PCA-13: #28 - Gasoline and Associated Products Storage in Fixed Tanks **PCA-14:** #49 - Salvage Yard, including automobile wrecking PCA-15: #58 - Waste disposal and waste

Analysis of the historical research, and information gathered during site reconnaissance, was used to determine if there were any PCAs, current or historic, found on-site and/or within the Study Area that may have resulted in creating an on-site APEC. PCA's within the study area are depicted in Figure 4a.

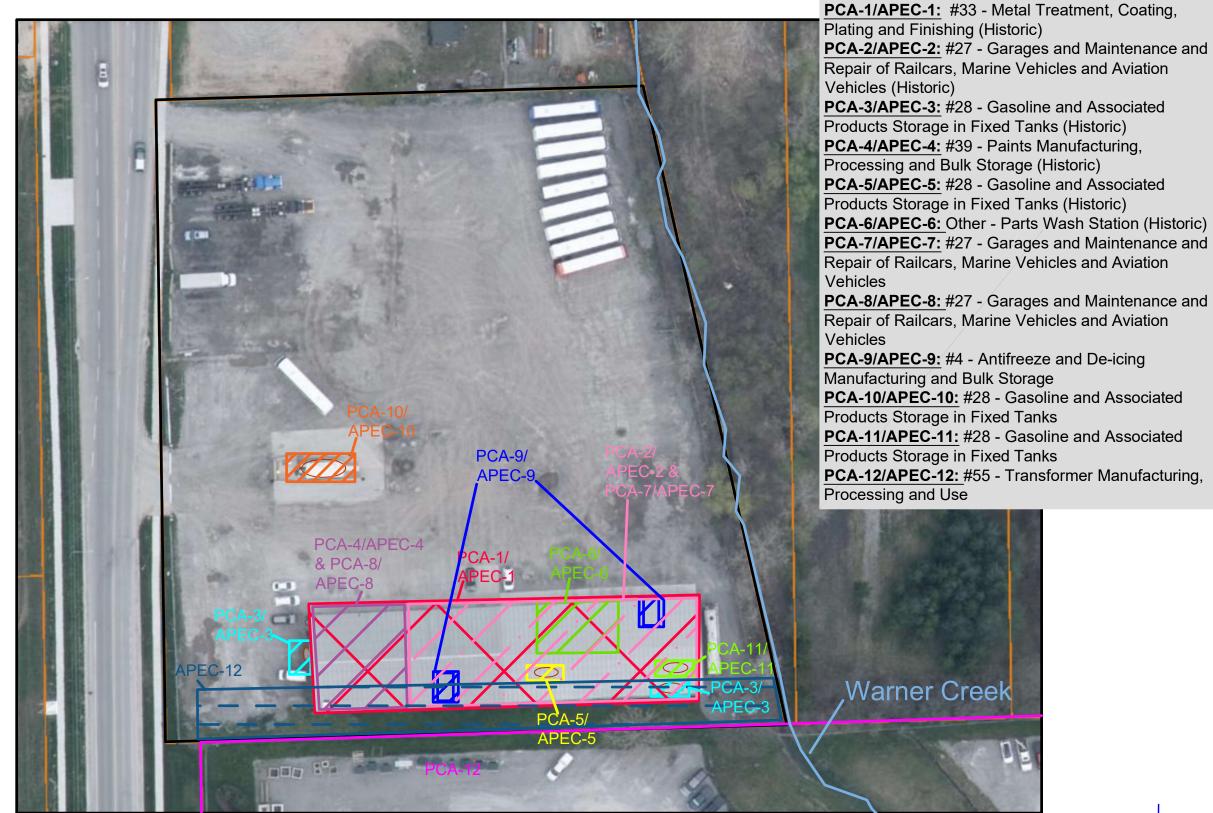
Legend Phase One Property APEC-1 (Trillium) APEC-2 (Wajax) APEC-3 (Wajax) APEC-4 (Trillium) APEC-5 (Wajax) APEC-6 (Wajax) APEC-7 (Coach Canada) APEC-8 (Phoenix/Arlington Crane) APEC-9 (Coach Canada) APEC-10 (Coach Canada) APEC-11 (Coach Canada) APEC-12 (NPE) PCA-# Inferred Groundwater Flow Direction Client: 2131595 Ontario Inc. c/o Dan Perri Project: Phase One ESA 7302 Kalar Road, Niagara Falls, ON Figure Name: Area's of Potential Environmental Concern (APECs) Project: E-23-35-1 Figure Inferred Groundwater **4b** August 2023 **Flow Direction** Drafted: AC Reviewed: N. Metz

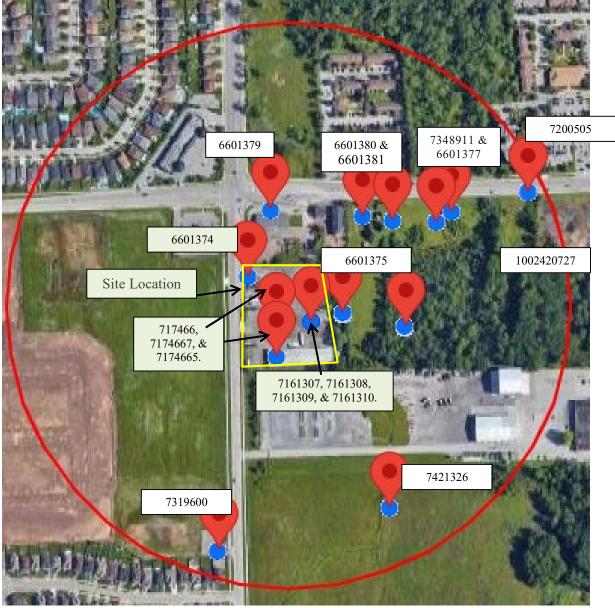
Oil, Gas & Salt Resources Library & Ministry of the Environment, Conservation and Parks Well <u>Records Database:</u>

Green shaded text boxes are indication that those wells on-site.

According to the Ministry of the Environment, Conservation and Parks Well Records database, there were eight (8) well records associated with the study sites, and ten (1) records were available from within the study area (250 m radius). Each record can contain information
