Four storey apartment Building 6259 Dorchester Road

Tree Inventory Preservation Plan

Tree Protection Plan

Landscape Concept Plan

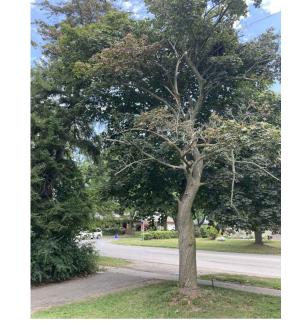
Tree #59

59	Norway Maple	Acer platanoides	52	D	G/F	Die back on the west side		Off Property	Save
60	Colorado Spruce	Picea punges	55	D	G	Slight lean east		Off Property	Save
61	White Mulberry  American Elm	Morus alba  Ulmus americana	Multi stem	D D	G		Conflicts with proposed berm	On Property  On Property	Save
63	Norway Maple	Acer platanoides	16	I	G	Tar spot	Conners with proposed bottom	On Property	Remove
64	White Spruce	Picea glauca	43	D	G			On Property	Save
65	Apple	Malus spp.	65	D	G			On Property	Save
66	Silver Maple	Acer saccharinum	Multi stem	С	P	Suckering from base		On Property	Save
67 68	Scots Pine Eastern White Cedar	Pinus sylvestris  Thuja occidentalis	35 30,30,32,25	C D	F G	Slight lean east, asymetrical growth  Multi stem		Boundary Off Property	Save Save
69	Norway Spruce	Picea abies	32	D	G	Asymetrical branch growth		Off Property	Save
70	Eastern White Pine	Pinus strobus	19	D	Р	Completely light suppressed by grapevine	Conflicts with proposed retaining wall	On Property	Remove

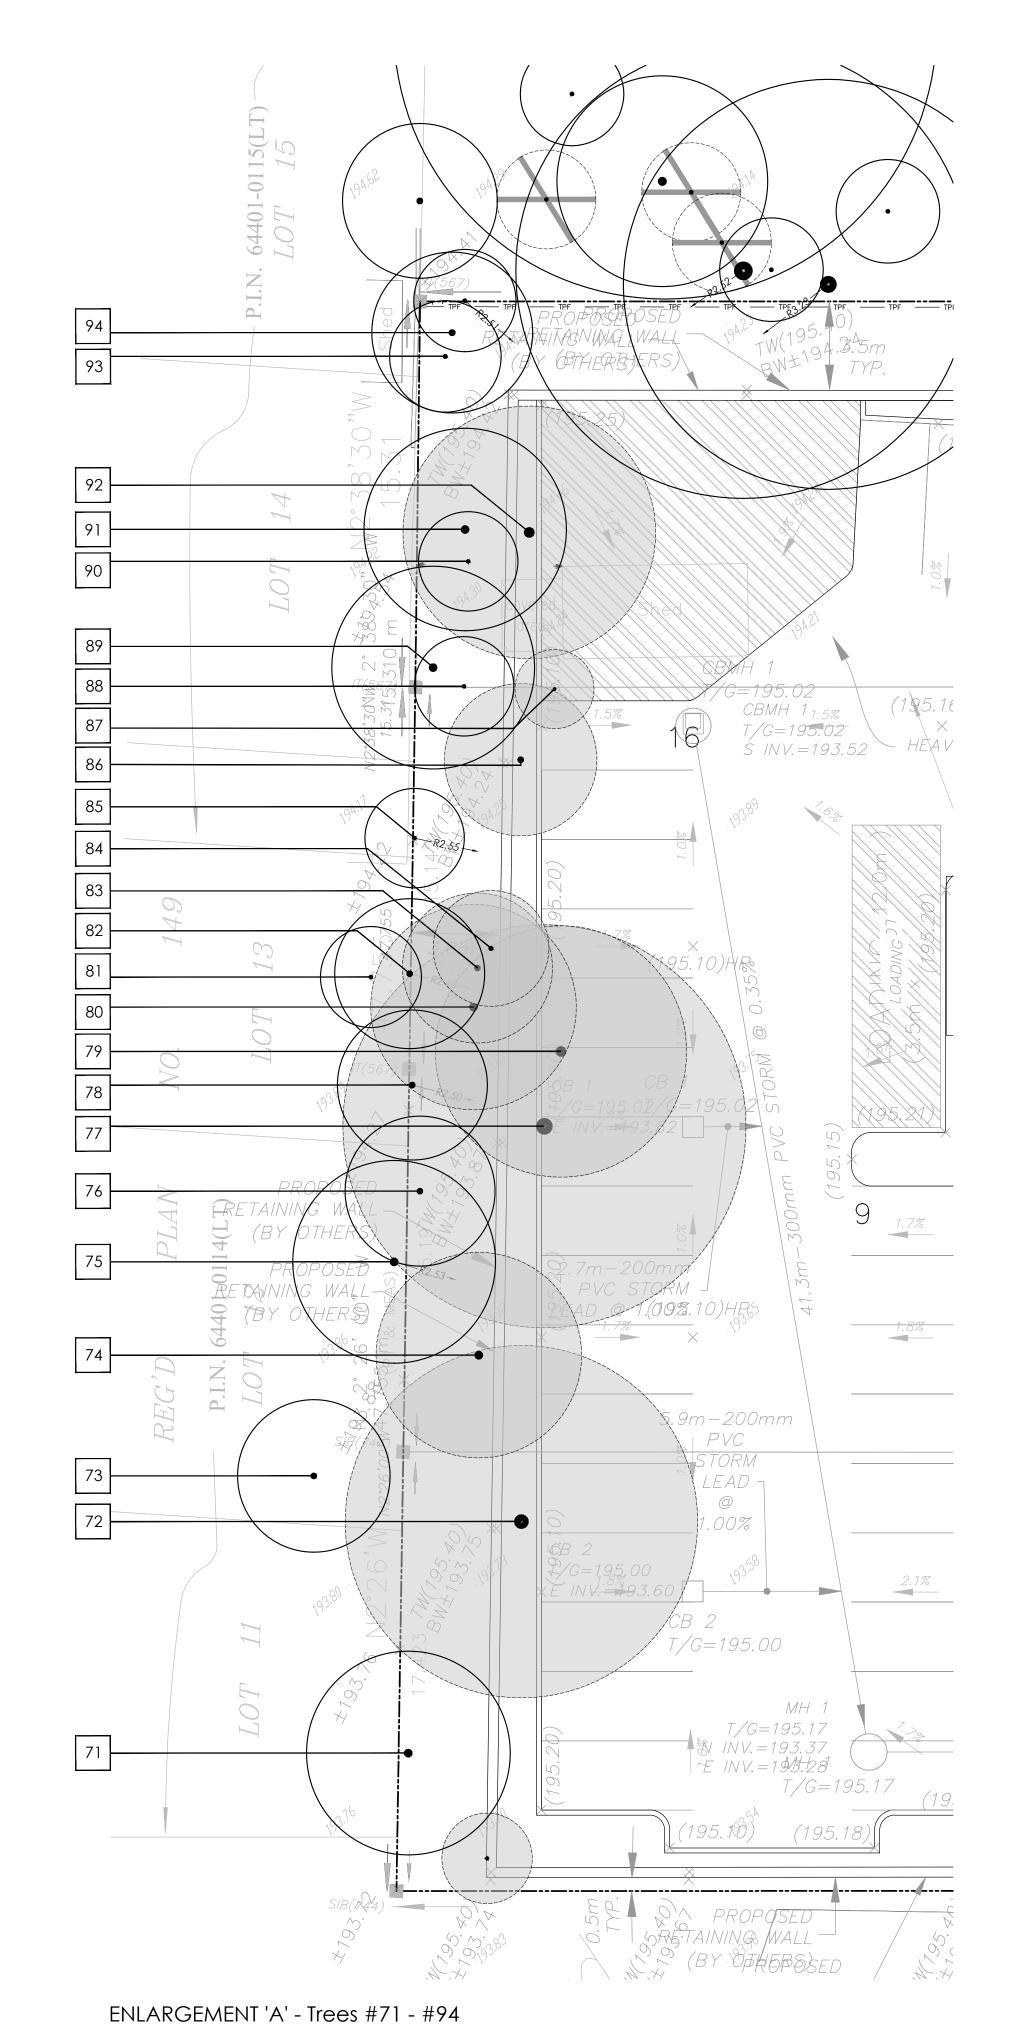
Tree Protection Fencing (with silt fence)

AREA TO BE PROTECTED AREA UNDER CONSTRUCTION 2.44m high t-bar stakes 3.0m on centre maximum Paige wire farm fence, secured to posts on uphill side Filter cloth fabric: woven geotextile fabric shall be terrafix 200 or 400, or equal. Secure to posts on uphill side with outdoor plastic locking tie wraps. EXISTING GRADE

TREE PROTECTION ZONE THIS FENCED AREA IS A TREE PROTECTION ZONE. ABSOLUTELY NO CONSTRUCTION ACTIVITY SHALL TAKE PLACE WITHIN THIS AREA \_presented SIGNAGE DETAIL 1.0m Min. preferred Vegetation to be retained NOTES: 1200mm height paige wire farm fence secured with 3.5mm tie wires, 300mm o.c. 1. The area within the dripline of all existing trees shall be properly protected with temporary fencing.

> Signage, see enlargement above - install min. 30m O.C. facing construction and grading activities

For combination tree

protection and erosion control refer to enlargement

- 2. The area within the protective fencing shall remain undisturbed with no construction activity, grade changes, surface treatment, compaction, or excavation. Area shall not be used for the storage of building materials or equipment access/storage or project related 3. Tree protection measures shall be installed prior to any demolition, tree removal or construction and shall remain until the completion of

- fine grading and sodding or seeding. 4. Prune all trees for dead, diseased, weak or hazardous branches only. also trim back branches which will interfere with construction, prune for structural restoration where necessary.

- 5. No stockpiles and/or excavated material shall be placed within the tree preservation area. 6. No rigging cable shall be wrapped around or installed to trees.7. Where root systems of protected trees are exposed directly adjacent to or damaged by construction work they are to be root pruned and

- 8. Any fine grading within the preservation area is to be done by hand. no heavy equipment is permitted within the preservation zone.
  9. Sediment accumulations to be removed by subdivider/builder when sediment deposits reach within 150mm of top of filter fabric barrier. 10. A copy of the approved and signed Vegetation Management Plan

the area back filled with topsoil to prevent root desiccation.

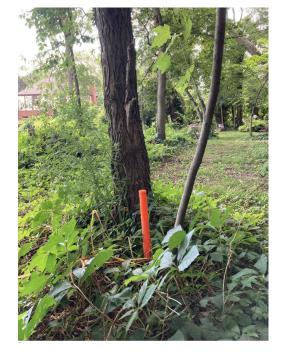
Tree #82

82	Black Locust	Robinia pseudoacacia	15	D	G			Boundary	Save
83	Black Locust	Robinia pseudoacacia	18	C-D	G/F F	Grapevine	Conflicts with proposed retaining wall  Conflicts with proposed retaining wall	On Property	Remove
84 85	Silver Maple Black Locust	Acer saccharinum  Robinia pseudoacacia	12 30,14	C-D D	F F	Lean to south	Commens with proposed retaining wall	On Property  Boundary	Remove Save
86	Black Locust	Robinia pseudoacacia	23	D	F		Conflicts with proposed retaining wall	On Property	Remove
87	American Elm	Ulmus americana	16	С	F		Conflicts with proposed retaining wall	On Property	Remove
88	Black Cherry	Prunus serotina	12	I	F	Light suppressed, growing from old stump		On Property	Save
89	Black Cherry	Prunus serotina	17	ı	F/P	Poorly trimmed, light suppressed, growing from old stump		On Property	Save
90	White Spruce	Picea glauca	16	1	G/F			On Property	Save
91	Silver Maple	Acer saccharinum	66	C-D	F/G	Storm damage, Light supp., lean to west		On Property	Save
