FINAL
Phase I Environmental
Site Assessment

7737 Lundy's Lane
Niagara Falls, Ontario

July 3, 2024

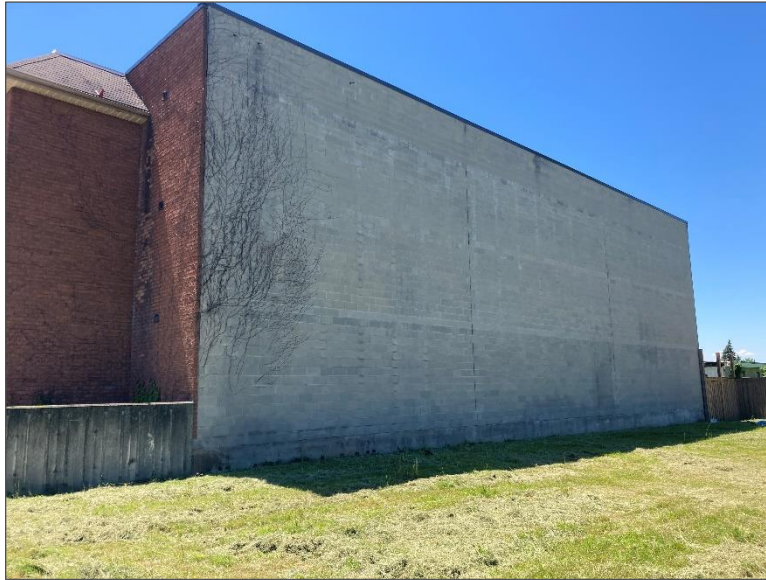
Photo 1 – Site Building (north elevation).

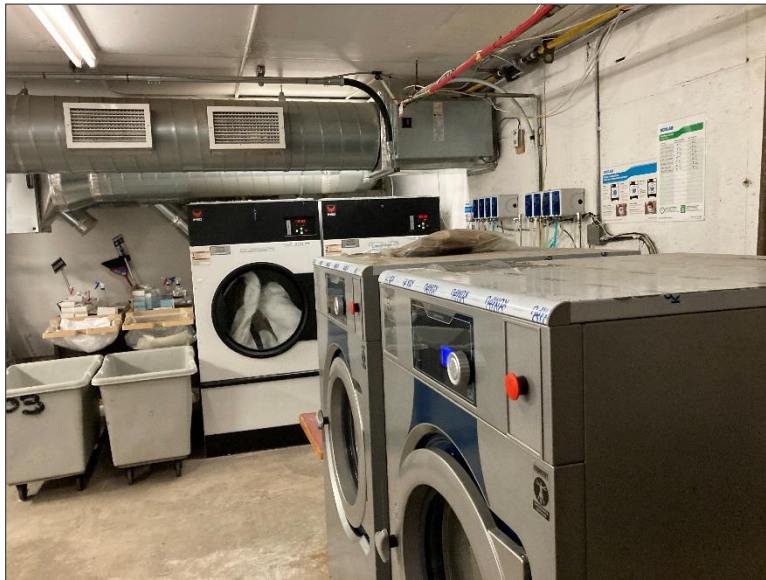
Photo 12 – View of the laundry room within the basement of the Site Building.

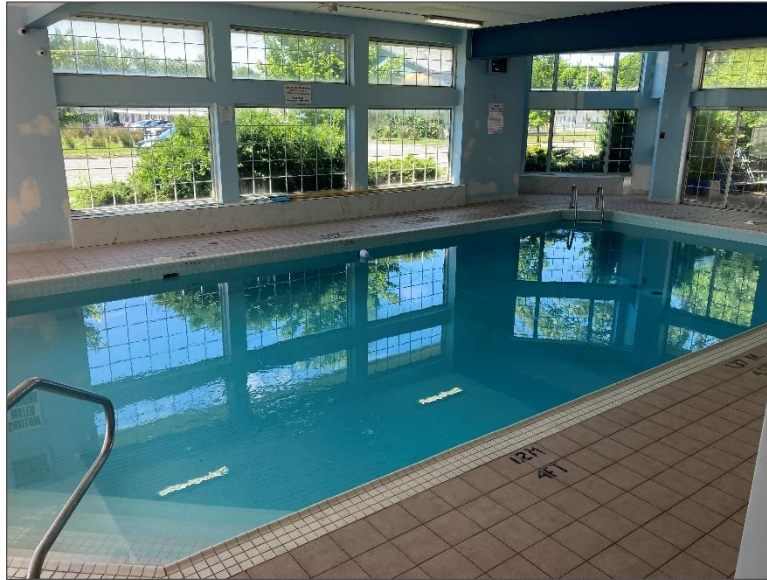
Photo 13 – View of pool room within the south portion of the Site Building.

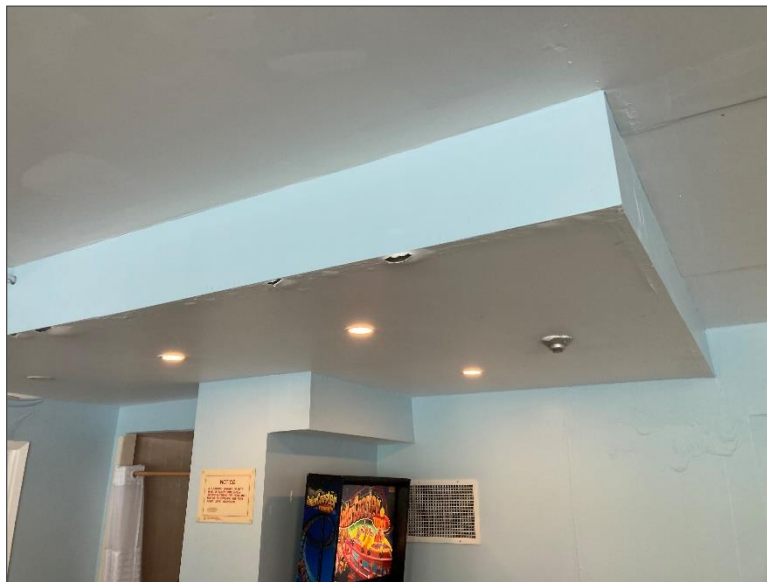
- Water-damaged and stained drywall were observed on the ceilings and walls within the pool room of the Site Building, likely due to condensation and poor ventilation;
- Water-stained ceiling drywall, joists and insulation within the interstitial space around the roof access;
- Water-stained ceiling tiles and drywall were observed within the Site Building; and
- Water-stained flooring and baseboards were observed in the basement of the Site Building.

Photo 14 – Representative view of water damage within the pool room of the Site Building.

At the time of the Site reconnaissance, water-stained and/or damaged materials which were observed by Pinchin. These materials should be removed/replaced in accordance with industry standards and routinely monitored for changes. The extent of the potential water damage or mould growth within wall/ceiling cavities was not assessed as part of this Phase I ESA. In order to further assess the potential presence of potential mould growth, a mould survey would be required.

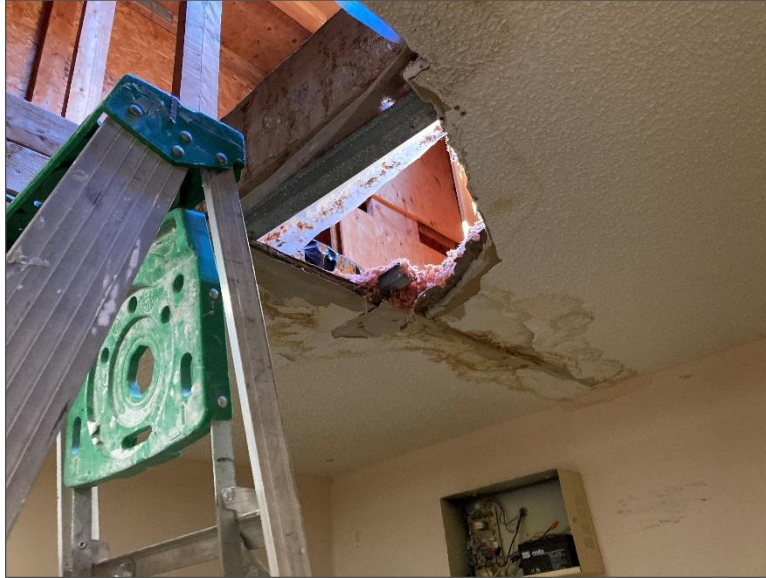
Photo 15 – View of water-stained building materials in the vicinity of the roof access.

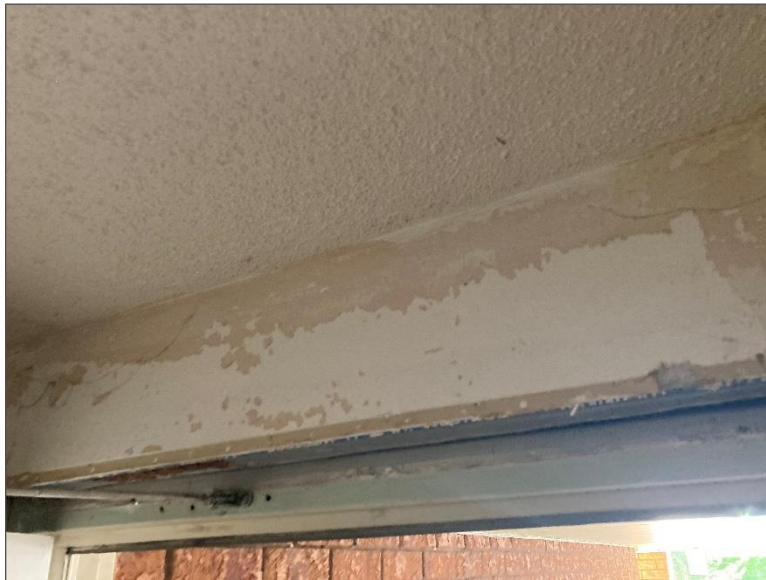
Pinchin did not conduct an assessment of lead in painted surfaces as part of this Phase I ESA, and the Site Representatives advised Pinchin that no surveys have been previously conducted at the Site. Prior to any demolition or renovation activities, a designated substance (including lead) survey would be required. During Pinchin's Site reconnaissance, Pinchin observed that painted surfaces at the following locations were in poor condition (i.e., peeling and/or flaking):

Photo 16 – Example of chipped and flaking paint within the Site Building.

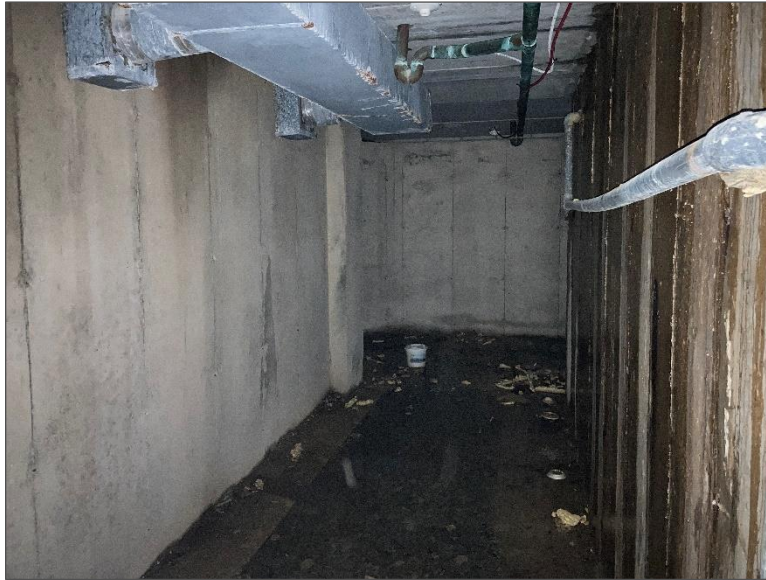
In addition, the pool was observed to be leaking through the concrete foundation into the basement of the Site Building; however, at the time of the Site reconnaissance, the floors and walls in this portion of the basement were unfinished and consisted of concrete and granular material, respectively. Water damage/staining observed on building materials (i.e., ceiling tiles) should be removed/replaced in accordance with industry standards and routinely monitored for changes. The extent of the potential water damage or mould growth within wall/ceiling cavities was not assessed as part of this Phase I ESA. In order to further assess the potential presence of potential mould growth, a mould survey would be required.

Photo 17 – View of unfinished basement in the vicinity of the inground pool.

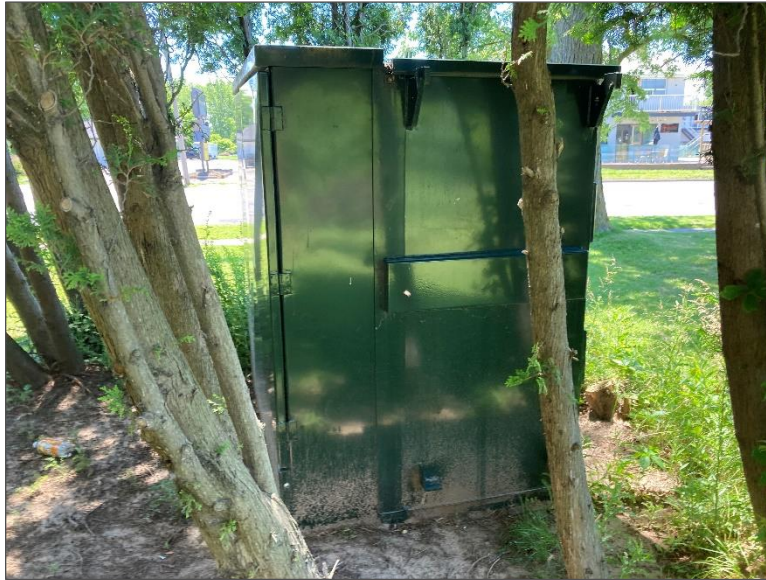
Given the year of construction of the Site Building (1987), it is unlikely that PCBs are present in on-Site electrical equipment. A pad-mounted oil-cooled transformer is located on the southeast portion of the Site. No staining was observed on the concrete pad in the vicinity of the transformer, and it should be noted that any maintenance and/or concerns associated with the high-voltage transformer would be the responsibility of Niagara Peninsula Energy.

Photo 19 – View of pad-mounted transformer located on the southwest corner of the Site.
