**PHASE ONE
ENVIRONMENTAL SITE ASSESSMENT
6158 ALLENDALE AVENUE AND
5602, 5592 & 5566 ROBINSON STREET
NIAGARA FALLS, ONTARIO**

Prepared for: La Pue International Inc.
6158 Allendale Avenue
Niagara Falls, Ontario
L2G 0A5

File No 7-21-0103-41
April 14, 2022

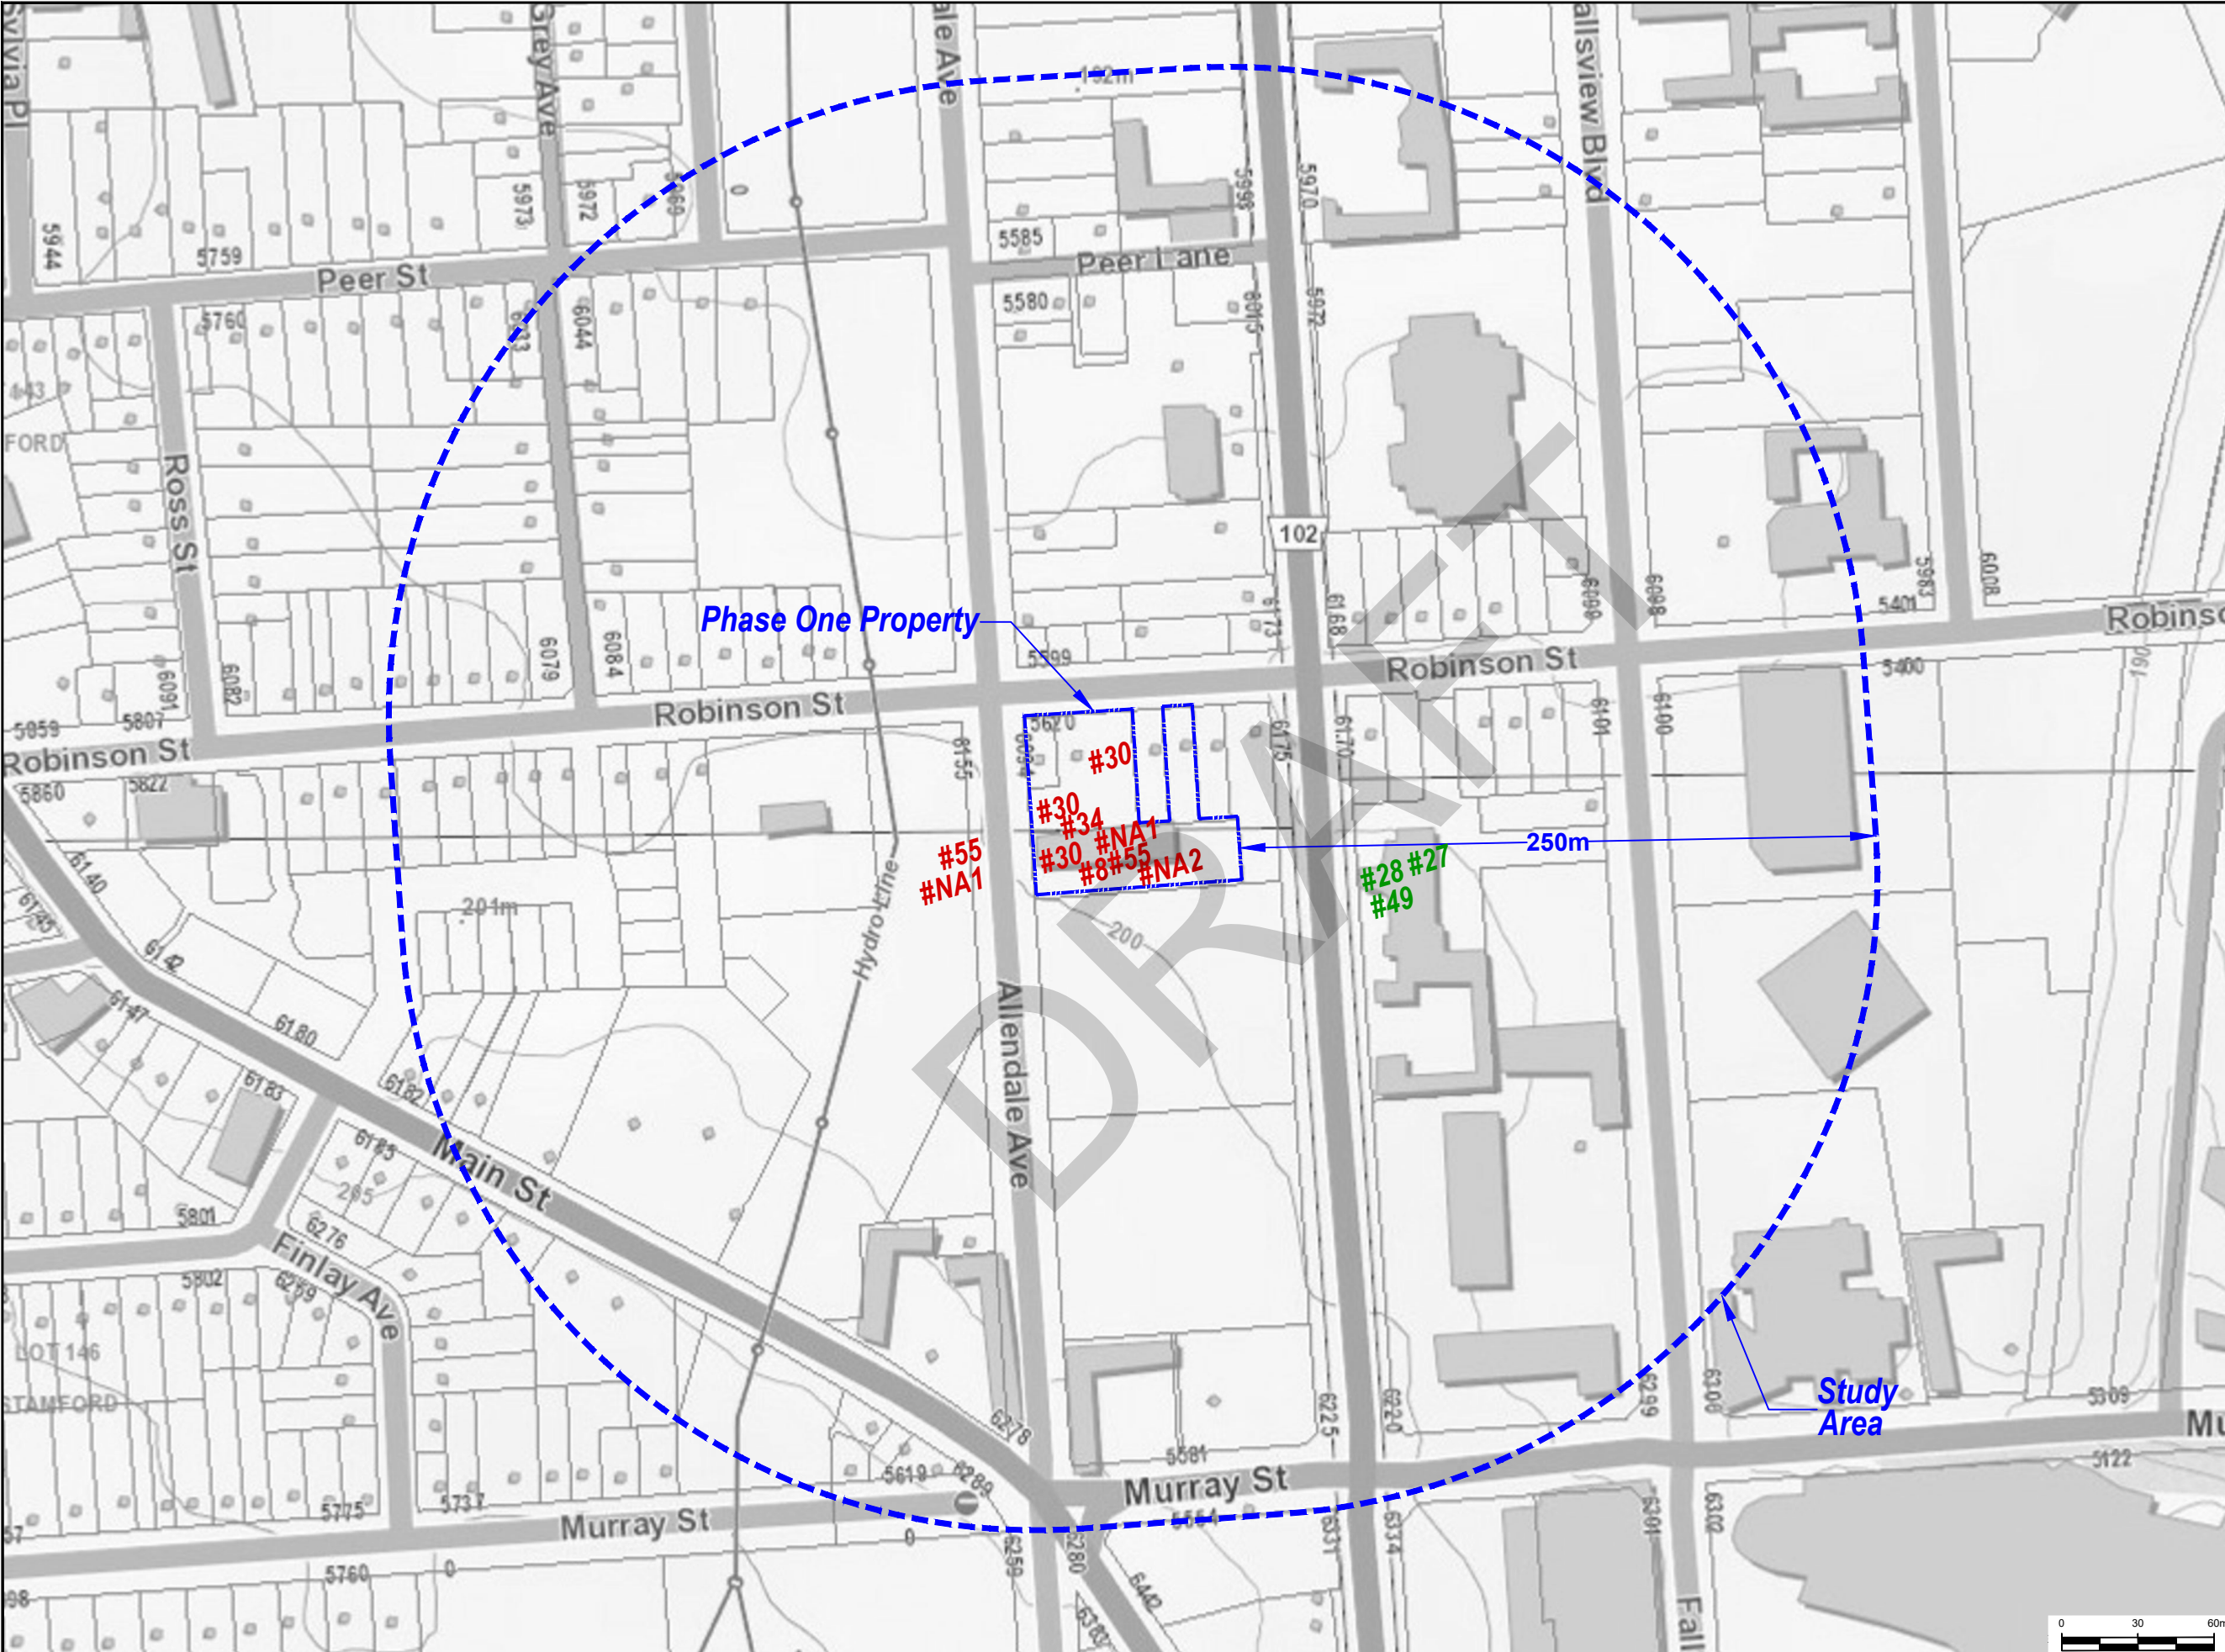
Figure Title:
 PCA LOCATIONS

The Phase One Environmental Site Assessment identified the following Potentially Contaminating Activities (PCAs) on the Property and within the Study Area. The locations of the PCAs are illustrated in Figure 5.

Phase One Study Area, 250m
#8	Chemical Manufacturing, Processing and Bulk Storage
#27	Garages and Maintenance and Repair of Railcars, Marine Vehicles and Aviation Vehicles
#28	Gasoline and Associated Products Storage in Fixed Tanks
#30	Importation of Fill Material of Unknown Quality
#34	Metal Fabrication
#49	Salvage Yard, including automobile wrecking
#55	Transformer Manufacturing, Processing and Use
#NA1	Registered Waste Generator
#NA2	Use of De-icing Salts

<i>The following is a description and assessment of:</i>	
i. Any areas where potentially contaminating activity on or potentially affecting the Phase	Figure 5 illustrates the locations of PCAs identified within the Phase One Study Area. Figure 2 illustrates the layout of specific

Phase One CSM	Information Pertaining to Property
<p>One Property has occurred,</p>	<p>features of interest (e.g., USTs) on the Phase One Property.</p> <p>PCAs illustrated on Figure 5 are colour-coded to indicate if they are assessed as having the potential to impact the Phase One Property (red) or not (green). The assessment of the potential to impact the Phase One Property was based on several factors including:</p> <ul style="list-style-type: none"> • The type of PCA. • The potential magnitude of the PCA (e.g., small-scale waste generation versus significant commercial activity). • The Contaminants of Potential Concern (CoPCs) associated with the PCA. • The nature of those CoPCs in terms of their mobility in soil, ground water, and sediment as applicable. • Shallow ground water is expected to flow in a westerly direction towards the Niagara River. • The anticipated hydraulic conductivity of saturated media at the Phase One Property and within the Phase Two Study Area. • The distance between the PCA and the Phase One Property (if the PCA is off-site). <p>The following is a summary of the PCAs located on the Phase One Property and within the Phase One Study Area:</p> <p>Phase One Property</p> <ul style="list-style-type: none"> • 6158 Allendale Avenue (On Phase One Property) • #34 – Metal Fabrication • PCA On-Site. This PCA has potential to cause an APEC on the Property due to the historic operation of Zippo Manufacturing Company Canada Ltd from 1939 to 2004. • Associated with APEC 1 <p>Phase One Property</p> <ul style="list-style-type: none"> • 6158 Allendale Avenue (On Phase One Property) • #8 – Chemical manufacturing, processing and bulk storage • PCA On-Site. This PCA has potential to cause an APEC on the Property due to the historic storage of chemicals associated with Zippo Manufacturing Company, including lacquer thinner and methyl hydrate. • Associated with APEC 2

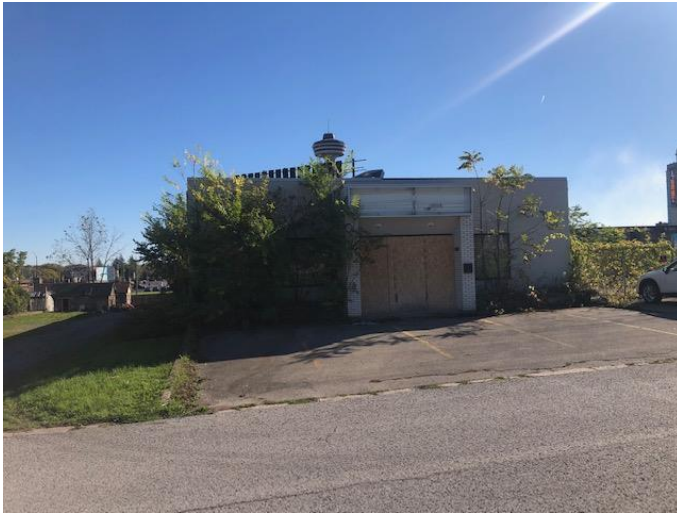
Photograph 1

Location: Phase One Property (6158 Allendale Avenue)
Viewing: East
Description: View of the south side of the commercial/light industrial building, and associated driveway and parking area.

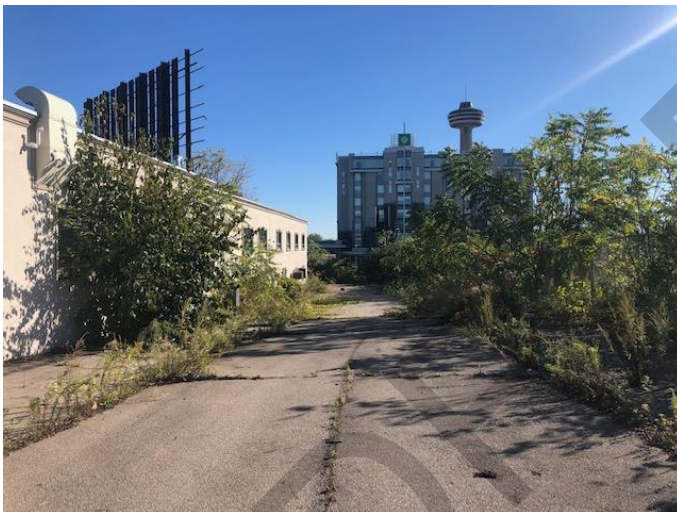
Location: Phase One Property (6158 Allendale Avenue)
Viewing: East
Description: View of the vacant commercial/light industrial building located at 6158 Allendale Avenue. The building was occupied by Zippo Manufacturing Company Canada Limited from approximately 1939 to 2004.

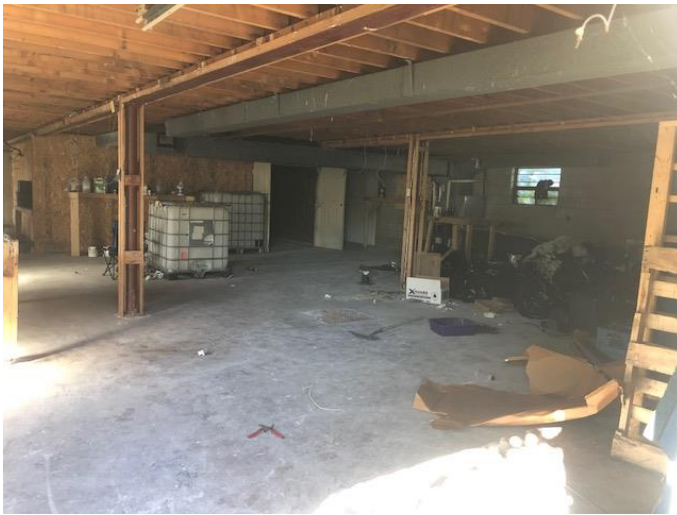
Photograph 3

Location: Phase One Property (6158 Allendale Avenue)
Viewing: West
Description: View of the west side of the building and associated loading dock area. Six 275-gallon intermediate bulk storage containers, which appeared to be containing varying amounts of water, were located on the west exterior wall.

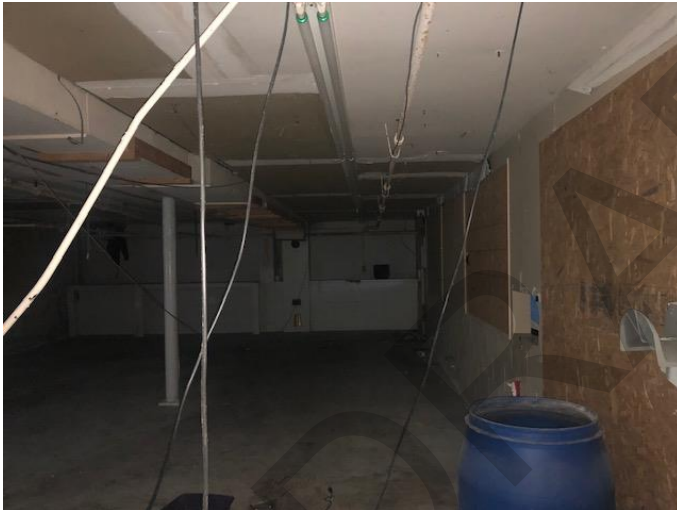
Photograph 4

Location: Phase One Property (6158 Allendale Avenue)
Viewing: Interior
Description: View of the main floor within the eastern portion of the building.

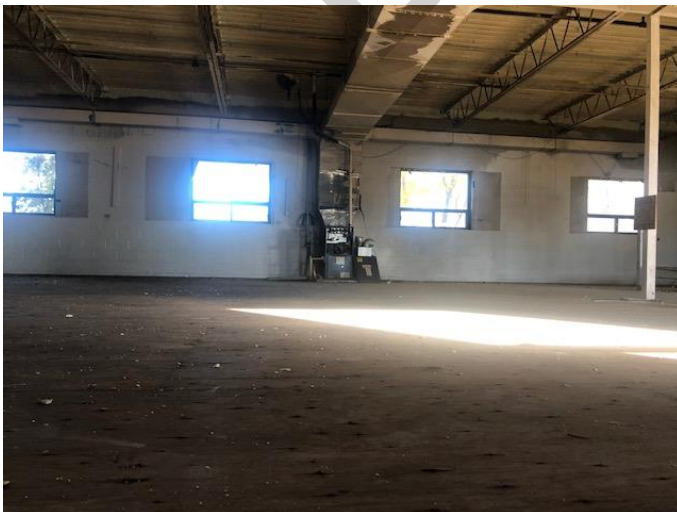
Photograph 5

Location: Phase One Property (6158 Allendale Avenue)
Viewing: Interior
Description: View of the main floor within the eastern portion of the building. Electrical components from the lighting had been stripped and reconfigured. A barrel containing a small amount of liquid, assumed to be water, was located near the entrance to the room.

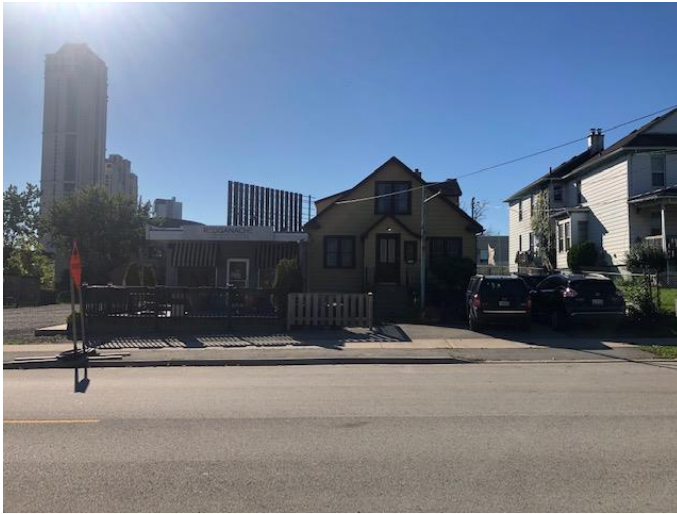
Photograph 7

Location: Phase One Property (5592 Robinson Street)
Viewing: South
Description: View of the residential dwelling and attached commercial bakery located at 5592 Robinson Street.

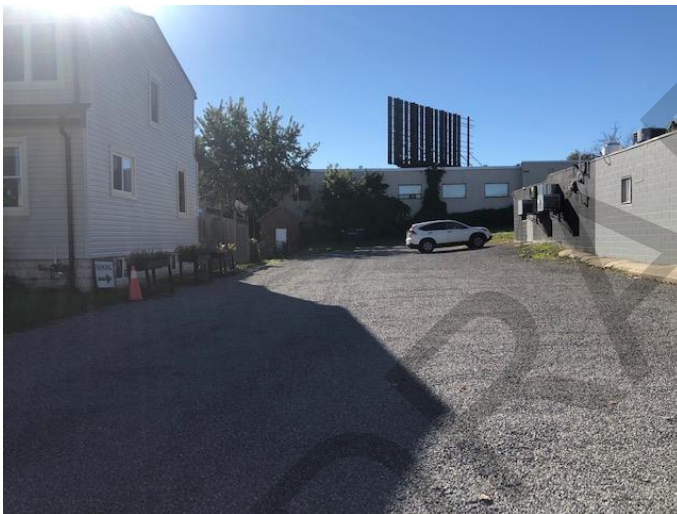
Photograph 8

Location: Phase One Property (5592 Robinson Street)
Viewing: South
Description: View of the parking area east of the bakery at 5592 Robinson Street
