PROJECT No.: SM 301724-E

**PHASE ONE ENVIRONMENTAL SITE ASSESSMENT
PROPOSED HIGH RISE DEVELOPMENT
LOT 175, PORTAGE ROAD
NIAGARA FALLS, ONTARIO**

**SOIL-MAT ENGINEERS & CONSULTANTS LTD.
130 LANCING DRIVE
HAMILTON, ONTARIO
L8W 3A1**

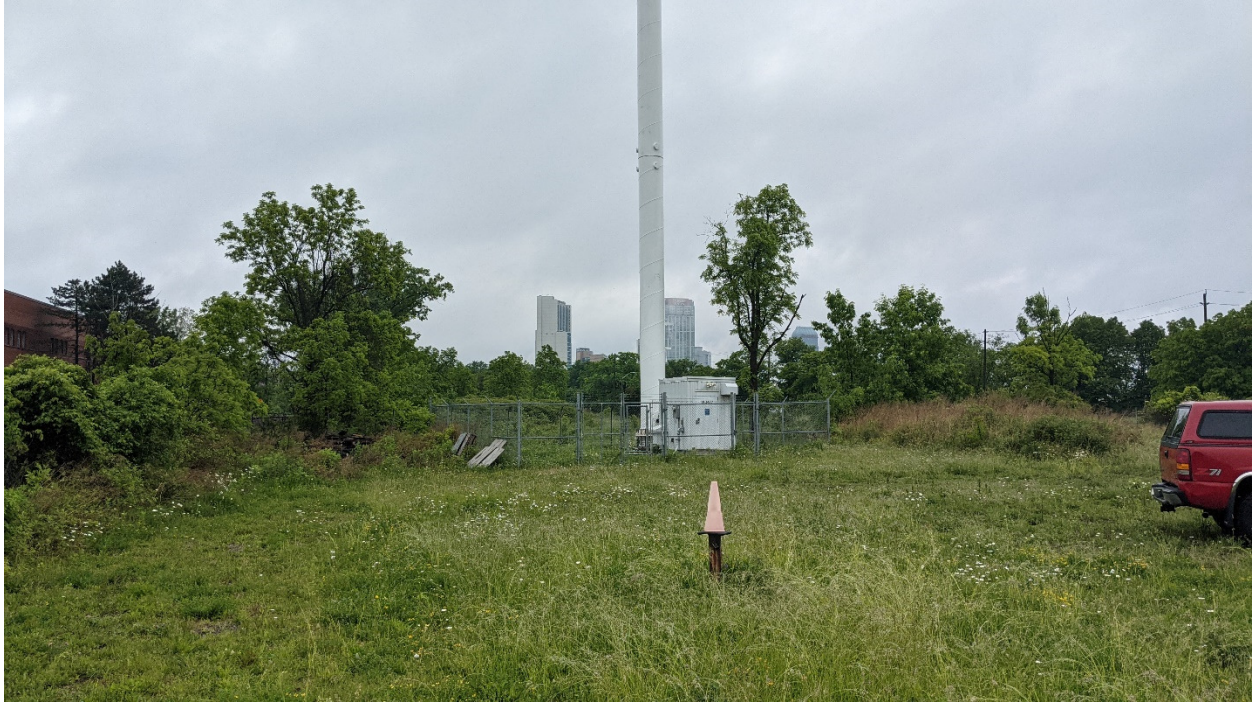
Details of Former and Current Wells	No potable groundwater wells were observed on the Site. However, one monitoring well was observed on the western portion of the Site, however the MOE Water Well Records do not have any records for the property.
Details of Sewage Works	The surrounding area is serviced with a municipal sewer line.
Details of Ground Surface Cover	With the exception of an asphaltic-concrete covered driveway and parking area and a small gravel covered area, the Site was primarily covered with overgrown grass and low-lying weeds.
Details of Former or Current Railway Lines	None observed, however, the 1962 topographic map illustrates two [2] railway spur lines on the Site.
Details of Stained Soil, Damaged Vegetation or Pavement	None observed

Hello Peter,
