PHASE ONE ENVIRONMENTAL SITE ASSESSMENT

5523, 5531, 5539, 5547 & 5555

Fraser Street, Niagara Falls, ON

Date: January 13, 2023
NSSL File No.: NS22123-01

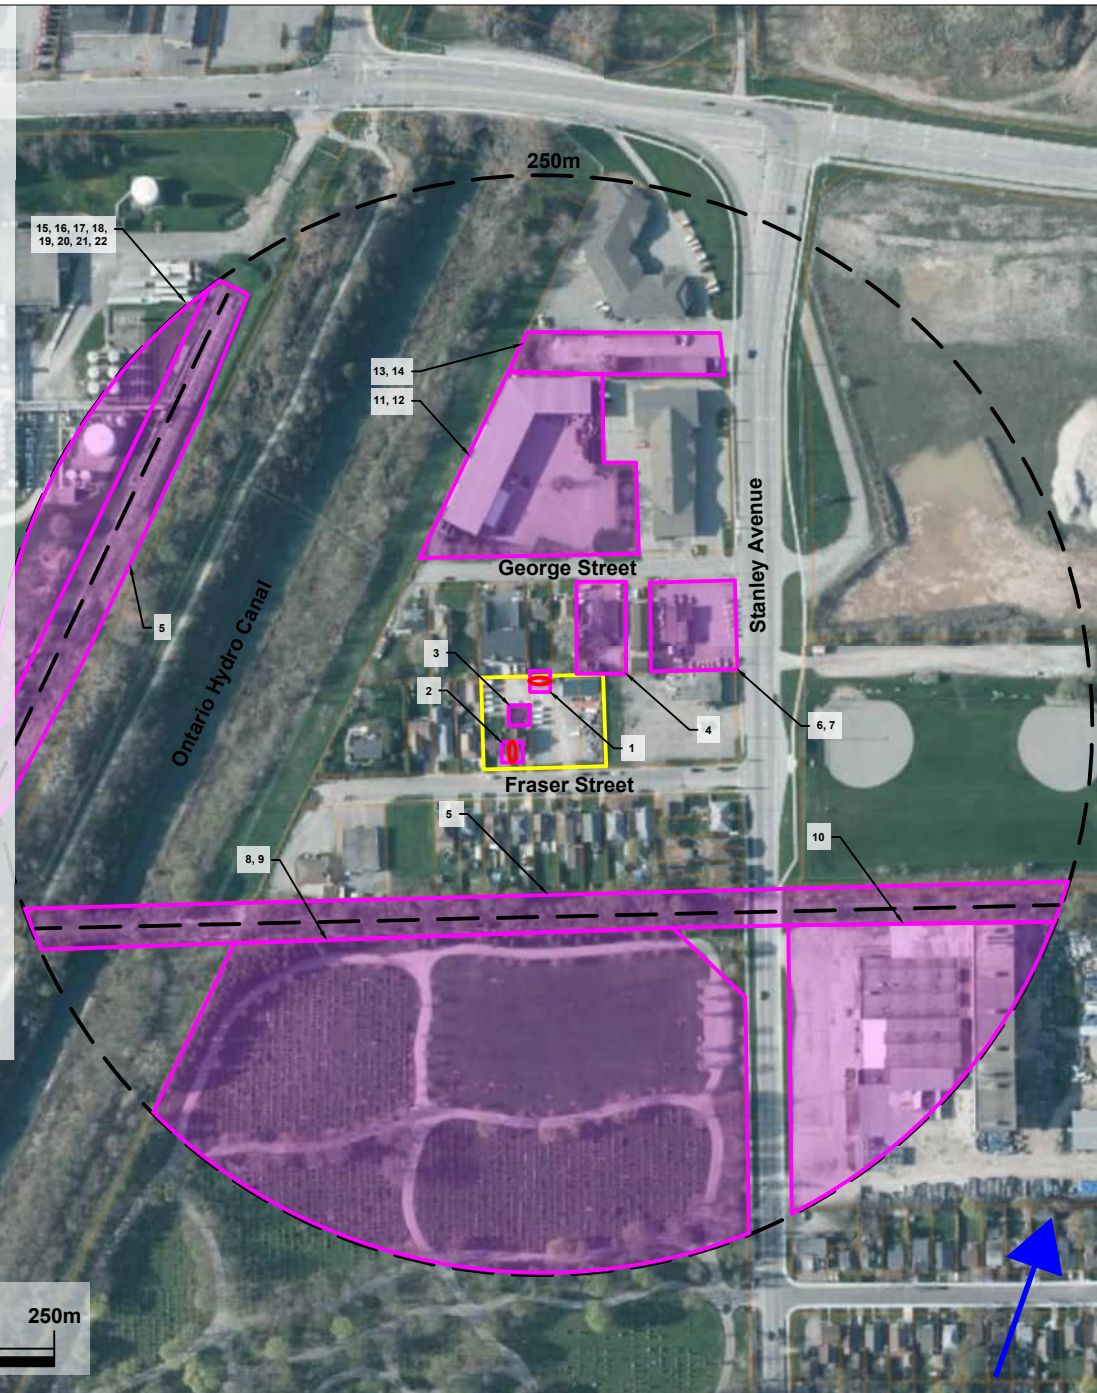
- #19 39. Paints Manufacturing, Processing and Bulk Storage.
- #20 41. Petroleum-derived Gas Refining, Manufacturing, Processing and Bulk Storage.
- #21 46. Rail Yards, Tracks and Spurs.

- #22 51. Solvent Manufacturing, Processing and Bulk Storage.

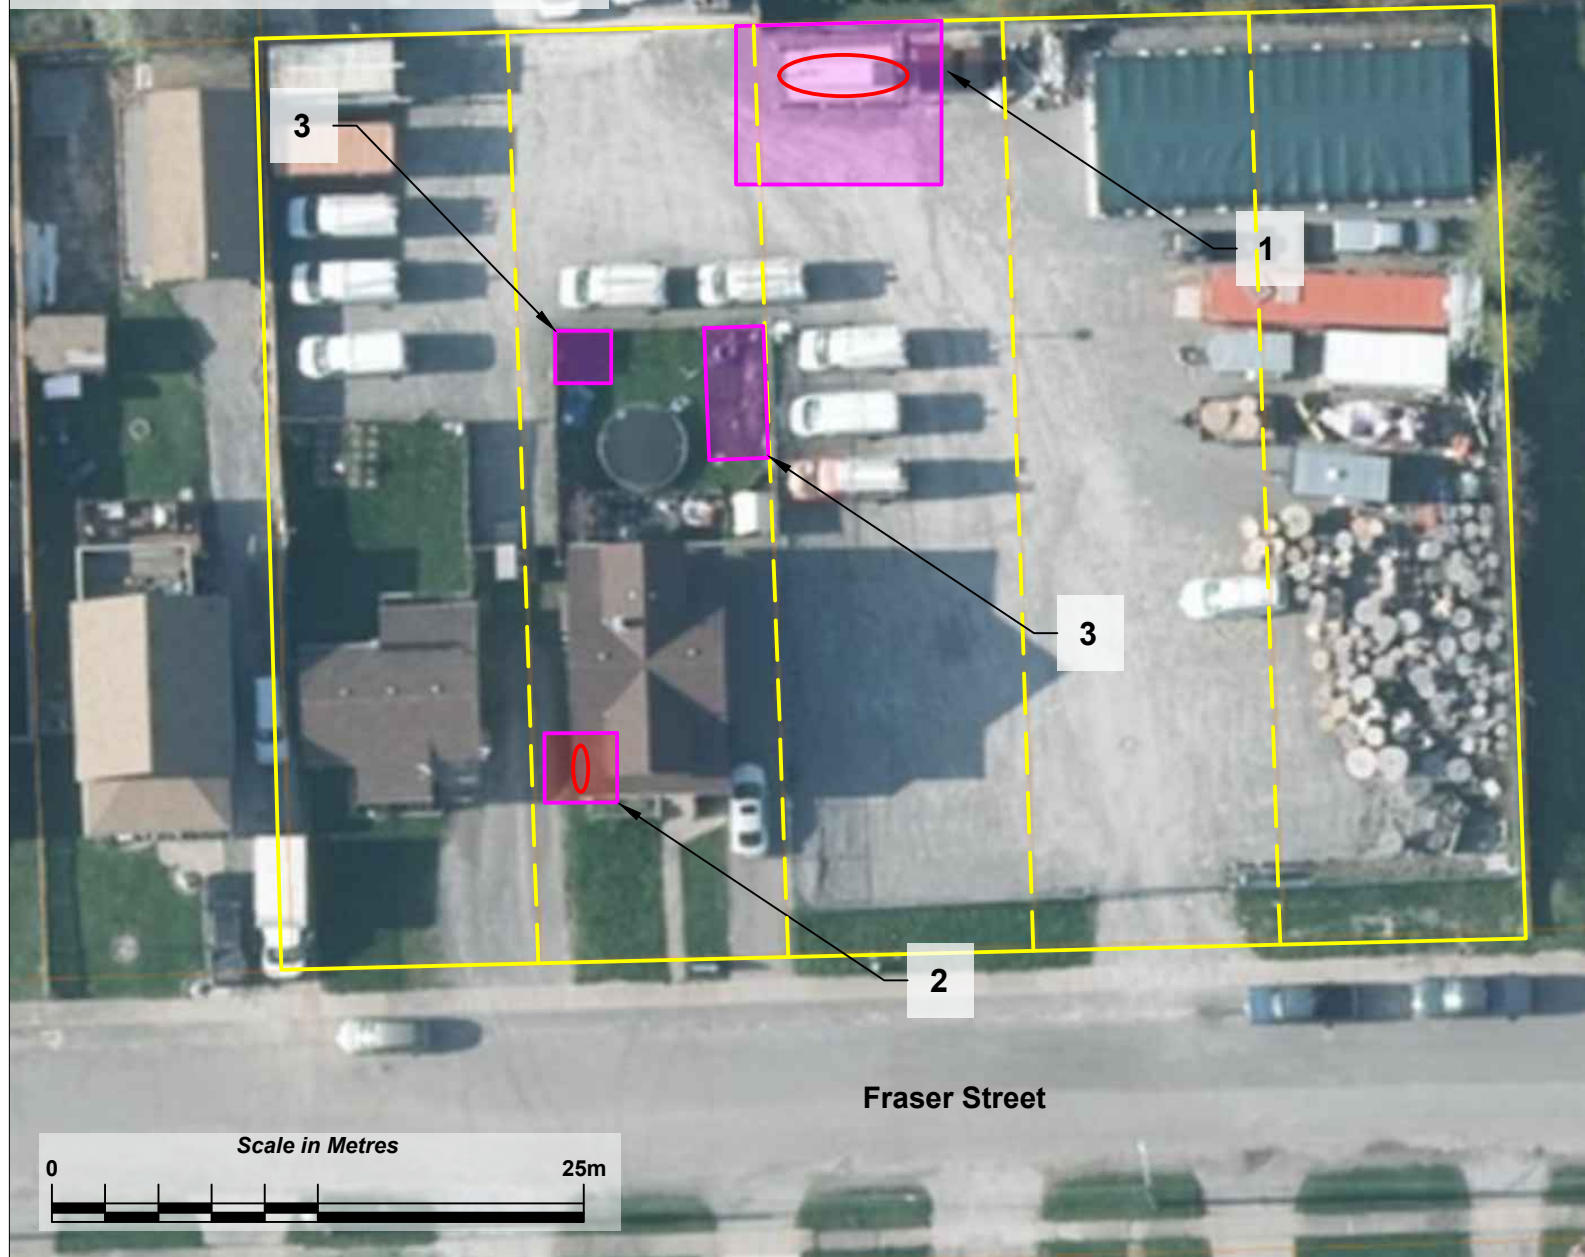
AREAS OF POTENTIAL ENVIRONMENTAL CONCERN

- #1 28. Gasoline and Associated Products Storage in Fixed Tanks.
- #2 28. Gasoline and Associated Products Storage in Fixed Tanks.
- #3 30. Importation of Fill Material of Unknown Quality.

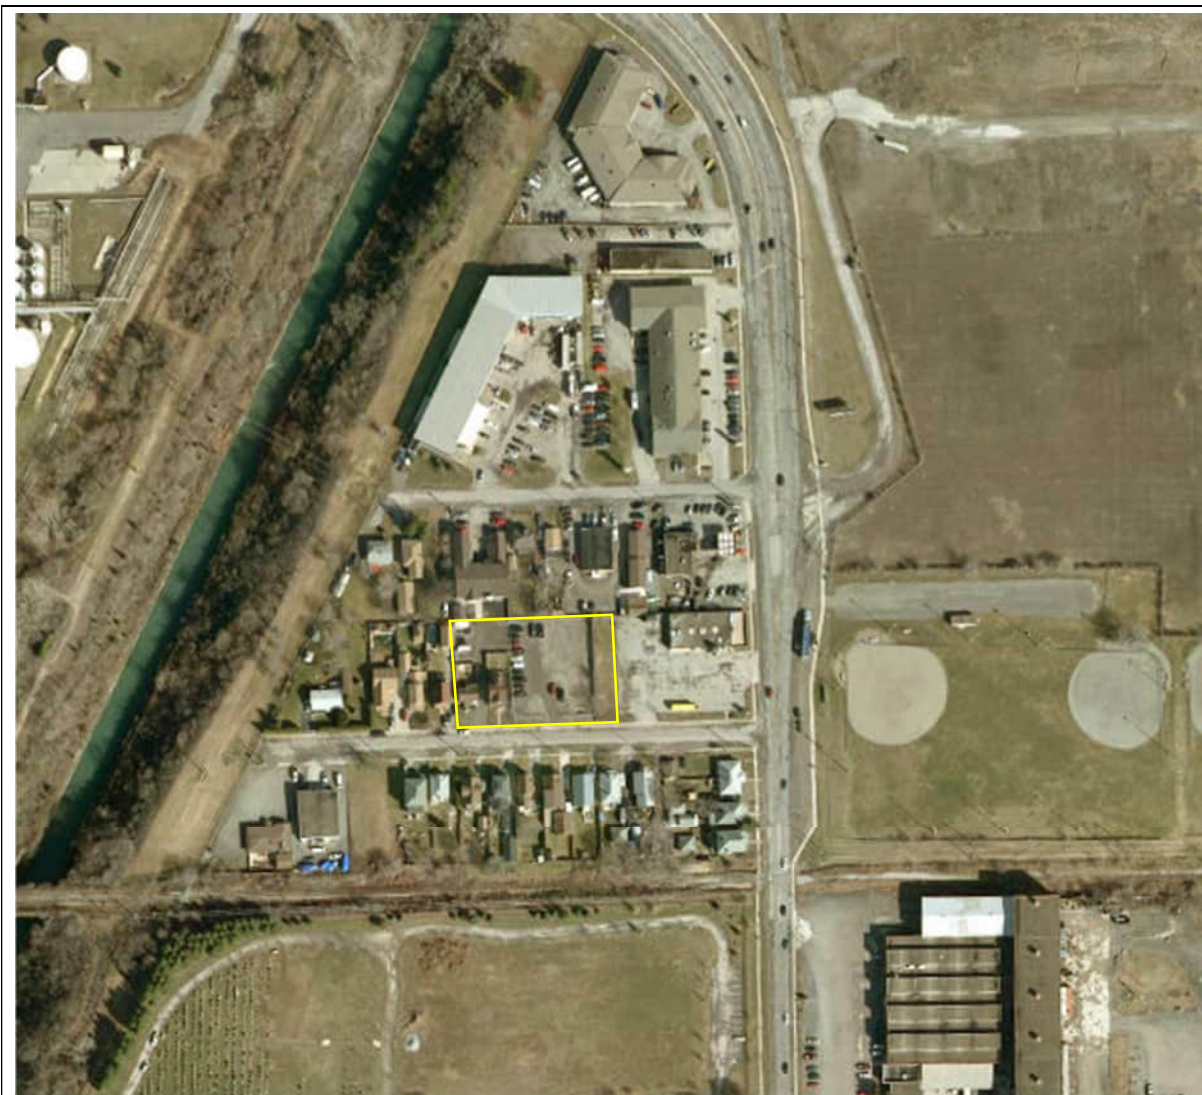
Photograph No. 7 – 2010

2010	5523, 5531 and 5539 Fraser Street homes have been torn down and replaced with an open parking lot in 2010.	Additional roads have been built within the cemetery. The baseball diamonds and large commercial structure remain to the east of Stanley Avenue in the study area. To the west of the hydro canal the Lubrizol Canada Ltd. property has expanded with tanks and structures visible. The commercial structure north of George Street adjacent to the hydro canal has had an expansion to the building on the north end.

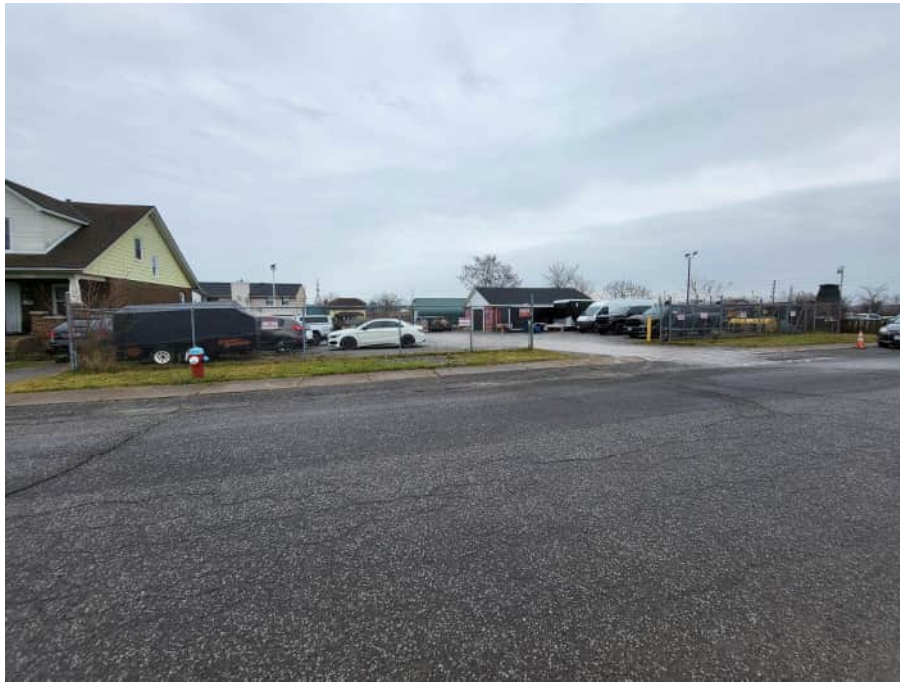
Photograph No. 1 – The Phase One property consists of five [5] parcels of land located side by side on the north side of Fraser Street. Three [3] of the parcels of land [shown above] are utilized for parking and storage area for an electrical business.

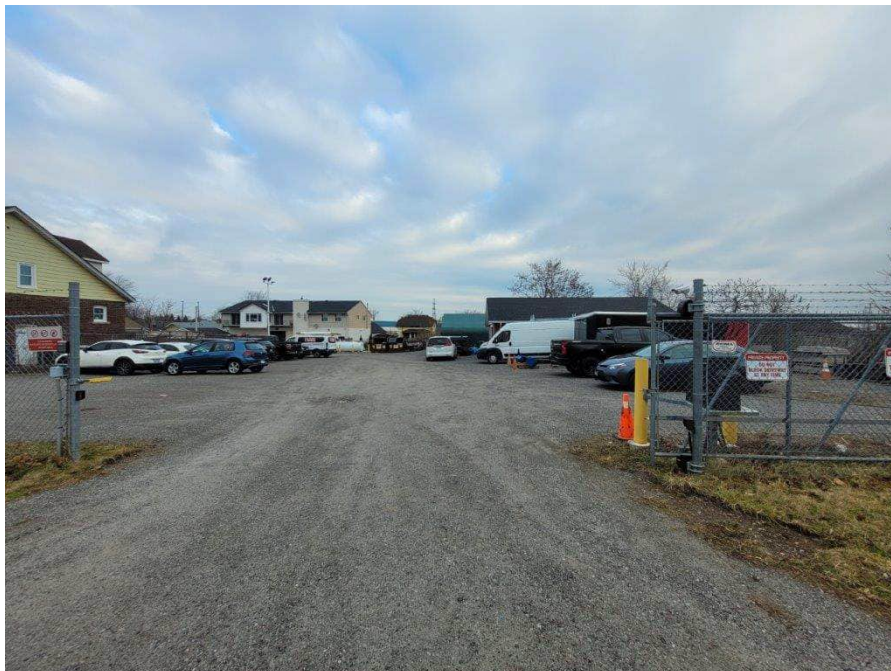
Photograph No. 2 – Looking north at the three [3] lots used for parking and storage. Residential dwellings were historically located on each individual parcel of land. The lots have been combined for parking and storage and are located within a gated security fence.

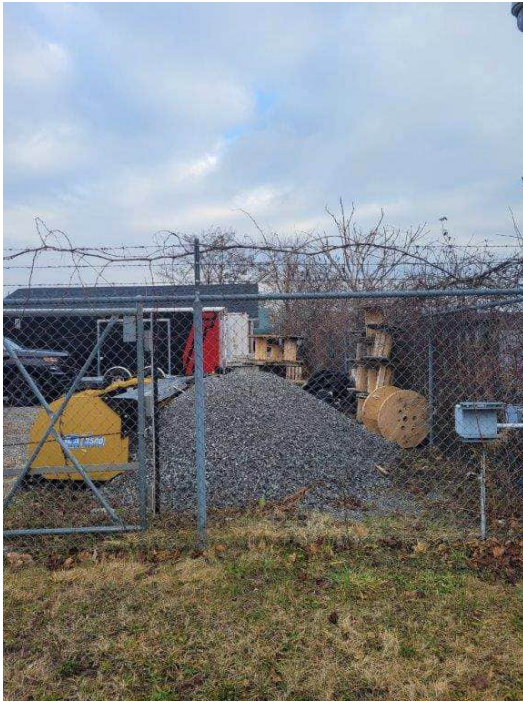
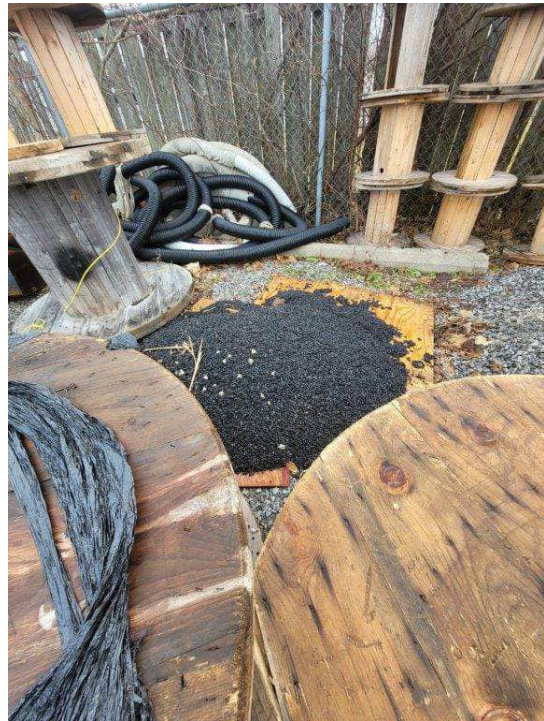
Photograph Nos. 3 & 4 – During the Site reconnaissance granular material [left] was observed piled in the southeast portion of the parking lot. A variety of small construction machinery is stored on this area of the lot. An area of mounded asphaltic concrete was noted to be stored [right] between wooden spools.

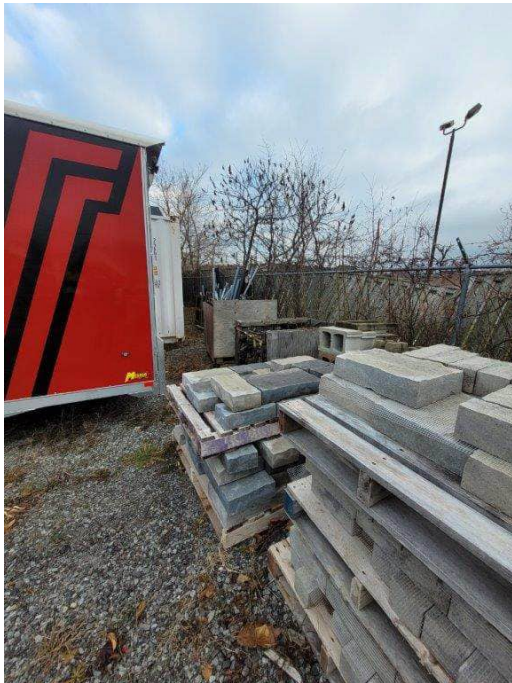
Photograph Nos. 5 & 6 - Image of a storage trailer and various construction materials [left] and commercial waste disposal bins [right] located towards the center of the gated parking area.

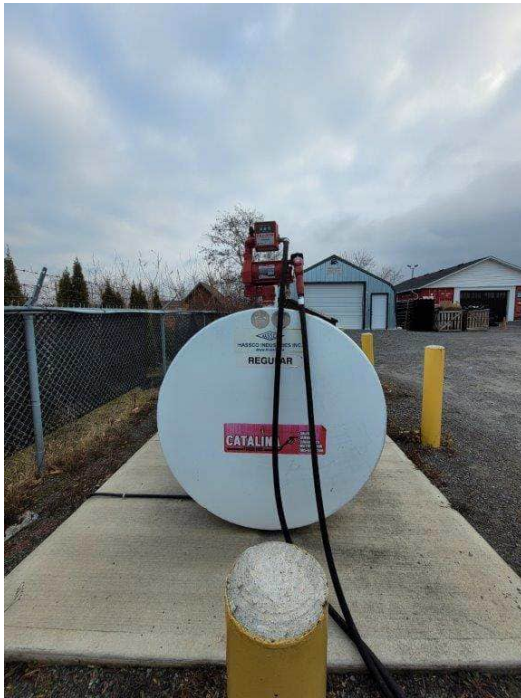
PCA-1/APEC-1: #28, Gasoline and Associated Products Storage in Fixed Tanks. A gasoline above ground storage tank is located on the parking lot property [5523, 5531 & 5539 Fraser Street] along the northern fence line. Property owner Mr. Visca indicated the tank was installed approximately three [3] years ago. The tank was placed on a cement platform with bumper guards surrounding. The presence of a tank represents an onsite PCA and APEC to the property.

Photograph Nos. 7 & 8 – At the time of the Site visit a gasoline above ground storage tank [AST] was noted situated at the north property boundary of 5531 Fraser Street, situated on a concrete pad surrounded by cement parking bollards. A fire hydrant was noted to be located on the south property boundary of 5539 Fraser Street [Lot 22]. The study area is serviced by all municipal utilities, including water and wastewater.

Based on the Phase One ESA research as summarized above, Niagara Soils Solutions Ltd. recommends a Phase Two ESA be completed to assess the potential environmental impacts to the soil at 5547 Fraser Street and the parking area lots due to the current and historic presence of an Above Ground Storage Tank and potential fill material.

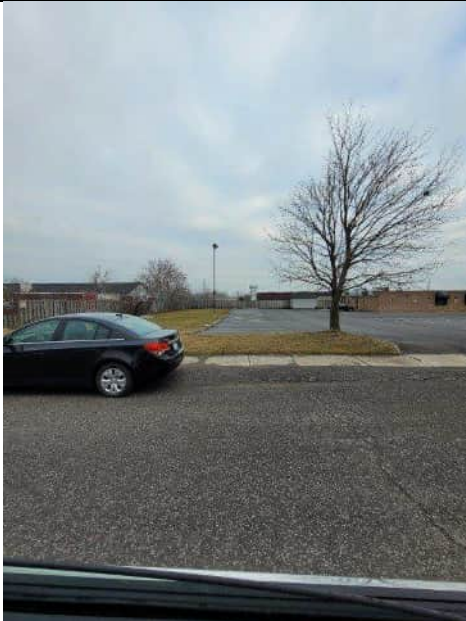
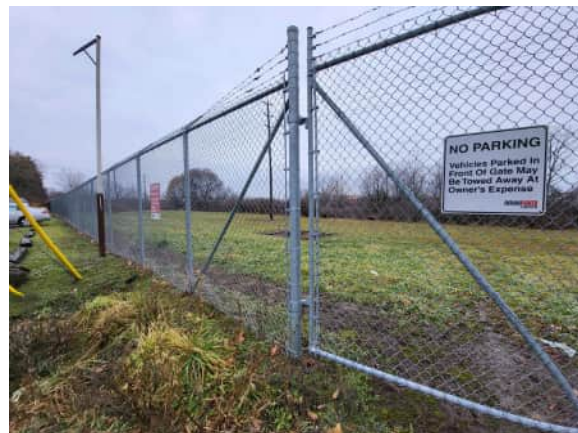
Photograph Nos. 9 & 10 – The east adjacent property is a large parking area and building structure currently utilized as a church [left]. Fraser Street is accessible from Stanley Avenue to the east, with Fraser Street ending at the Queenston-Chippawa Hydro Canal [right].

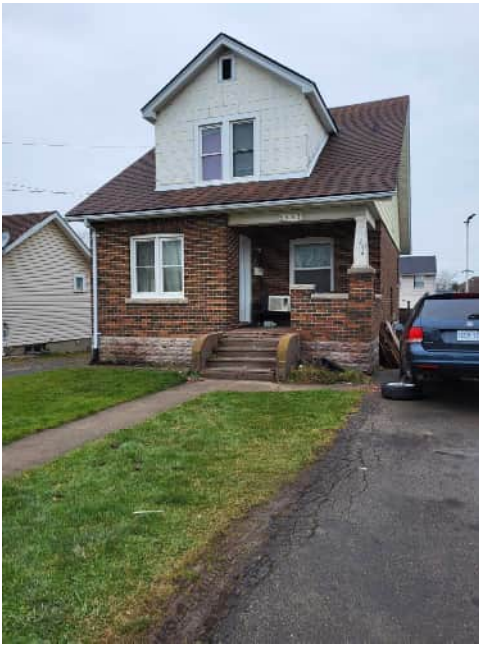
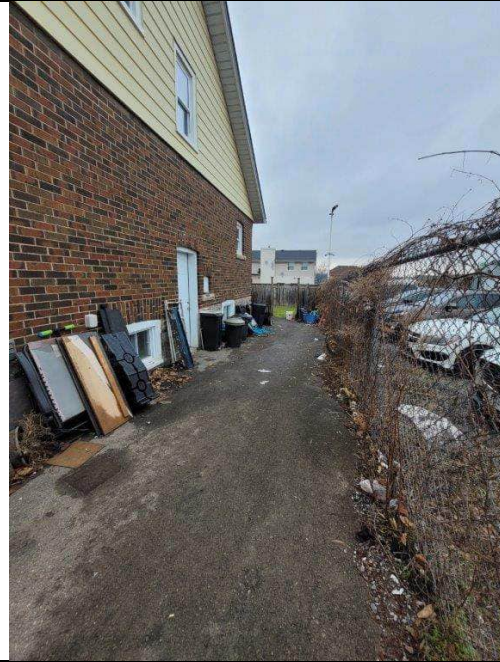
Photograph Nos. 11 & 12 – The residential dwelling at 5547 Fraser Street is a 1.5 storey home situated on the north side of Fraser Street [left], on the west side the commercial properties. Miscellaneous household materials were stored on the driveway between the dwelling and the fenced commercial property [right].

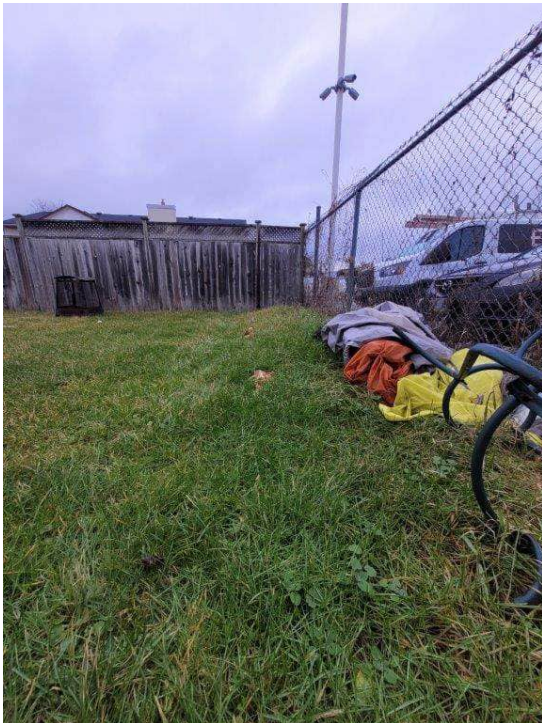
PCA-3/APEC-3: #30. Importation of Fill material of Unknown Quality. Potential fill material was noted in the backyard of 5547 Fraser residence. Fill material of unknown origin and composition is a PCA and APEC.

Photograph Nos.13 & 14 – The fenced rear yard of 5547 Fraser [Lot 21] was observed to have manicured grass landcover and storage of a variety of items. The stairs and deck located at the rear of the dwelling were observed to have multiple containers of liquid fuels [right].

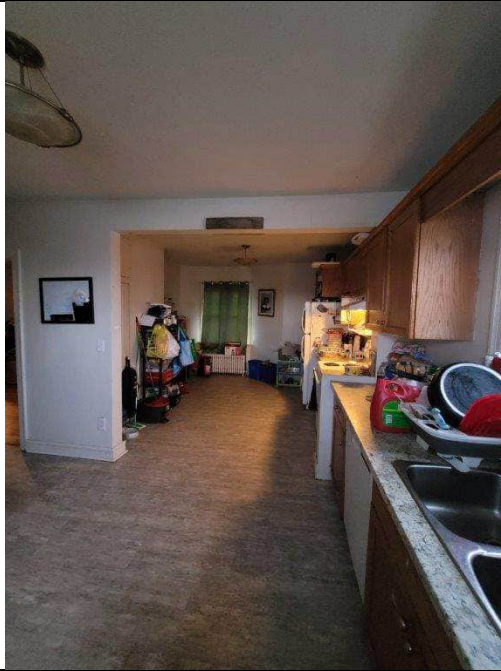
Photograph No.15 – The first floor of 5547 Fraser Street [left] is comprised of a kitchen, living room and main floor bedroom. Newer laminate flooring was observed during the Site visit.

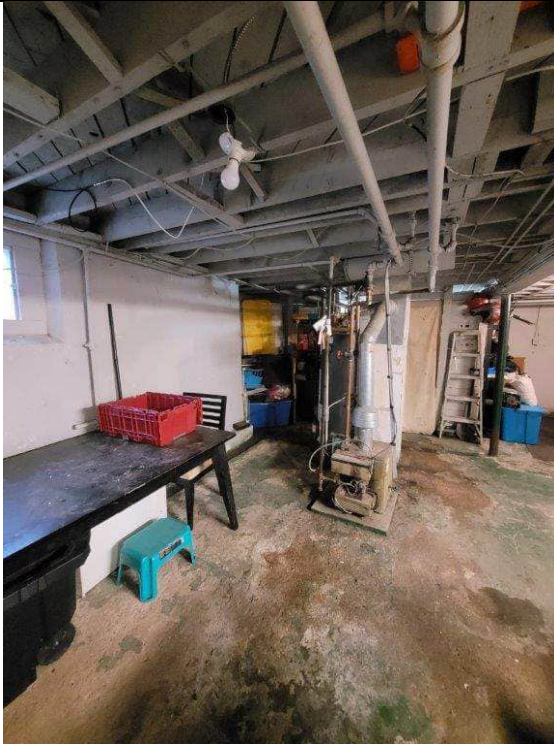
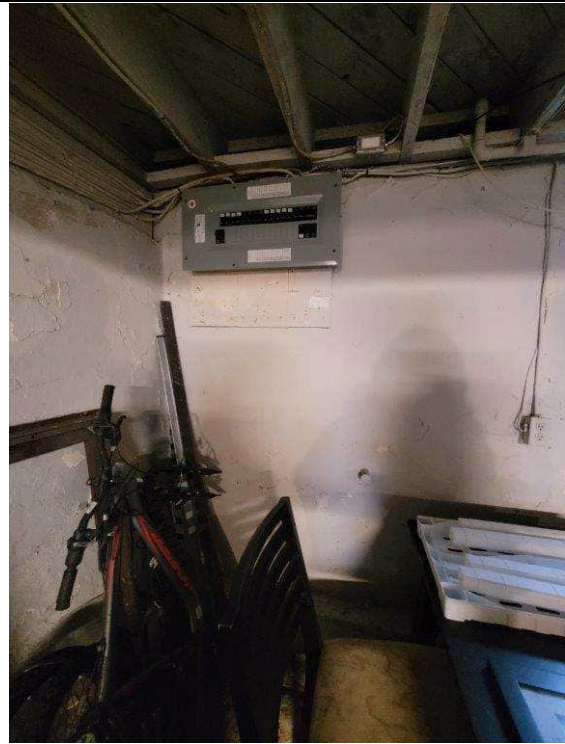
PCA-2/APEC-2: #28, Gasoline and Associated Products Storage in Fixed Tanks. Evidence of a former above ground storage tank utilized to contain heating oil was identified in the basement at 5547 Fraser Street. The presence of a tank represents an onsite PCA and APEC to the property.

Item	Specific Observation
Existing and Former Heating/cooling Systems	Evidence of a former heating oil tank was identified in the southwest corner of the basement at 5547 Fraser Street. A capped pipe was noted protruding from the wall in this area. Additionally, the exterior wall of the residence appeared patched and was discontinuous as compared to the rest of the exterior foundation wall of the house.
Catch basins, drains, pits, pumps or sumps	Floor drains were observed in the basement of the residences. Some water was visible surrounding the drain at 5547 Fraser.
Staining and corrosion	None observed
Wells	A records review shows that there are no drinking water wells within a 250 m radius of the Subject Site. Environmental monitoring wells are noted east and west of the subject property. No sources of potable water were identified during the Site Reconnaissance.
Sewage Work	The study area is serviced by municipal water and wastewater.

Photograph Nos.16 & 17 – The basement of the residential home at 5547 Fraser was noted to have areas of stained flooring [left surrounding the furnace]. Piping for an historical heating fuel Above ground Storage Tank was observed on the southwest wall [right].

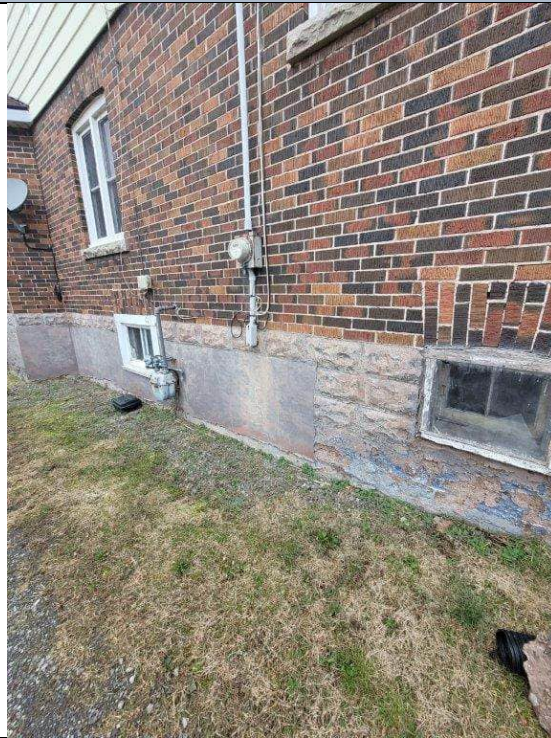
Photograph No.18 – The exterior wall of 5547 Fraser Street has been repaired at the location where piping associated with the heating fuel tank would have exited the house.

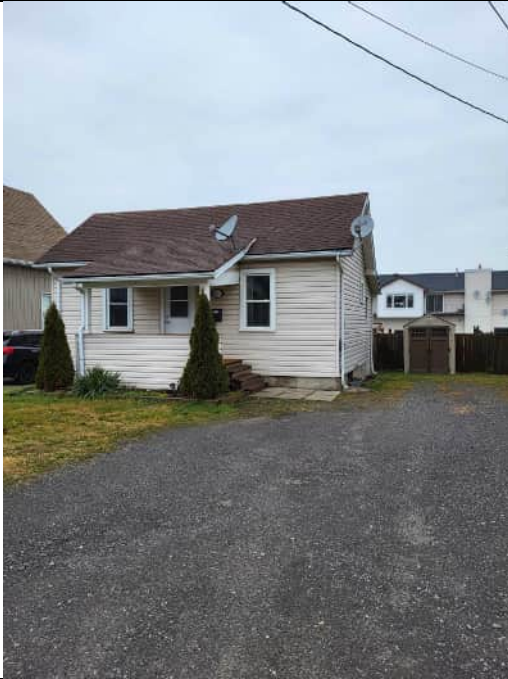
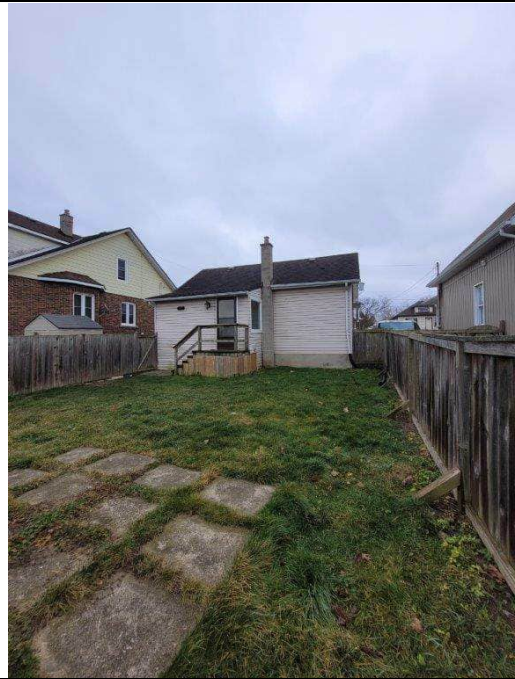
Photograph Nos. 19 & 20 – The dwelling on the second and most western parcel of land is 5555 Fraser Street. The 1 storey cement block foundation structure faces south towards Fraser Street [right] and has a fenced backyard [right].

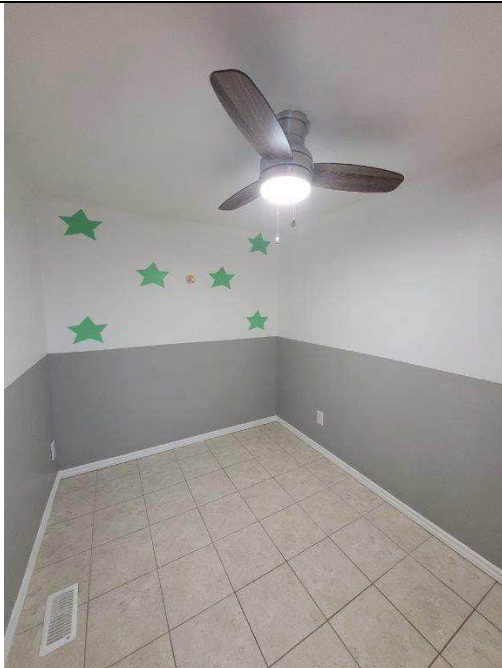
Photograph Nos. 21 & 22 – Two small bedrooms are located on the main floor at the front of the house. The ceiling, wires, beams and pipes located in the basement of the structure were observed to have been painted white. The hot water tank and heater located in the basement can be seen in the photograph to the right.
