NOTE:  
Vegetation inventory undertaken by Adesso Design Inc., on 2024-09-24.

VISCA Residential Development  
5523-5555 Fraser Street  
Building A

Tree Protection Plan

L-1

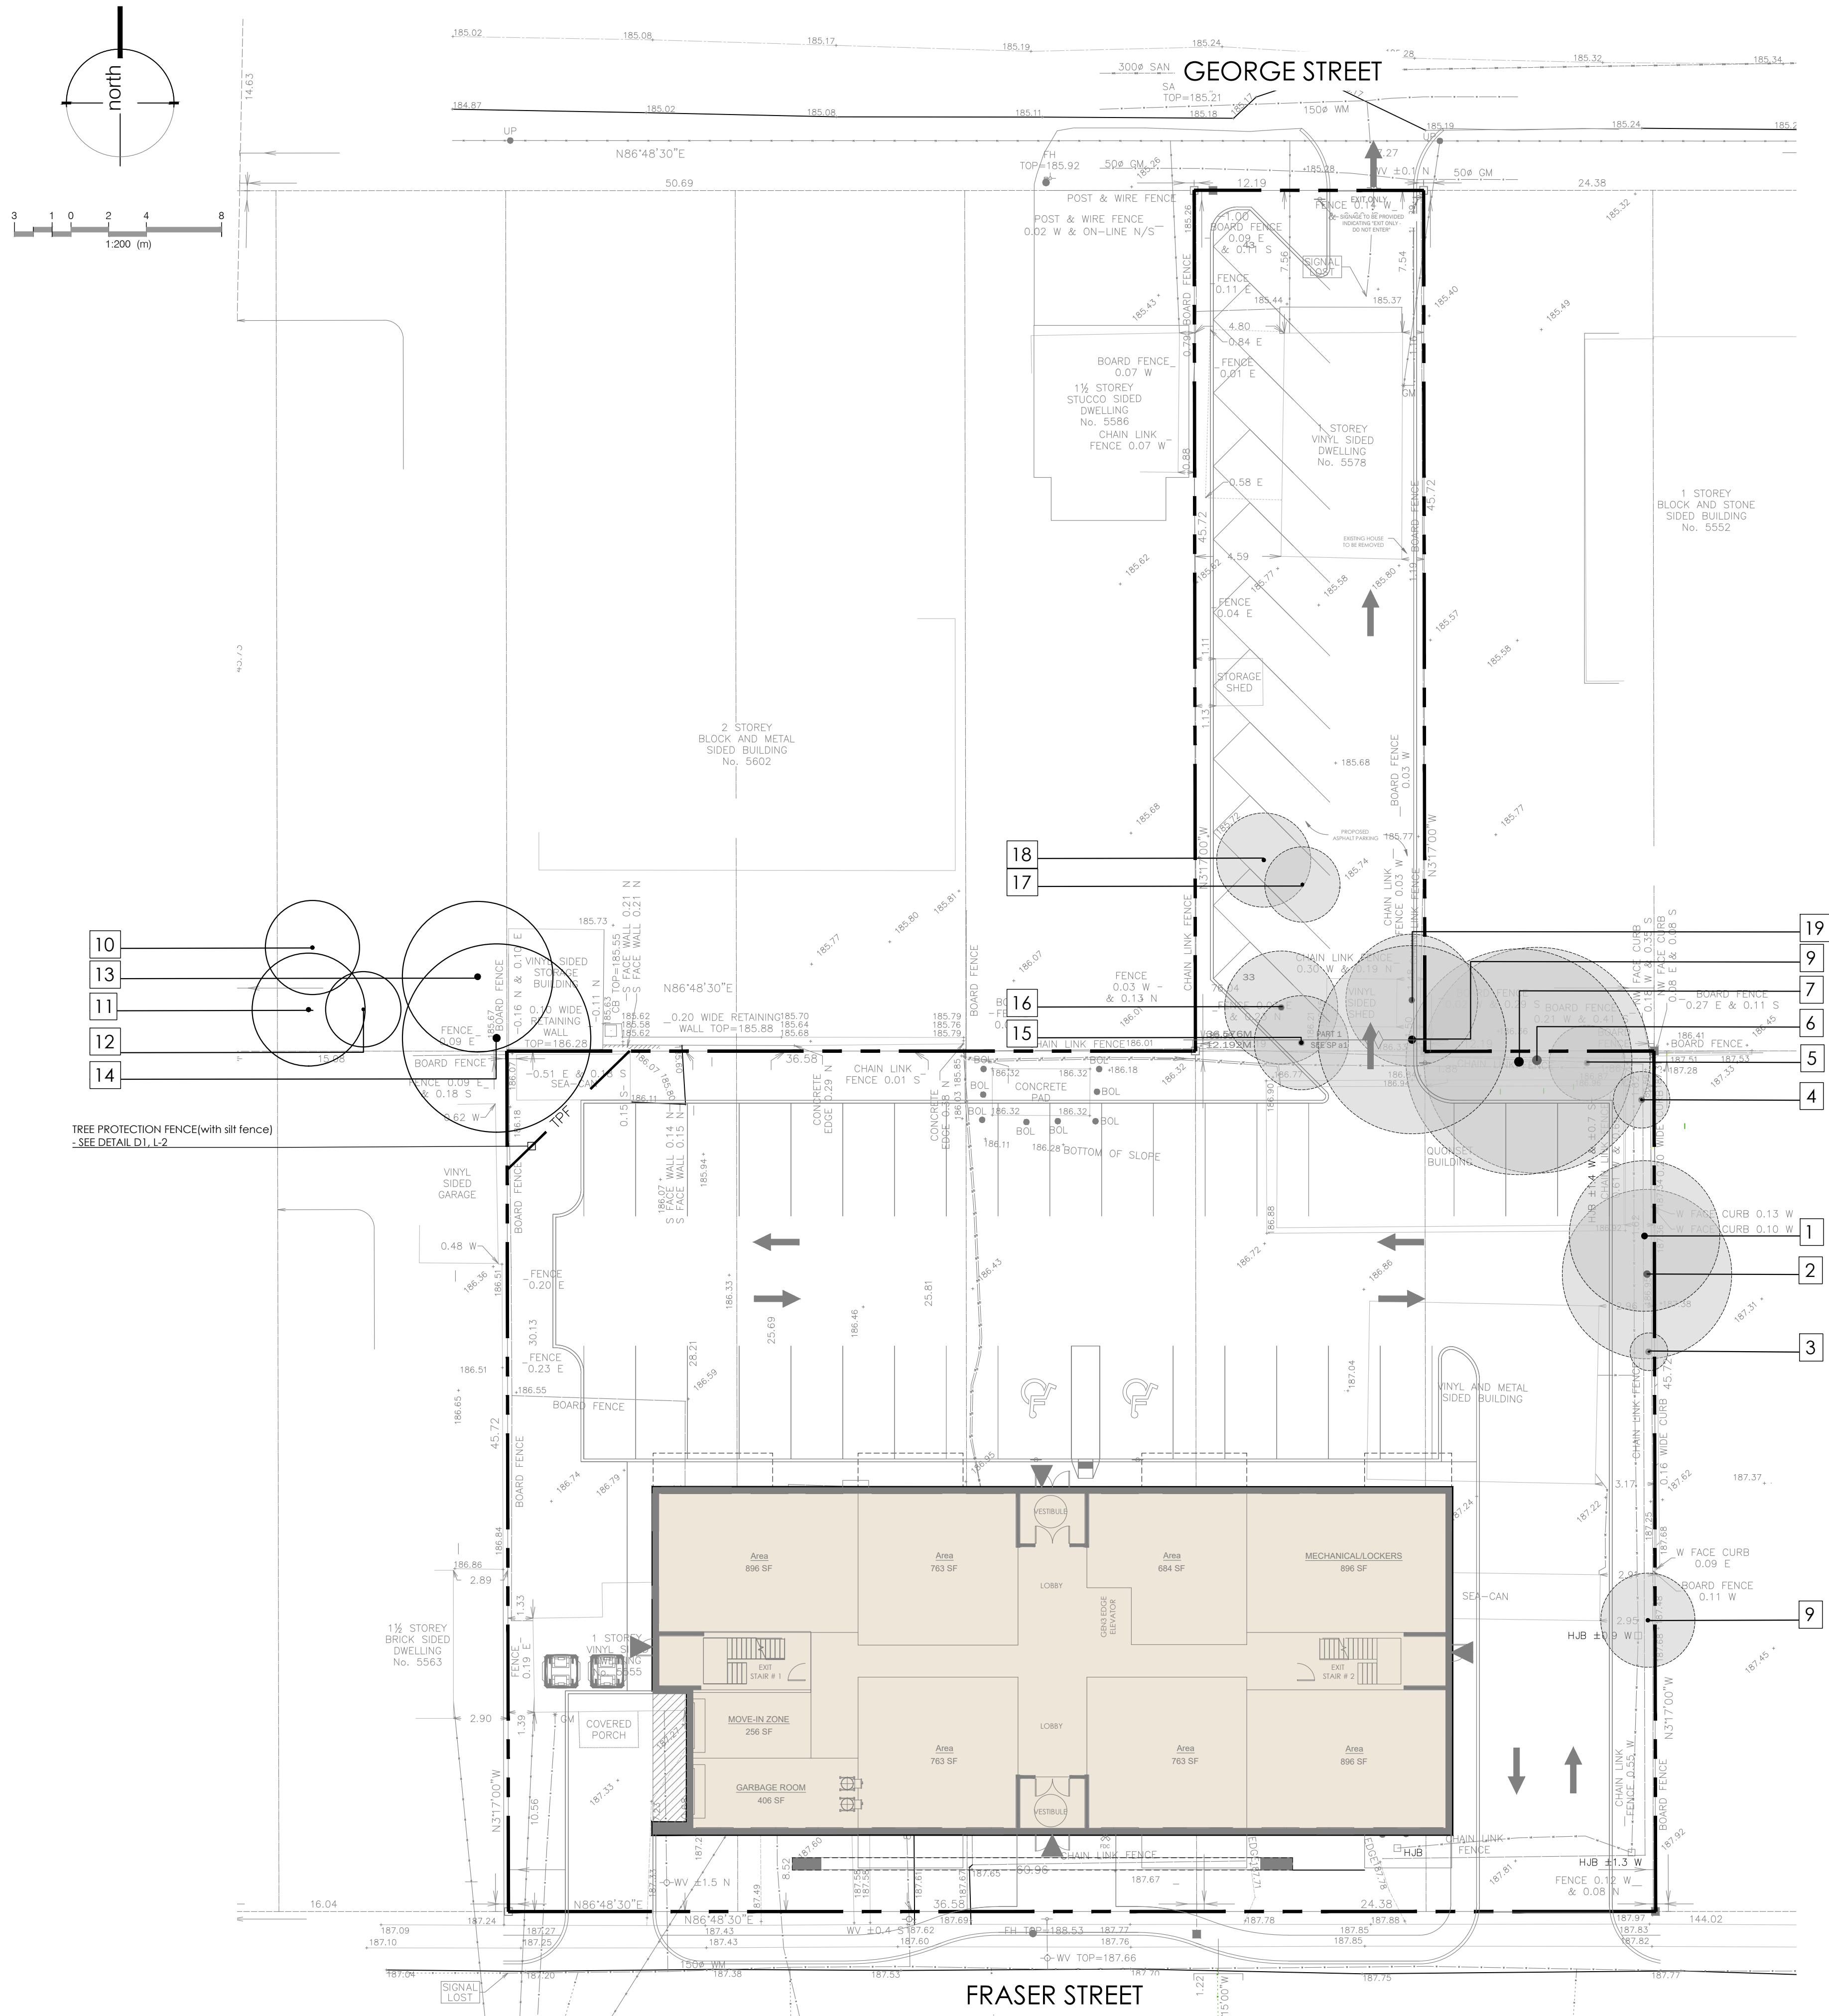
- property line
- UNIT 2 vegetation unit (refer to chart)
- 2 existing tree number (refer to chart)
- existing vegetation to remain
- existing vegetation to be removed
- existing elevations
- tree protection fence (with silt fence) - see detail D1, L-2

1. The area within the drip-line of all existing trees shall be properly protected with temporary fencing.
2. All existing trees on the project site shall remain undisturbed with no construction activity, grade changes, surface treatment, compaction, or excavation. Area shall not be used for the storage of materials or equipment access/storage or project related garbage.

3. Tree protection measures shall be installed prior to any demolition, construction activity, or other activity that may harm until the completion of fine grading and sodding or seeding.

8. Where root systems of protected trees are exposed directly adjacent to or damaged by construction work they are to be pruned and replaced with a tree of similar size and species. An Arborist is required to be on site for any injury or cutting to the root system or surface roots of a protected tree.

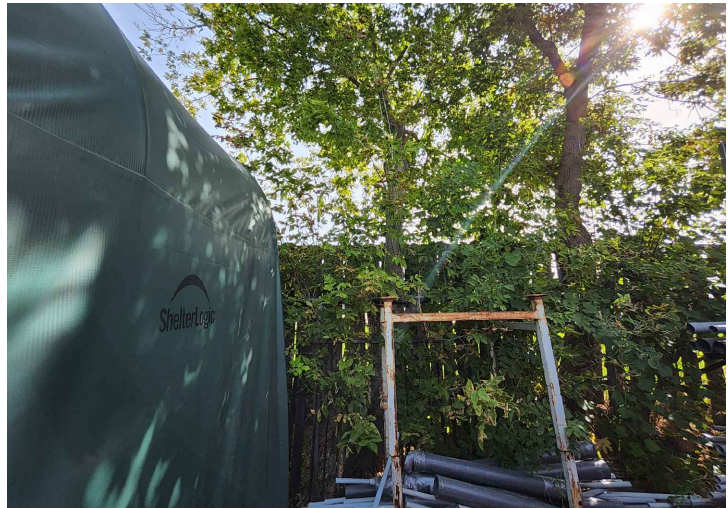
Tree#1

Tree #	Species (Common Name)	Species (Botanical Name)	DBH (cm)	Crown Class*	Condition**	DL (m)	Comments	Potential Impacts from Construction	Ownership	Recommendation
1	Manitoba Maple	<i>Acer negundo</i>	23.15	CD	P	4	Between Cain Link Fence and Wood privacy Fence, Water Sprouts, Included Metal,	Conflicts with proposed Construction	Property	Remove
2	Manitoba Maple	<i>Acer negundo</i>	25	CD	P	4.5	Between Cain Link Fence and Wood privacy Fence,Stem Wounds, Included Metal, poor Form			
3	Manitoba Maple	<i>Acer negundo</i>	15	S	P	1	Cut Stems, Between Chain Link Fence and Wood Privacy Fence, Water Sprouts	Conflicts with proposed Construction	Property	Remove
4	White Ash		13	CD	P	1.5	Between Cain Link Fence and Wood privacy Fence,Stem Wounds, Included Metal	Conflicts with proposed Construction	Property	remove
5	Manitoba Maple	<i>Acer negundo</i>	12	S	P	2	Between Cain Link Fence and Wood privacy Fence,Water Sprouts, Poor Form	Conflicts with proposed Construction	Property	Remove

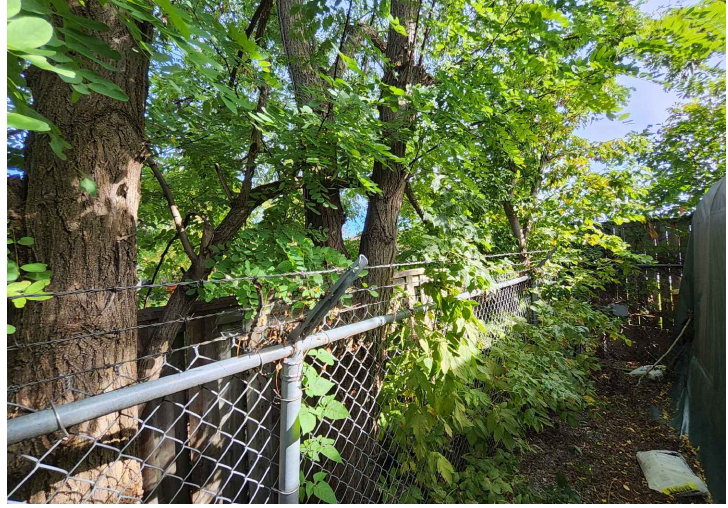
Tree#6

6	Black Locust		32	CD	F	6	Between Cain Link Fence and Wood privacy Fence,Included Bark	Conflicts with proposed Construction	Property	Remove
7	Black Locust		25	CD	FP	6	Between Cain Link Fence and Wood privacy Fence,Included Bark, Water Sprouts	Conflicts with proposed Construction	Property	Remove
8	Manitoba Maple	<i>Acer negundo</i>	30,10.5,15	CD	P	5	Heavy Pruning, Water Sprouts, Poor Form, Asymetric Canopy	Conflicts with proposed Construction	Property	Remove
9	Manitoba Maple	<i>Acer negundo</i>	18,15	CD	P	2.5	Between Cain Link Fence and Wood privacy Fence,Included Bark, Water Sprouts, poor form, union at base	Conflicts with proposed Construction	Property	Remove
10	Sweet Cherry	<i>Prunus avium</i>	13	CD	F	2.5	Lean north west		Neighbouring	Save
11	Chokecherry	<i>Prunus Virginiana</i>	16	CD	FP	3	Slight Lean West, Included bark, sap wounds		Neighbouring	Save
12	Green Ash	<i>Fraxinus pennsylvanica</i>	12	CD	P	2	Emerald Ash borer Infestation, poor form, frowing next to wood privacy fence		Neighbouring	Save

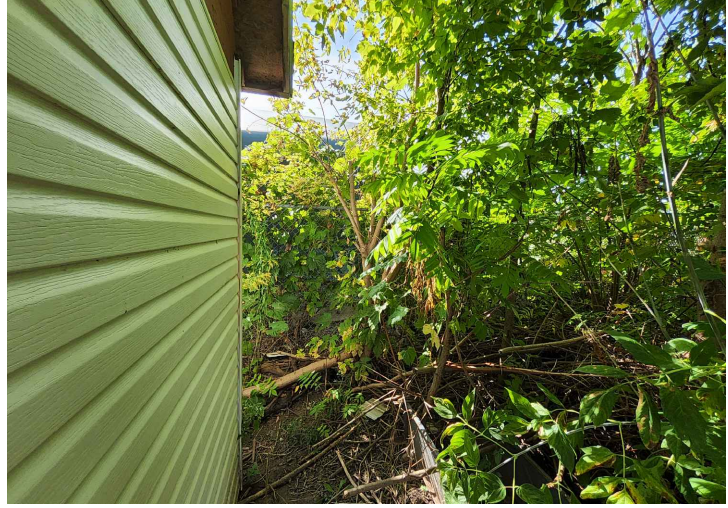
Tree#15

13	Green Ash	<i>Fraxinus pennsylvanica</i>	18	CD	P	4	Emerald Ash borer Infestation, Slight lean East		Neighbouring	Save
14	Sweet Cherry	<i>Prunus avium</i>	20,11.5	CD	FG	5	Asymetric Canopy,Multiple leaders		Neighbouring	Save
15	Manitoba Maple	<i>Acer negundo</i>	11,7.8	CD	P	2.5	Union at Base, Rotting roof Flare	Conflicts with proposed Construction	Property	Remove
16	Manitoba Maple	<i>Acer negundo</i>	12.6,8.9	CD	P	3	Union at Base,cut stems, poor form	Conflicts with proposed Construction	Property	Remove
17	Manitoba Maple	<i>Acer negundo</i>	10	CD	P	2	Dirt piled around Base, Lean East	Conflicts with proposed Construction	Property	Remove
18	Buckthorn		16,14	CD	P	2.5	Cut Stems,GrapeVine Competition in canopy	Conflicts with proposed Construction	Property	Remove
19	Manitoba Maple	<i>Acer negundo</i>	30,10,11,13	CD	P	3.5	Growing in Chain link fence, included bark	Conflicts with proposed Construction	Property	Remove
