**PROJECT NO.: SM 220717-E**

**PHASE ONE ENVIRONMENTAL SITE ASSESSMENT  
DORCHESTER ROAD & OLDFIELD ROAD - LOT 197  
NIAGARA FALLS, ONTARIO**

**UPPER CANADA PLANNING & ENGINEERING LTD.**

**SOIL-MAT ENGINEERS & CONSULTANTS LTD.  
401 GRAYS ROAD  
HAMILTON, ONTARIO  
L8E 2Z3**

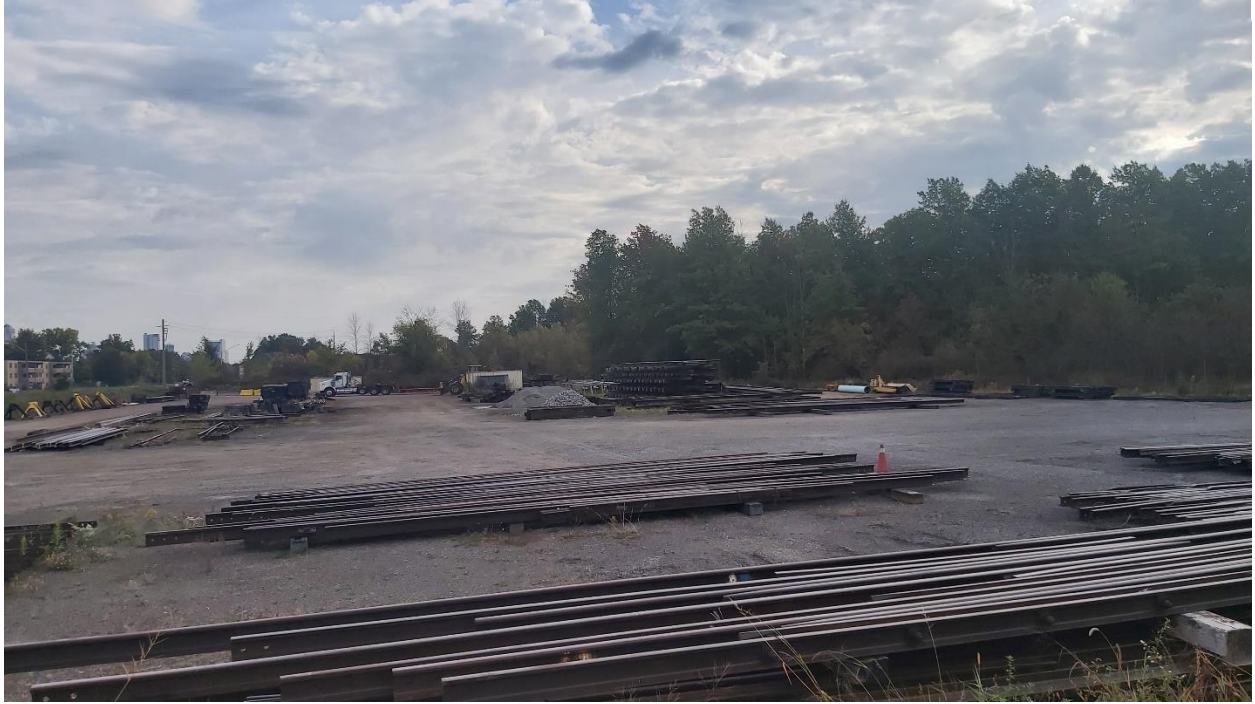
General photo of the railway part storage area. Taken from the northwestern portion of the Site, facing east.

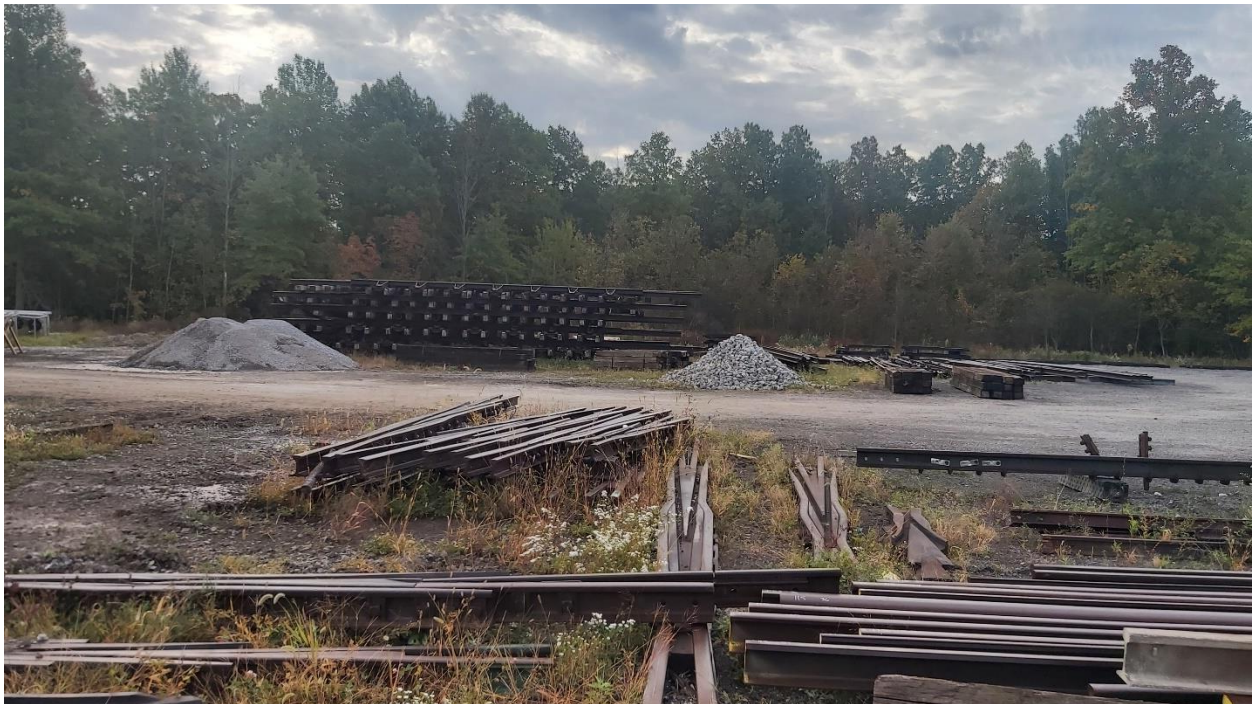
Photo of the railway parts and gravel stockpiles. Taken from the northern central portion of the Site, facing south.

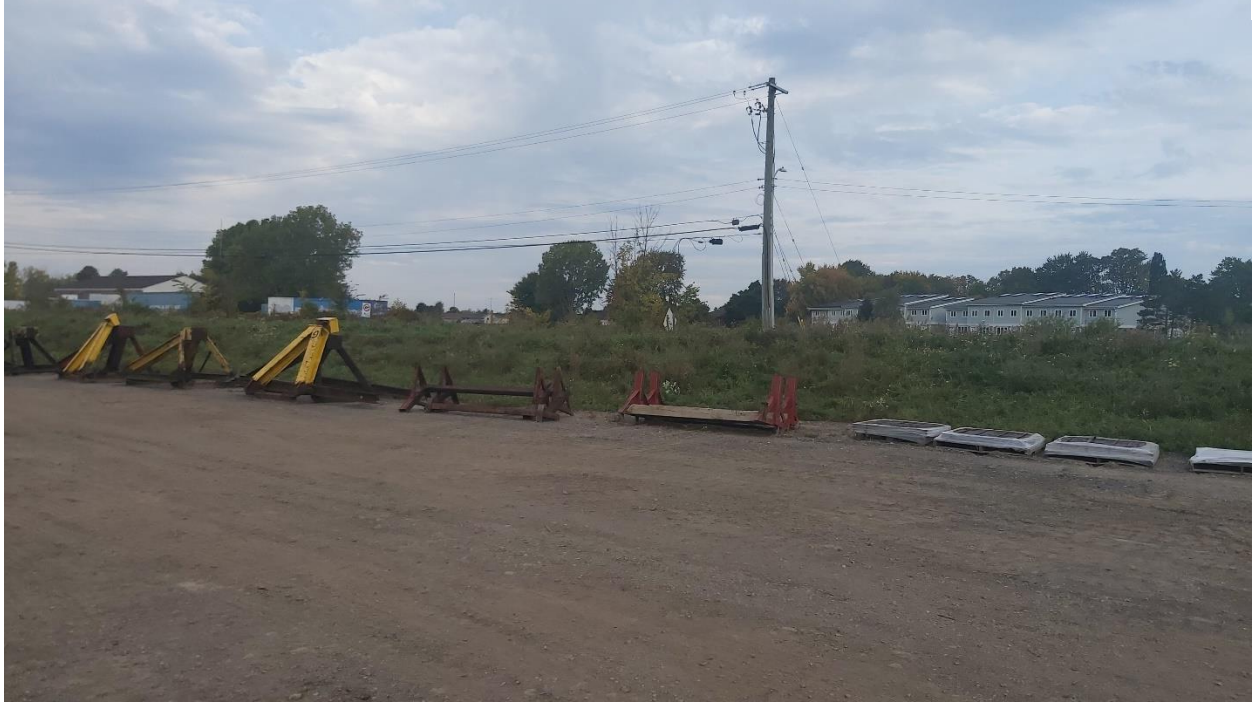
- Our visual observations of the Phase One Property revealed a berm along the portion of the property fronting Dorchester Road. The origin and quality of the material in the berm was not known at the time of this Report. In addition, various small stockpiles of fill material were observed on the northern portion of the Phase One Property, and;
- Information contained in the aerial photographs, as well as our visual observations of the Phase One Study Area, revealed numerous piles of railway ties and railway tracks stored across the northern portion of the Phase One Property.

Photo of the berm at the northern portion of the Site. Facing northwest.

Area of Potential Environmental Concern	Environmental Liability	Recommendation	Rationale
APEC #1	1. PCA No.: 30. Importation of Fill Material of Unknown Quality	Advance a series of hand-dug test pits in the existing berm fronting Dorchester Road and in the various small stockpiles observed on the Phase One Property.  The contaminants of potential concern [COPCs] include Metals, PHCs and BTEX.	Assess the environmental characteristics of the fill material to determine the suitability of the fill material for use on the Phase One Property.
APEC #2	2. PCA No.: 49: Rail Yards, Tracks and Spurs	Advance a series of shallow boreholes throughout the northern portion of the Phase One Property.  The COPCs include Metals, PAHs and VOCs.	Assess the potential of adverse impacts to the soil medium as a result of the storage of railway ties throughout the Phase One Property.

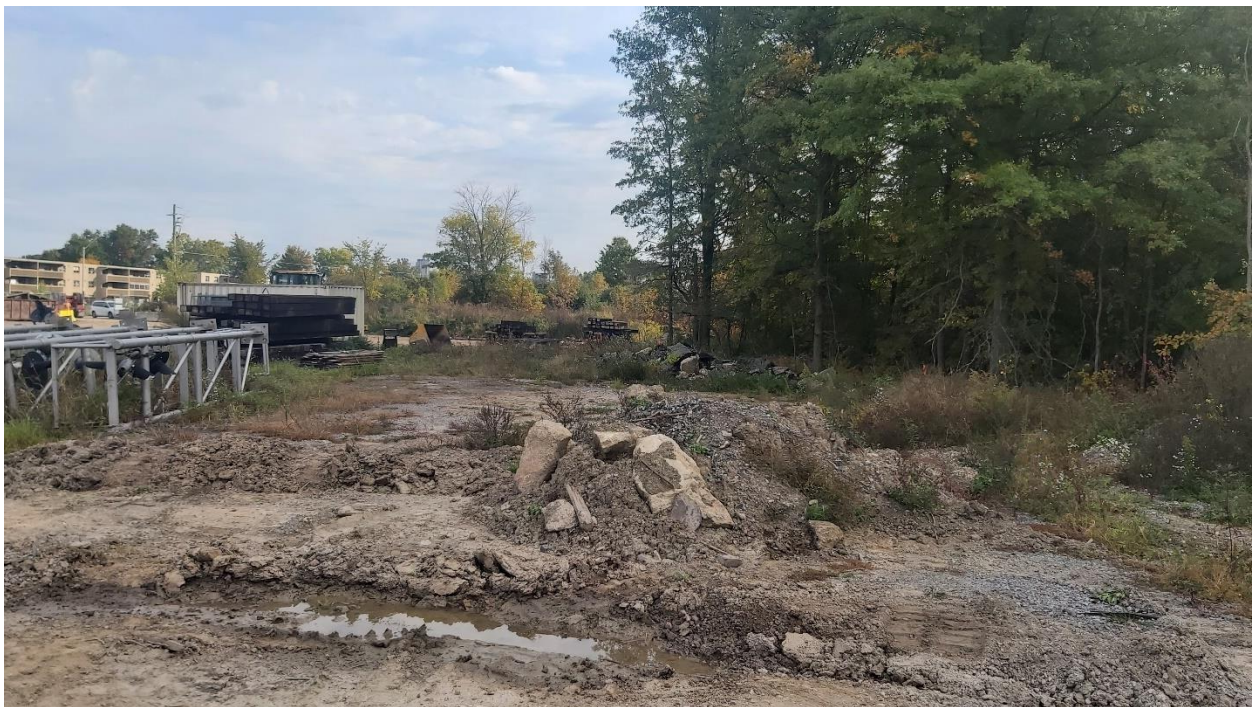
Reporting Requirements	SOIL-MAT ENGINEERS' Details
Areas Where Fill and Debris Materials Appear to be Present	<p>Two [2] stockpiles of gravel, a stockpile of waste asphaltic-concrete and a soil stockpile were observed on the Site.</p> <p>In addition, an area of suspected fill material was observed fronting Dorchester Road.</p>
PCAs	<p>PCA No.: 30 – Importation of Fill Material of Unknown Quality: associated with the existing berm fronting Dorchester Road and the existing stockpiles of gravel, soil and asphaltic-concrete;</p> <p>PCA No.: 46 – Rail Yards, Tracks and Spurs: associated with the storage of former railway ties and tracks on the northern portion of the Site;</p> <p>PCA No.: 8 – Chemical Manufacturing, Processing and Bulk Storage: associated with the plastics manufacturing plant that formerly maintained operations at 8100 Dorchester Road;</p> <p>PCA No.: 28 – Gasoline and Associated Products Storage in Fixed Tanks: associated with the two [2] expired full-service liquid fuel tanks and an expired full-service/self-service private fuel outlet located approximately 80 metres north-northwest of the Phase One Property;</p> <p>PCA No.: 34 – Metal Fabrication: associated with the metal fabrication facility that formerly maintained operations at 8100 Dorchester Road;</p> <p>PCA No.: Other – Metal Sandblasting Shop: associated with the sandblasting and powder coating facility that formerly maintained operations at 8100 Dorchester Road; and</p> <p>PCA No.: Other – Construction Vehicle and Equipment Manufacturing and Bulk Storage: associated with the construction equipment sales, service and assembly plant that maintains operations at 7942 Dorchester Road.</p>

Photo of the soil stockpile, taken from the southern portion of the railway part storage area, facing east.

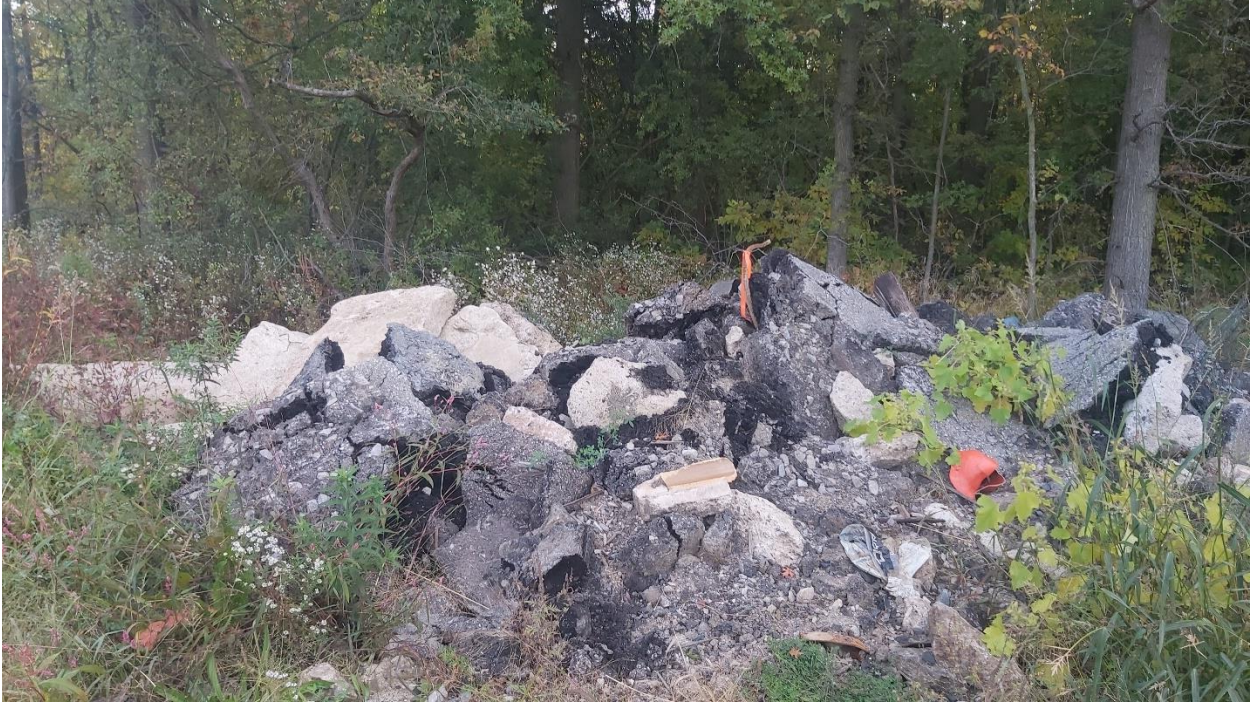
Photo of the asphaltic-concrete stockpile, taken from the southern portion of the railway part storage area, facing south.
