**PHASE ONE ENVIRONMENTAL SITE ASSESSMENT  
OAKLANDS GOLF COURSE  
8970 STANLEY AVENUE  
NIAGARA FALLS, ONTARIO**

**RICCI LAW PROFESSIONAL CORPORATION  
4025 Dorchester Road, Suite 331  
Niagara Falls, Ontario  
L2E 7K8**

**Wood Environment & Infrastructure Solutions,  
a Division of Wood Canada Limited  
3300 Merrittville Hwy., Unit #5,  
Thorold, Ontario  
L2V 4Y6**

**September 29, 2021**

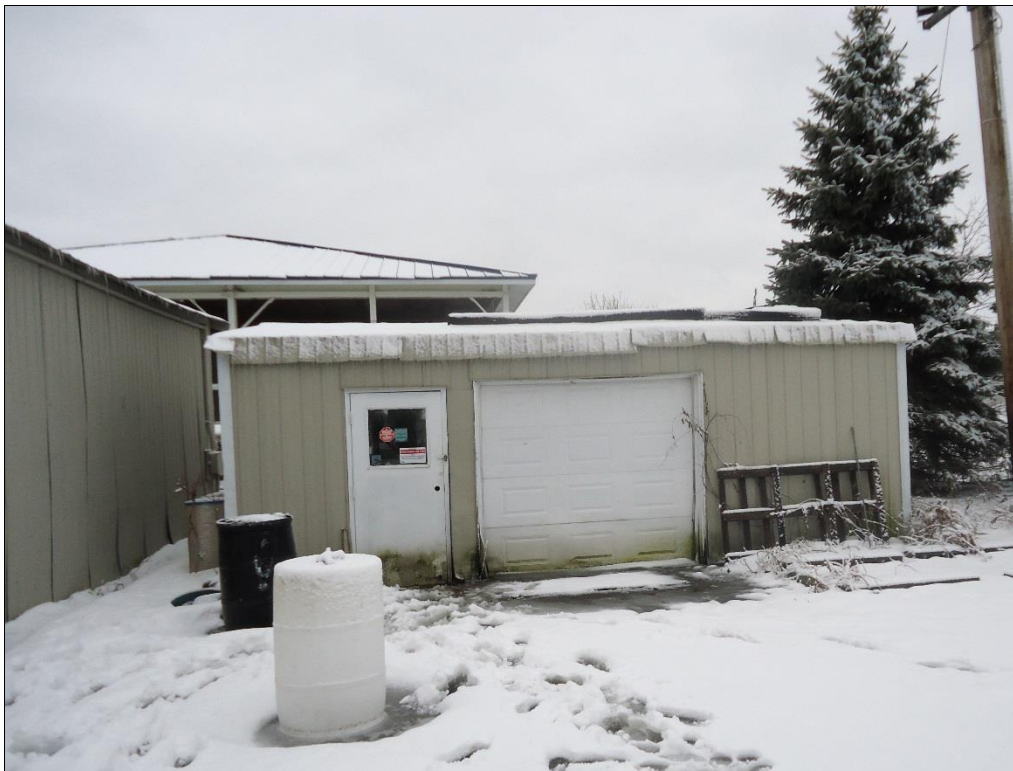
**Photo 2:**  
Maintenance shed

- Wood noted the particle board on the walls and ceiling of the maintenance shed appeared to be heavily stained with a black and grey colour, and possibly contained mould. This issue should be addressed.

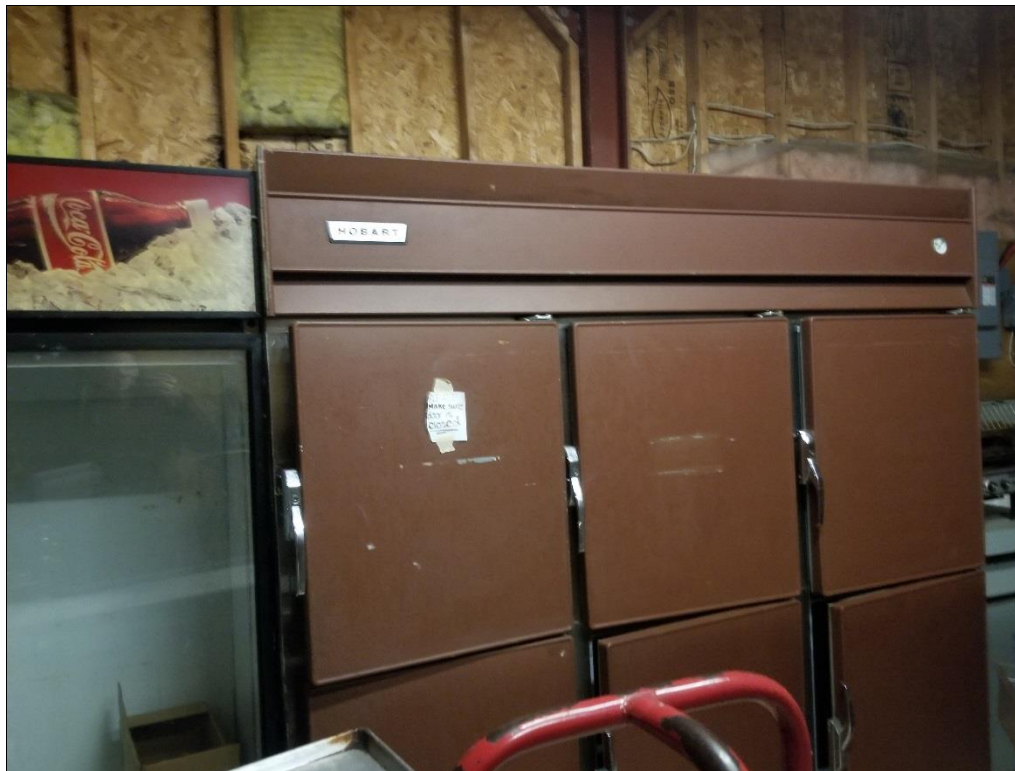
**Photo 6:**  
Old refrigeration units no longer in use

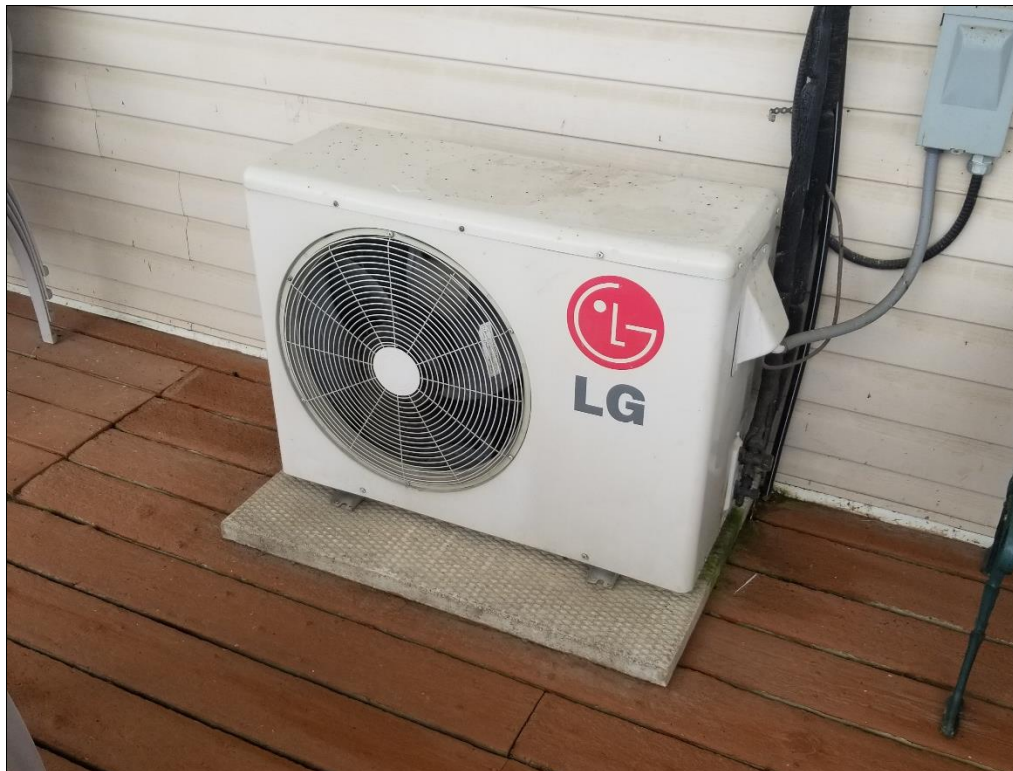
The heat source for the buildings was three electric heat pumps located on the exterior of the clubhouse, however the buildings are not heated in the winter. These pumps were only used for heat during cool days at the beginning and end of the golf season. These pumps were used for air conditioning purposes in the summer as well. It is believed that the buildings have not had any other historic heat source. No evidence (e.g., fill or vent pipes) of potential historic oil or coal heating sources was observed during the reconnaissance.

**Photo 8:**  
Electric heat pump

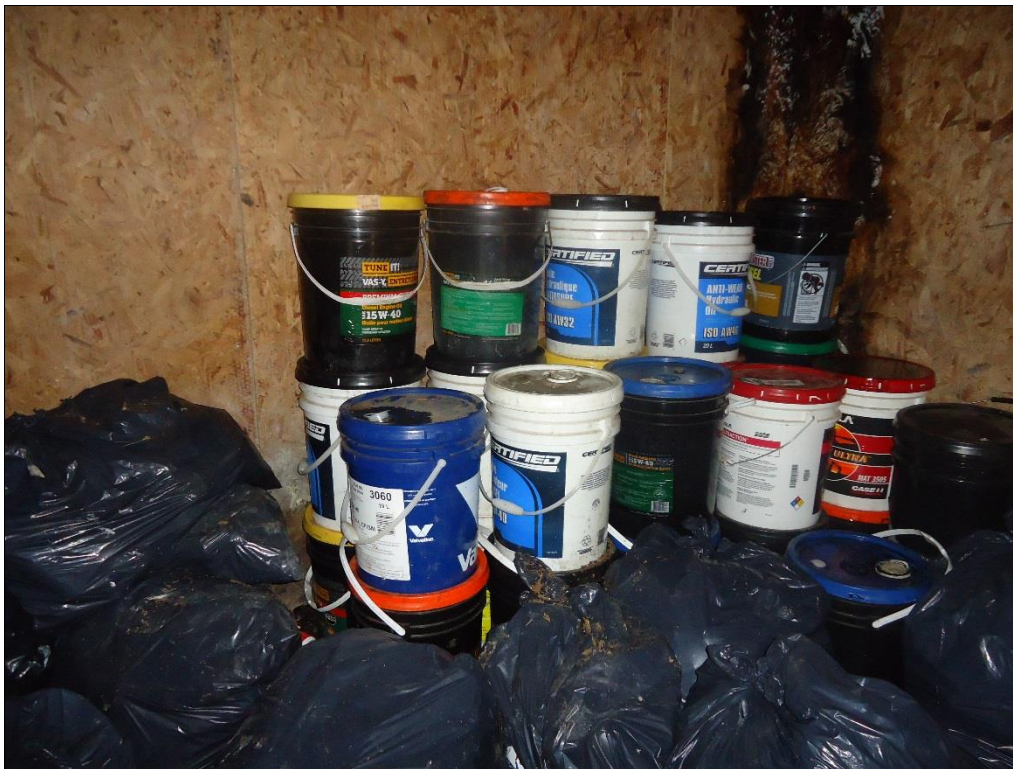
**Photo 10:**  
Pails of hydraulic oil  
and motor oil as well  
as garbage bags  
inside maintenance  
shed

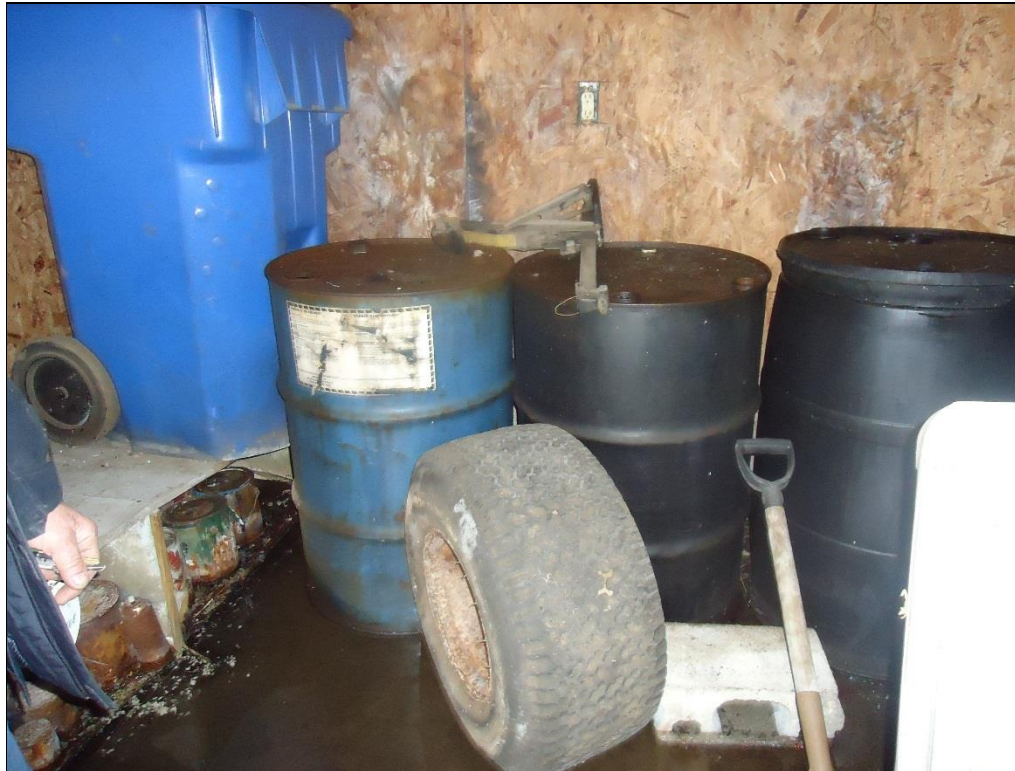
**Photo 11:**  
Multiple steel drums, mostly empty, blue drum on the left labelled varsol

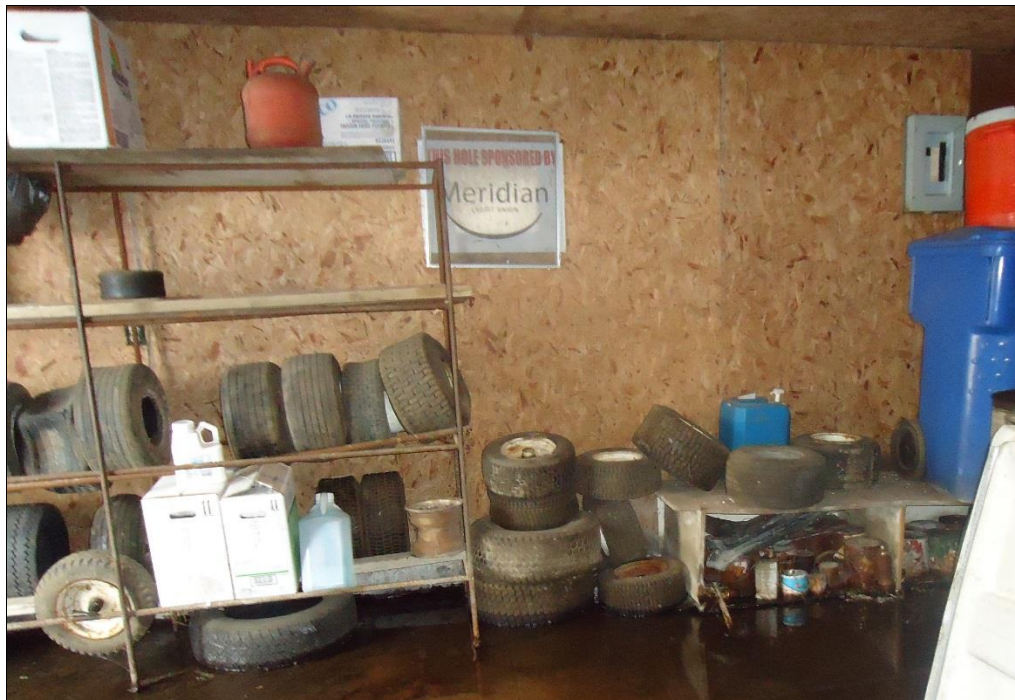
The condition of the flooring in the maintenance building/garage was good, however there was flooding and petroleum-like odours noted in the maintenance shed.

**Photo 12:**  
Entire maintenance shed flood with 2-3 inches of water, tire storage, rusty paint cans, Mirage Stressgard (fungicide), Roundup (liquid herbicide) and jerry cans of gasoline found on shelves.

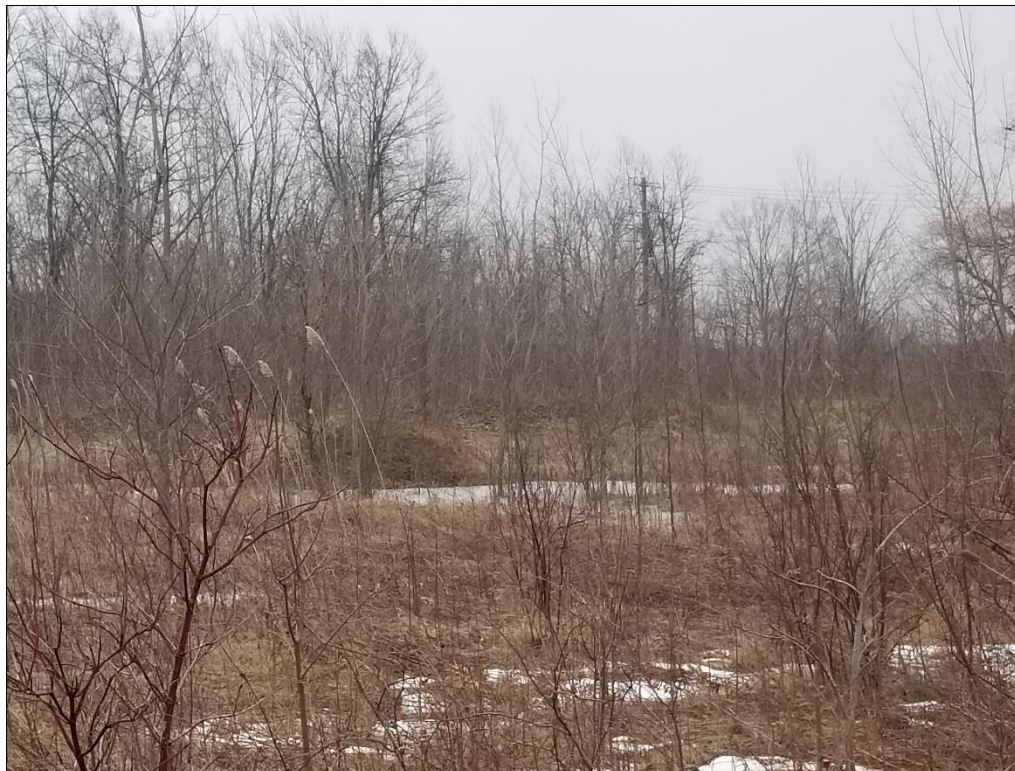
**Photo 18:**  
Southwestern portion  
of Site suspected to  
be scattered with  
small piles of fill.

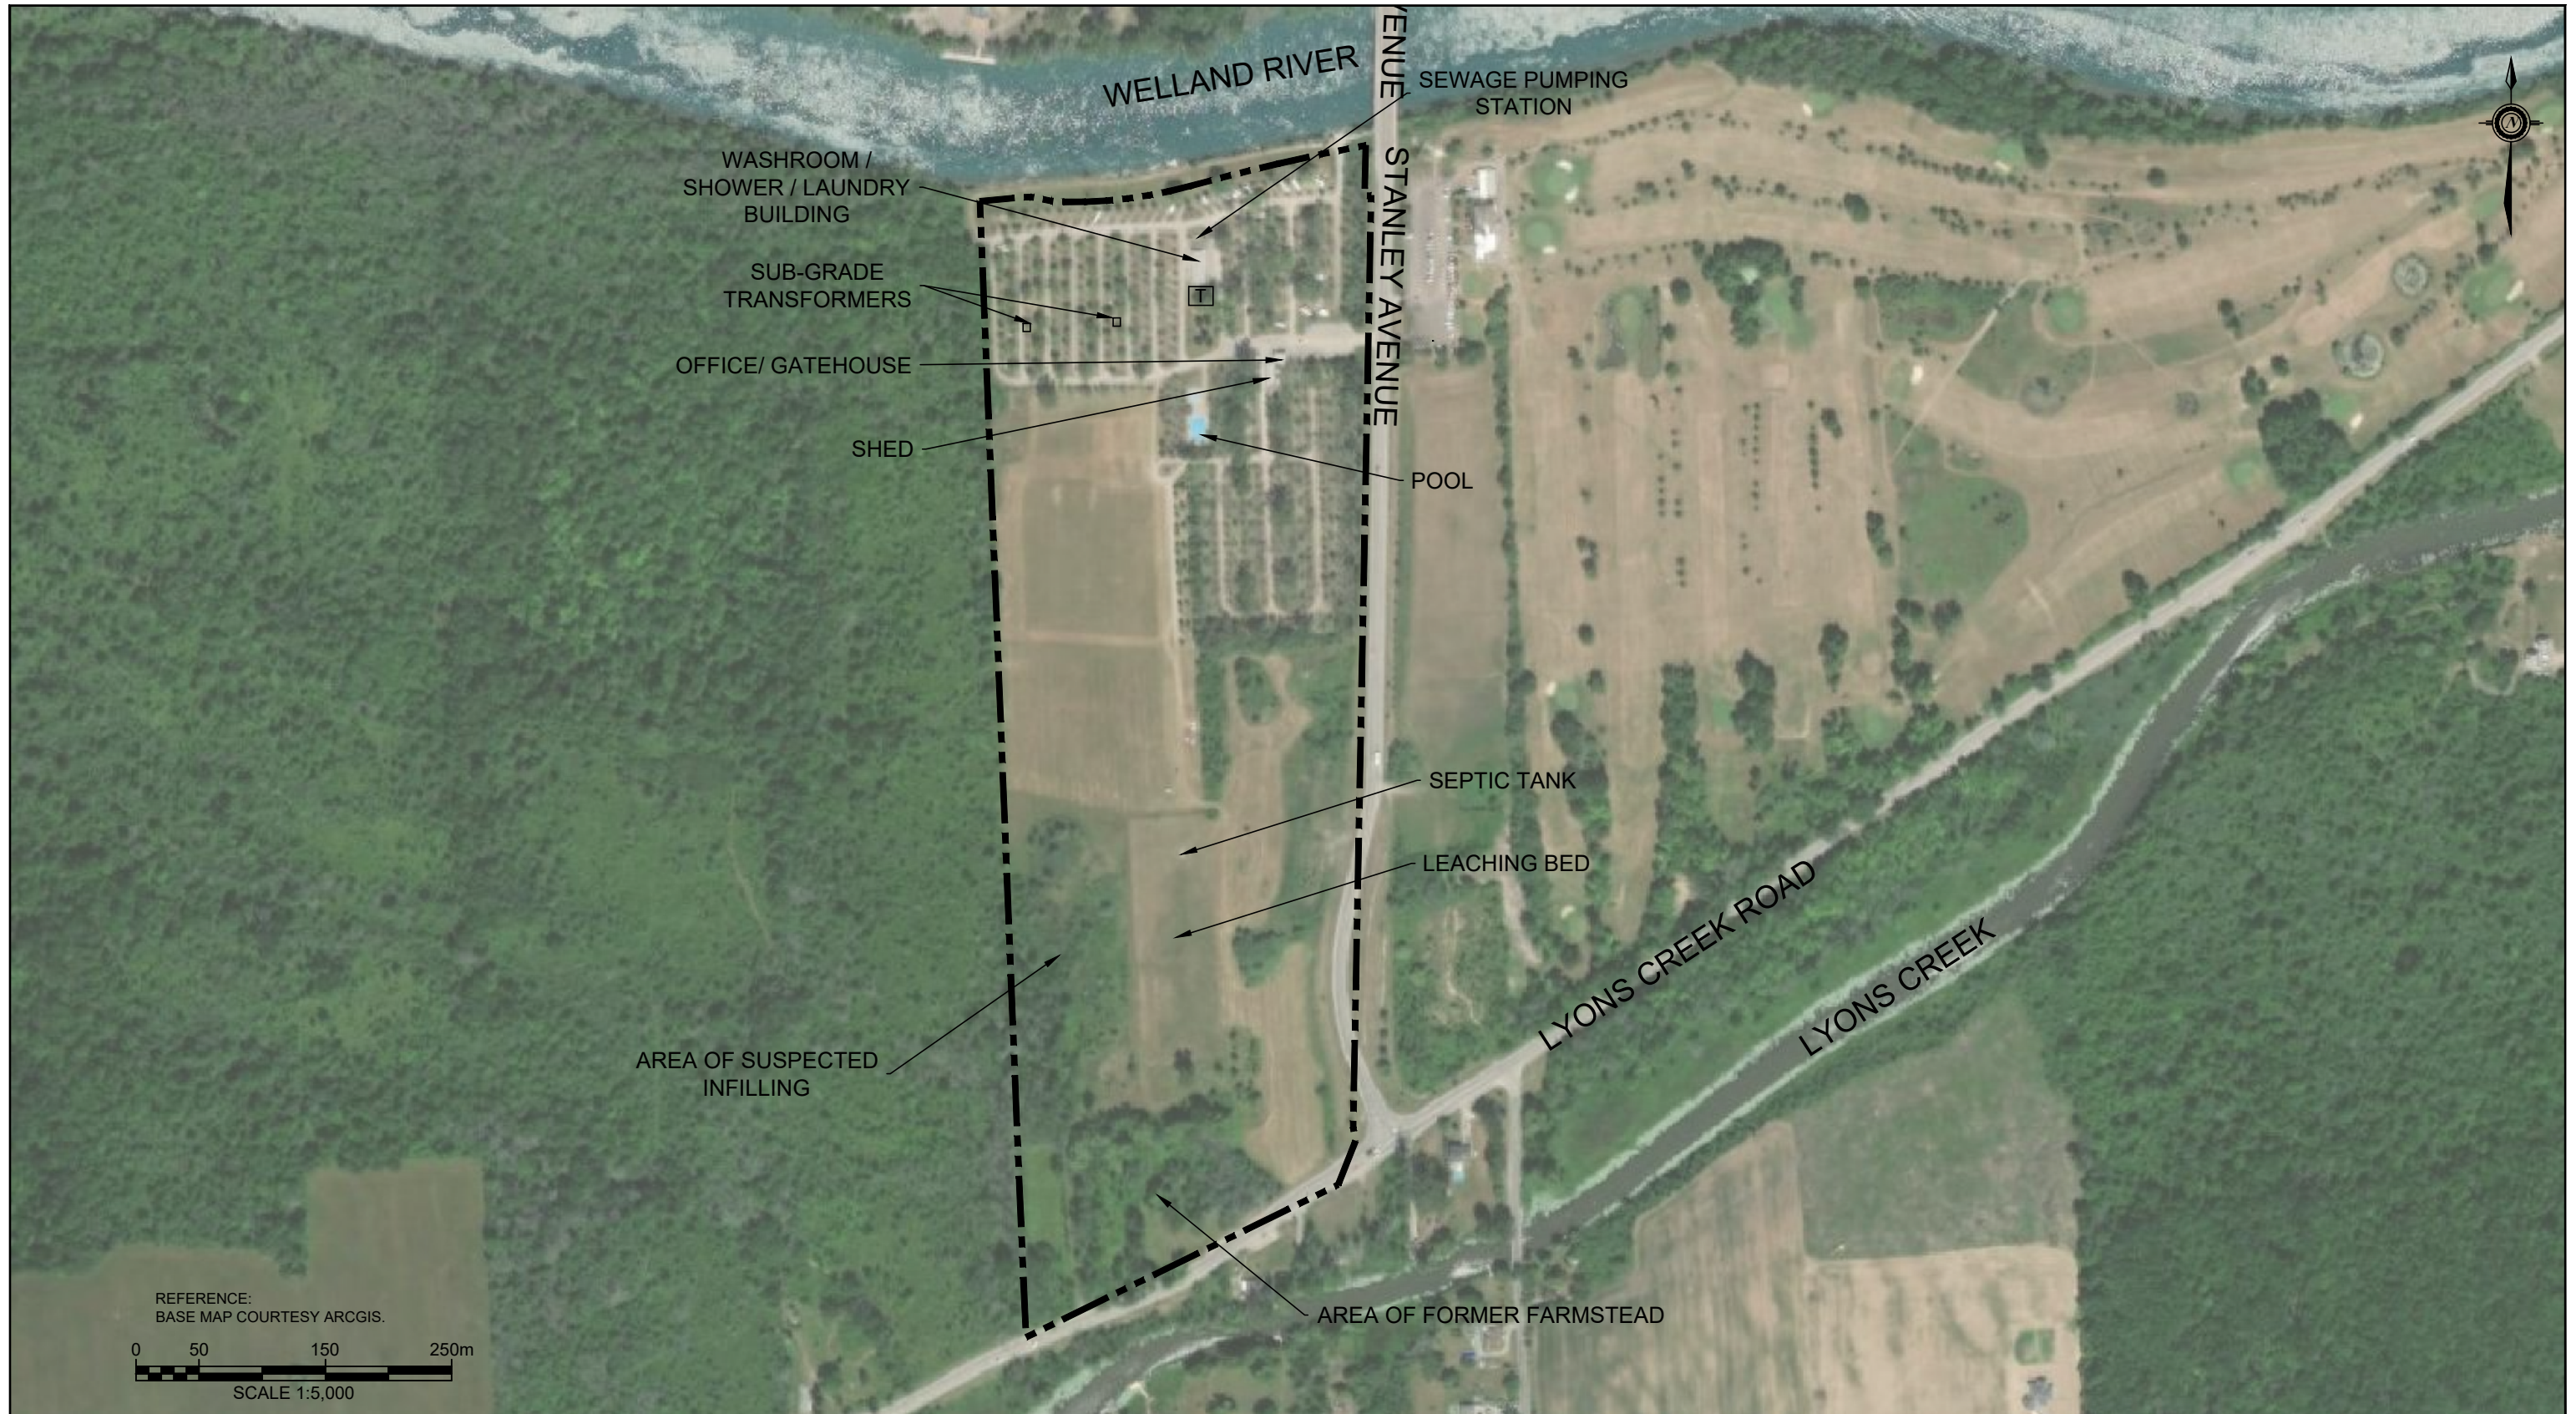
MAP ID	ADDRESS	CURRENT/PAST USES OF CONCERN	APEC ON POP
<b>PHASE ONE STUDY AREA</b>			
1	ON-SITE	POTENTIALLY CONTAMINATED FILL MATERIALS	APEC - 1
2	ON-SITE	PRESENCE OF ELECTRICAL TRANSFORMER	APEC - 2
3	ON-SITE	PRESENCE OF ELECTRICAL TRANSFORMER	APEC - 3
4	ON-SITE	PRESENCE OF ELECTRICAL TRANSFORMER	APEC - 4
5	5795 DON MURIE STREET	FORMER AUTOMOTIVE PARTS MANUFACTURING	NO
6	5955 DON MURIE STREET	FORMER PLASTICS MANUFACTURING	NO
7	8699 STANLEY AVENUE	FORMER TABLEWARE AND SILVERWARE MANUFACTURING	NO
APEC ON POP = APEC ON PHASE ONE PROPERTY

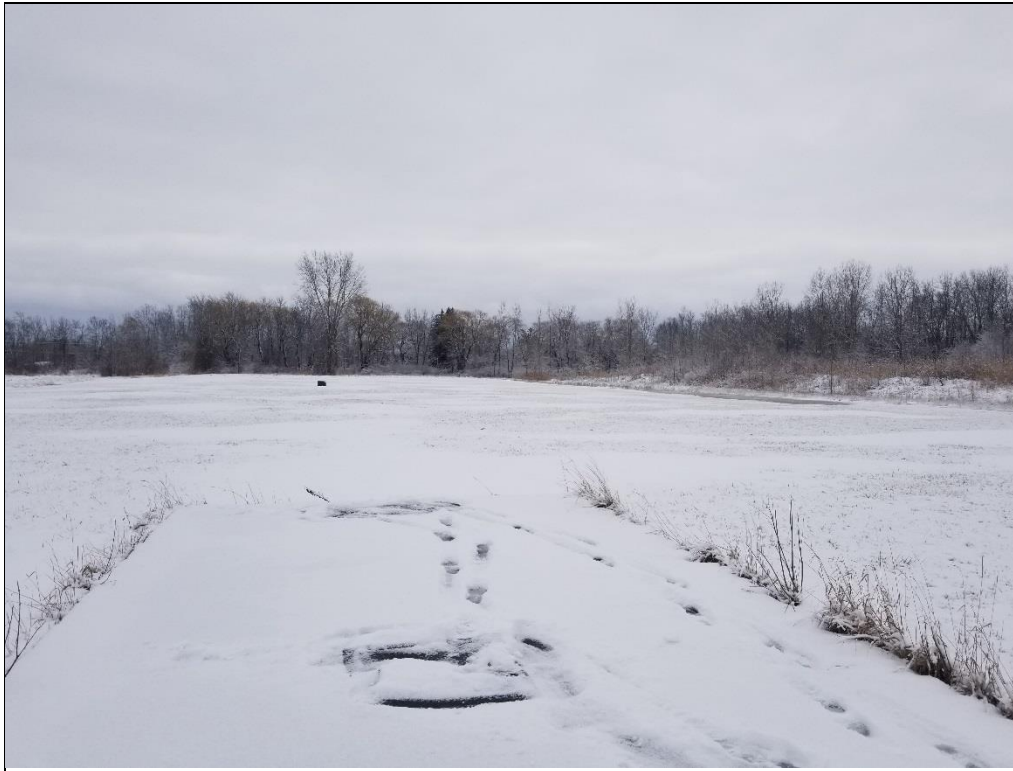
**Photo 7:**  
On-site sewage works, showing septic tank and leaching bed, located in southern portion of Site.
