# *Ecological & Environmental Solutions*

March 1, 2023

**Re:    **Scoped Impact Assessment for proposed Plan of Condominium  
      7769, 7751 & 7735 Thorold Stone Road, City of Niagara Falls****

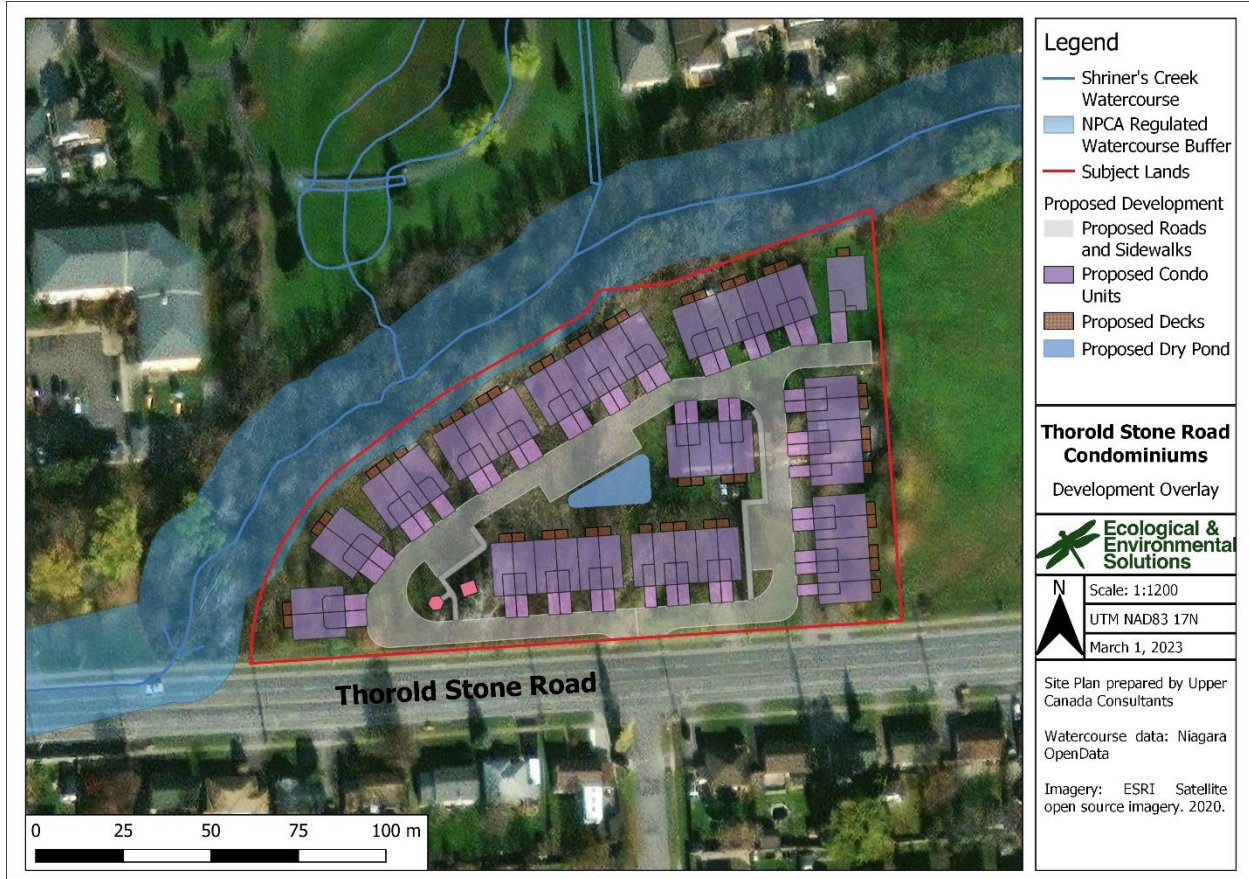
Figure 1: Proposed site plan for the Thorold Stone Road condominiums at 7769 Thorold Stone Road, in the City of Niagara Falls.

Site plans for the subject lands include construction of forty-nine condominiums on the subject lands. Twenty-four units are proposed to back onto Shriner's Creek and associated buffer, ten units will be located along the eastern property boundary, and fifteen located central to the site. A 6m roadway will provide access to all units and will include an additional twenty-two parking spaces. A dry pond is proposed in the central portion of the site and a 1.5m perimeter fence is proposed along the northern boundary of the property where it interfaces with Shriner's Creek. Along the eastern property boundary, a 1.8m wood board fence will be installed.

Development within the 15m watercourse buffer is limited to the installation of the perimeter fencing. No building footprints are proposed within the buffer.

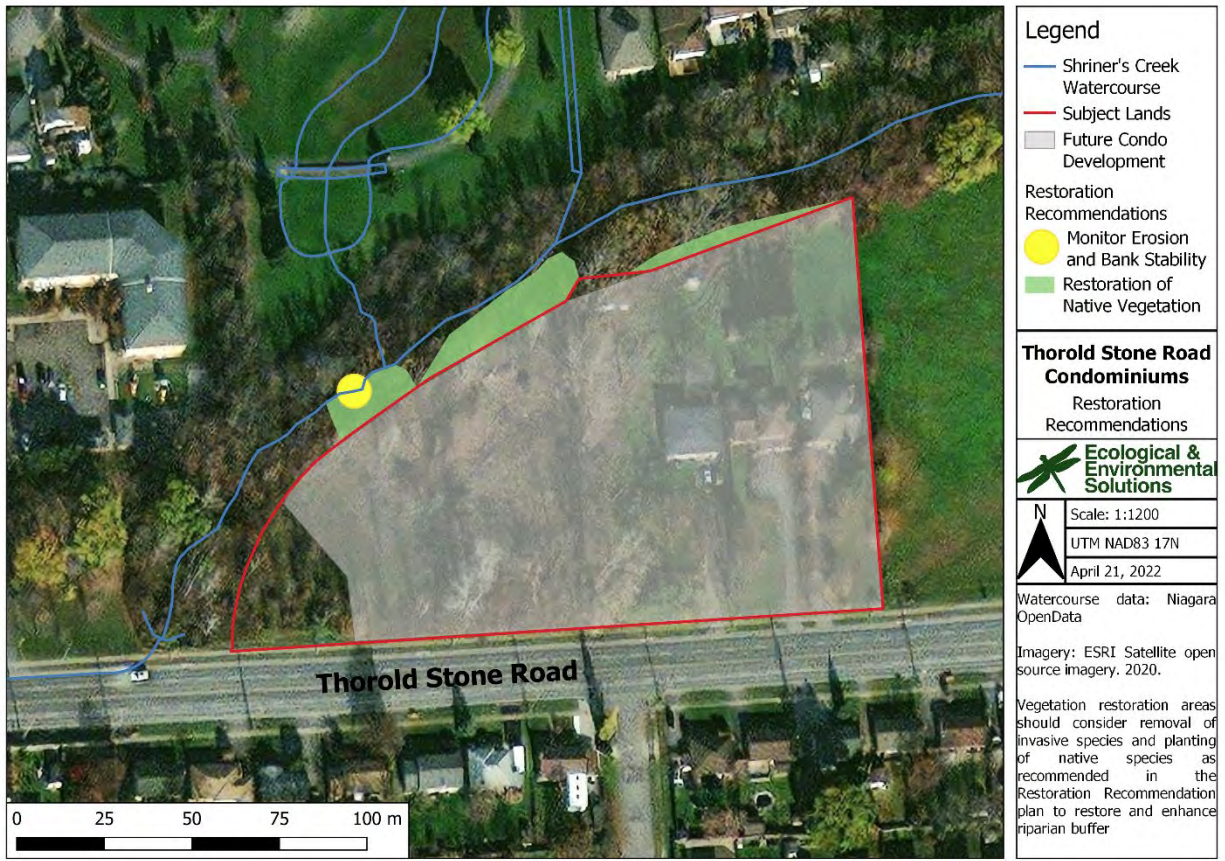
Figure 1: Restoration recommendations for the Mount Carmel Woodlot and Shriener's Creek Riparian buffer, adjacent to the proposed Thorold Stone Condominiums.

Some portions of the buffer, especially in the upstream portion of the site are sparsely vegetated and planting native trees and shrubs would enhance this area. Suggested tree species have been provided above. Native shrubs which should be considered include Red-osier Dogwood, Grey Dogwood, Sandbar Willow, or raspberry.

Invasive species are present sporadically within this portion of the riparian buffer including Multiflora Rose, Phragmites, and wild grape. These species should be removed prior to planting native species and ongoing monitoring and management should take place. Wild grape has formed a dense layer through some of the tree canopies and threatens to hinder healthy canopy development as well as establishment of native species in the understory or ground layer.

Prior to planting any native vegetation, invasive species including Multiflora Rose, European Common Reed, Sweetbrier, invasive Honeysuckle, and wild grape should be removed. Following removal of invasives, a variety of native trees and shrubs should be planted. A list of recommended trees and shrubs has been included in Table 1, below. In accordance with NPCA density recommendations, plantings should be installed at densities of 3 – 5m off centre for caliper trees, and 1m off centre for shrubs to ensure full coverage of any areas currently devoid of vegetation.

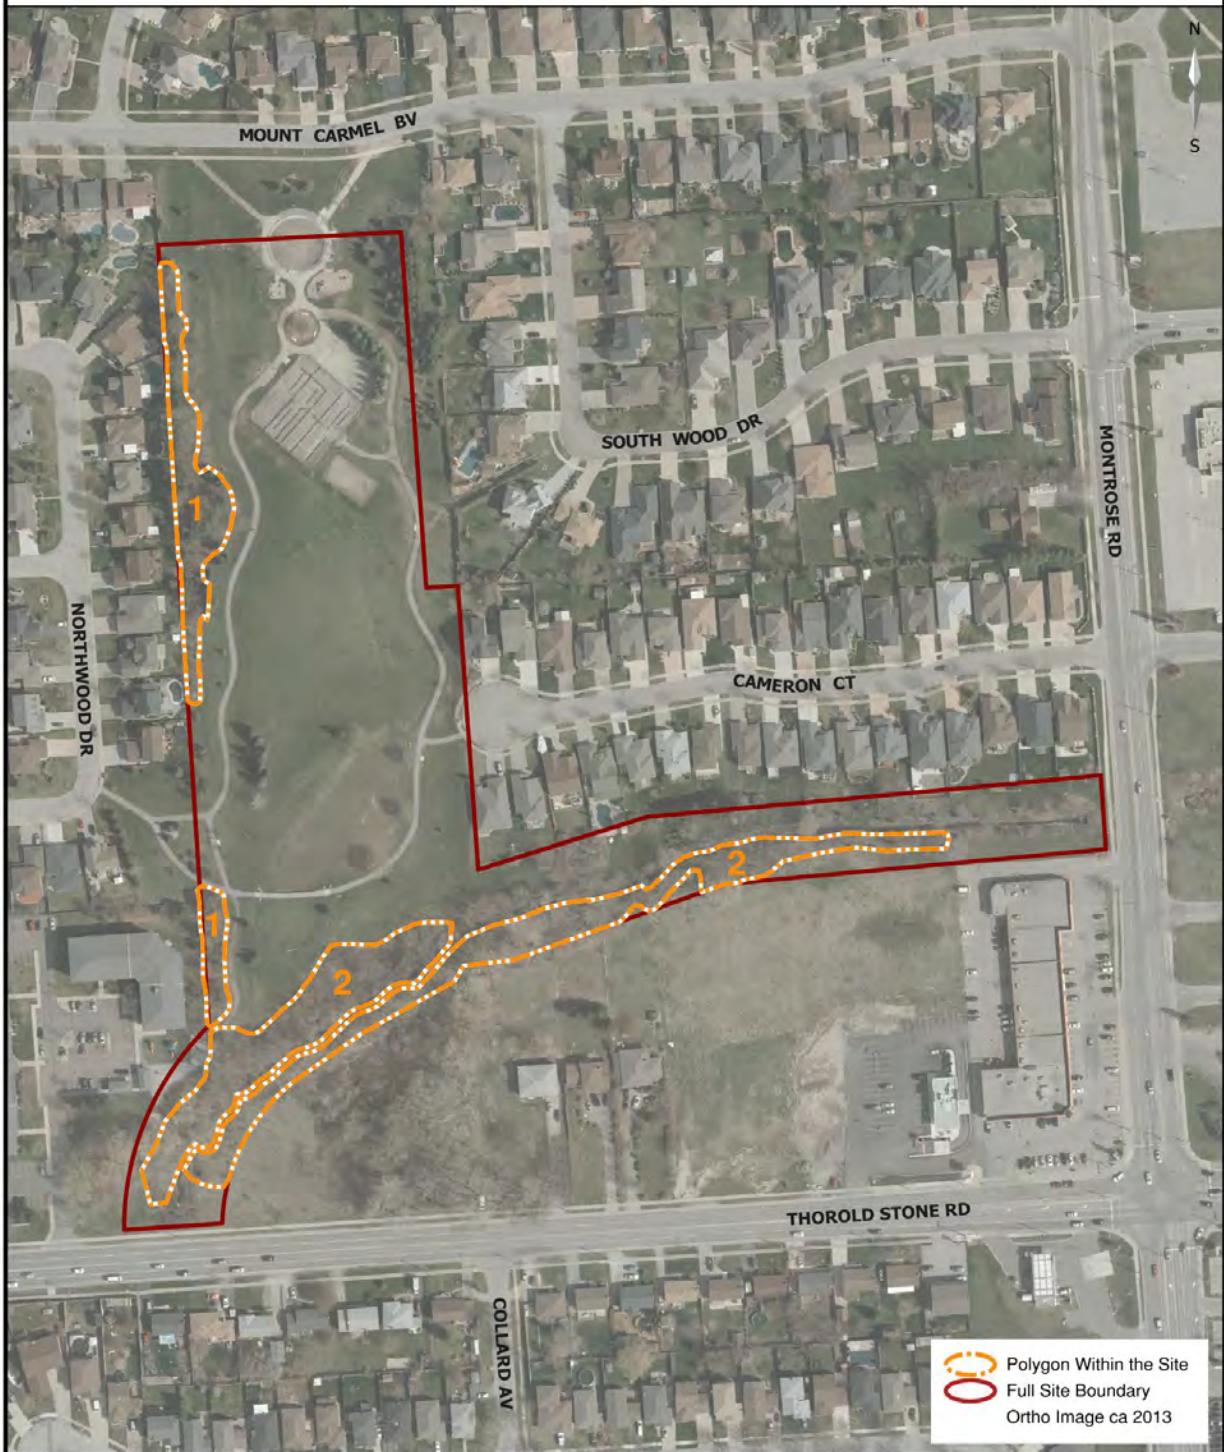
Table 6- Mount Carmel Park

| <i>Polygon 2</i> | Polygon 2 is a naturalized area around the creek, containing some native trees and shrubs. Sweetbrier and Multiflora Rose are the most noticeable invasive species, and they are truly abundant. Encroachments where the park met the backyards were noticed, some of which extended almost all the way to the creek. There were tree plantings, mowed lawns, fire pits and gardens. Dumping of garden debris, lumber and other materials had also occurred. |

| <i>Recommendations</i> | <ol style="list-style-type: none"><li>1. Neighbour encroachments shall be removed from the woodland. In addition to being illegal under the City parks by-law, these encroachments degrade the quality of the natural habitat and may negatively impact the public use of the lands.</li><li>2. Extending the riparian zone around the creek by removing invasive species and planting some native species would improve the area and perhaps the health of the creek.</li><li>3. To raise awareness of the woodland features and functions, informative signage should be put on site. The signage should be installed near a main trail or access point to the woodland.</li><li>4. Litter and debris should be removed from the woodland. Consideration should be made for the installation of waste receptacles at the entrance to the woodland in a convenient location for both the public and maintenance staff. Natural debris from dead trees shall be left on-site but moved off trails.</li></ol> |

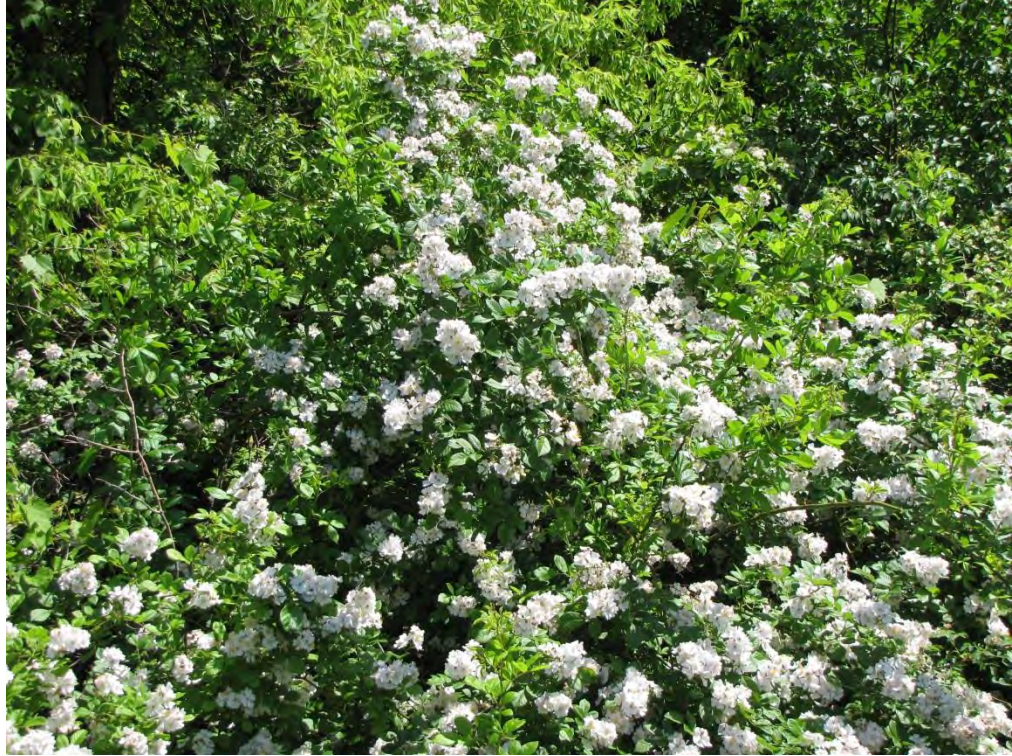
Figure 1 – Multiflora rose, which is invasive. Credit: NF Nature Club

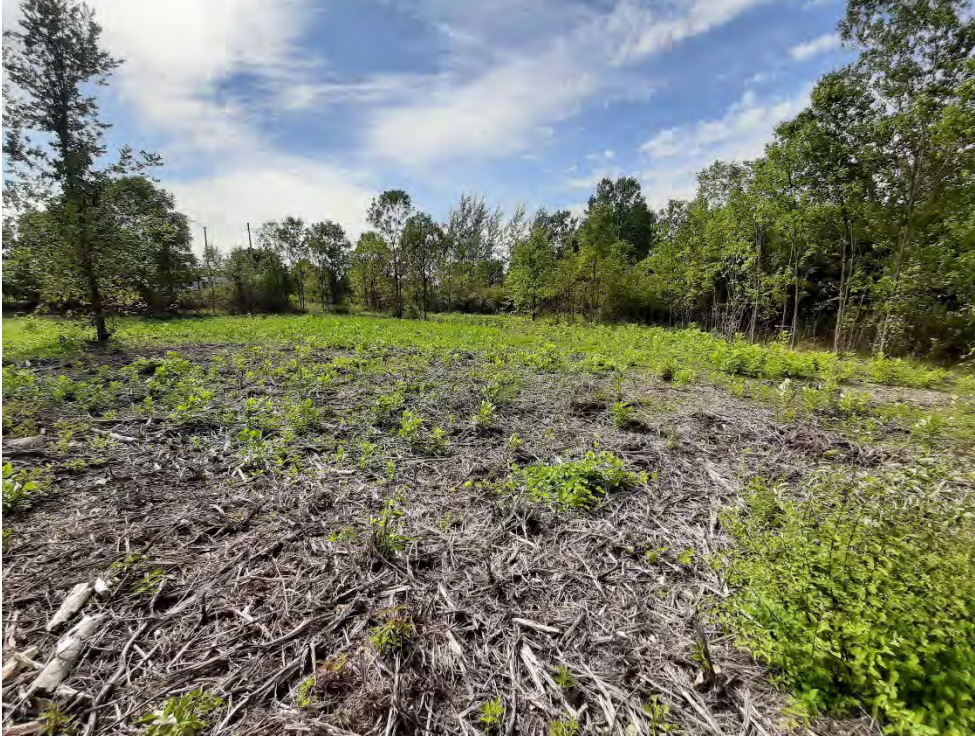
Presently, the subject properties are largely devoid of vegetation with a few Black Walnut, Ash, and Maple trees scattered through the property. The perimeter of the study area contains native shrubs such as Staghorn Sumac and Grey Dogwood. Site Photos are included in Appendix C.

*Figure 2: View of site clear of vegetation. Facing west, with Shriners' Creek riparian on right side of photo*

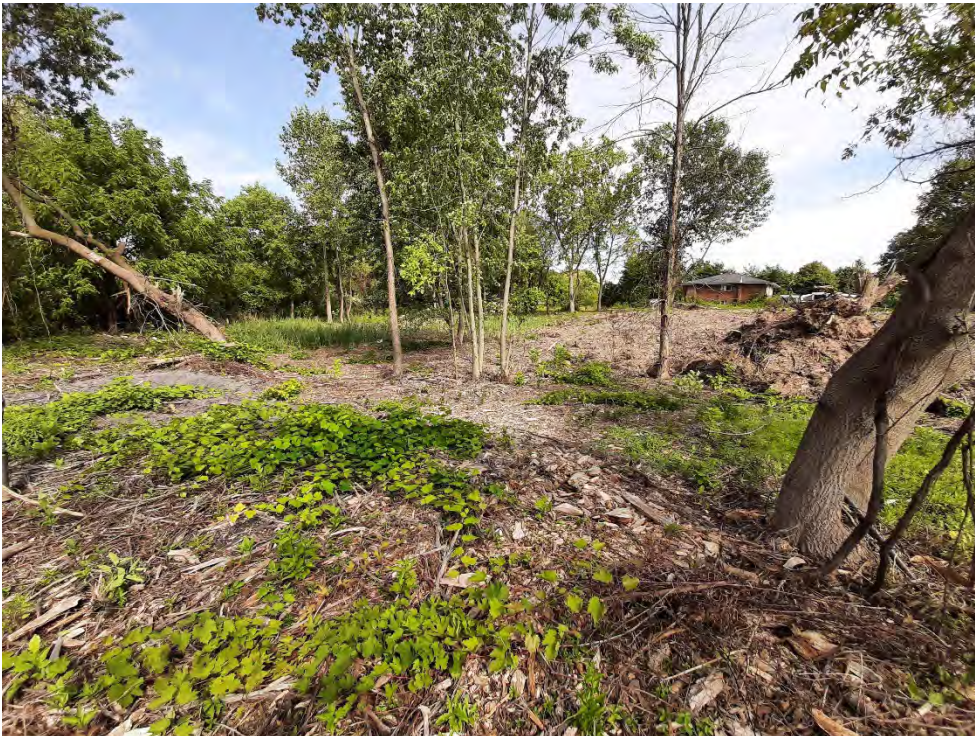
EES noted that the area which had been identified by the agencies as a potential unevaluated wetland is a small depression that was likely created during construction of the residential dwelling between 1968 and 2000 to facilitate site grading. The depression is approximately 0.05 hectares and there is no surface connection to the adjacent Shriner's Creek. Vegetation within the depression was limited to new growth of the invasive *Phragmites australis* and wild grape. Based on the existing conditions, including size and lack of surface connection to the adjacent watercourse the area does not provide wetland habitat as it is defined under the Conservation Authority's Act.

*Figure 3: Photo facing east, showing existing residential dwelling and small depression.*

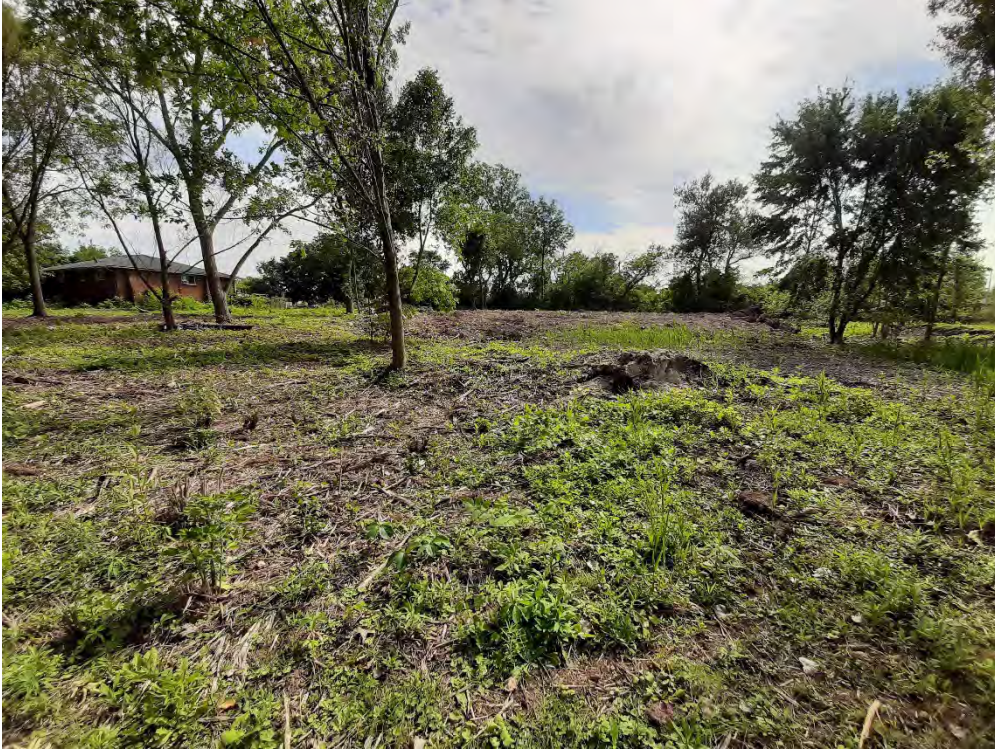
*Figure 4: Photo taken from northern boundary of property, facing south.*

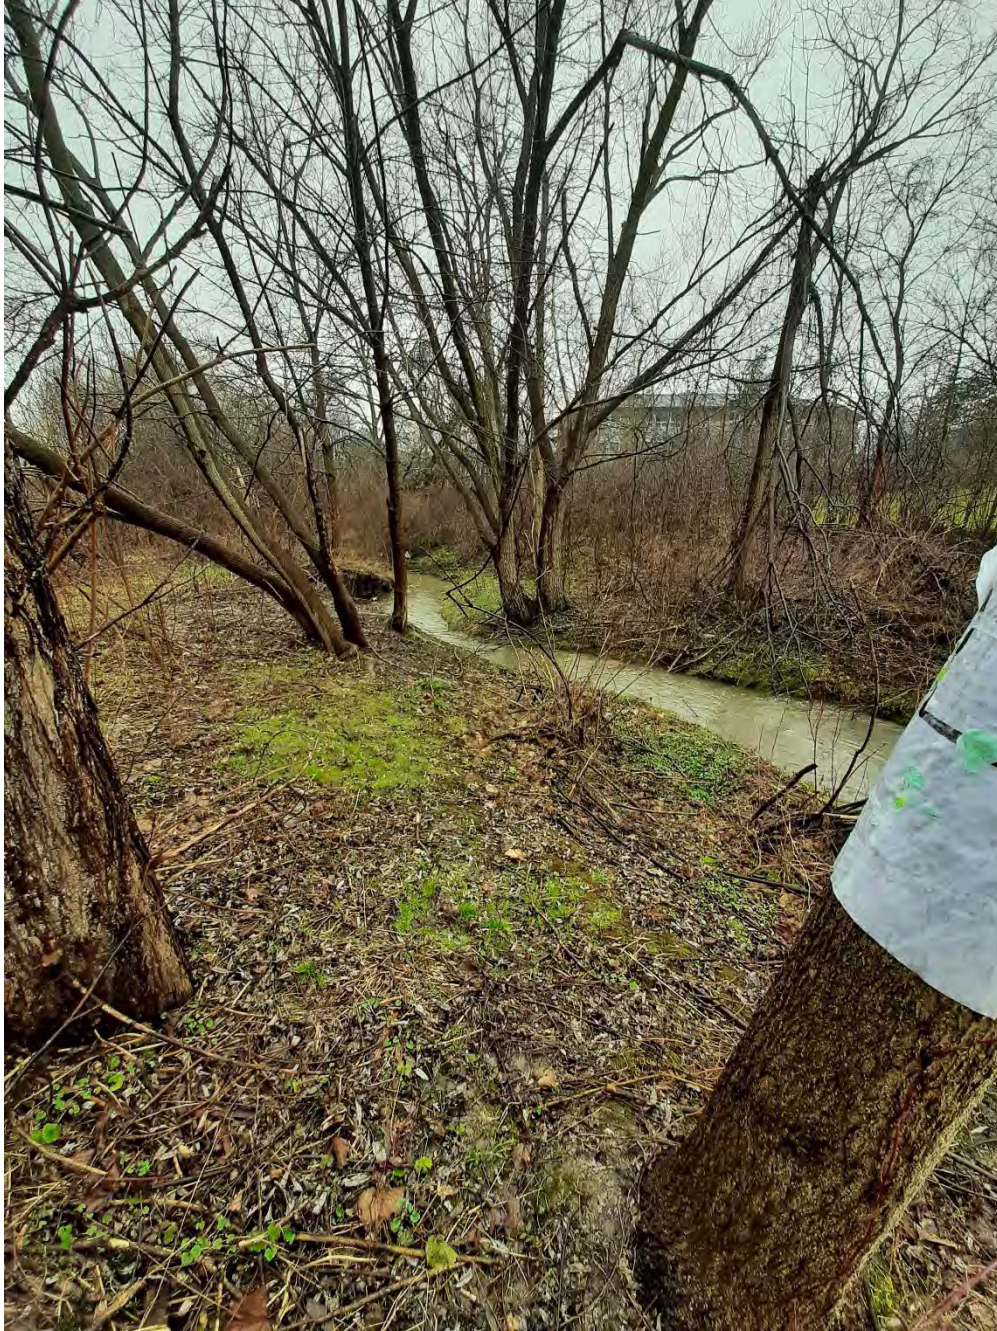
*Figure 5: Photo of Shriver's Creek, looking downstream (west).*

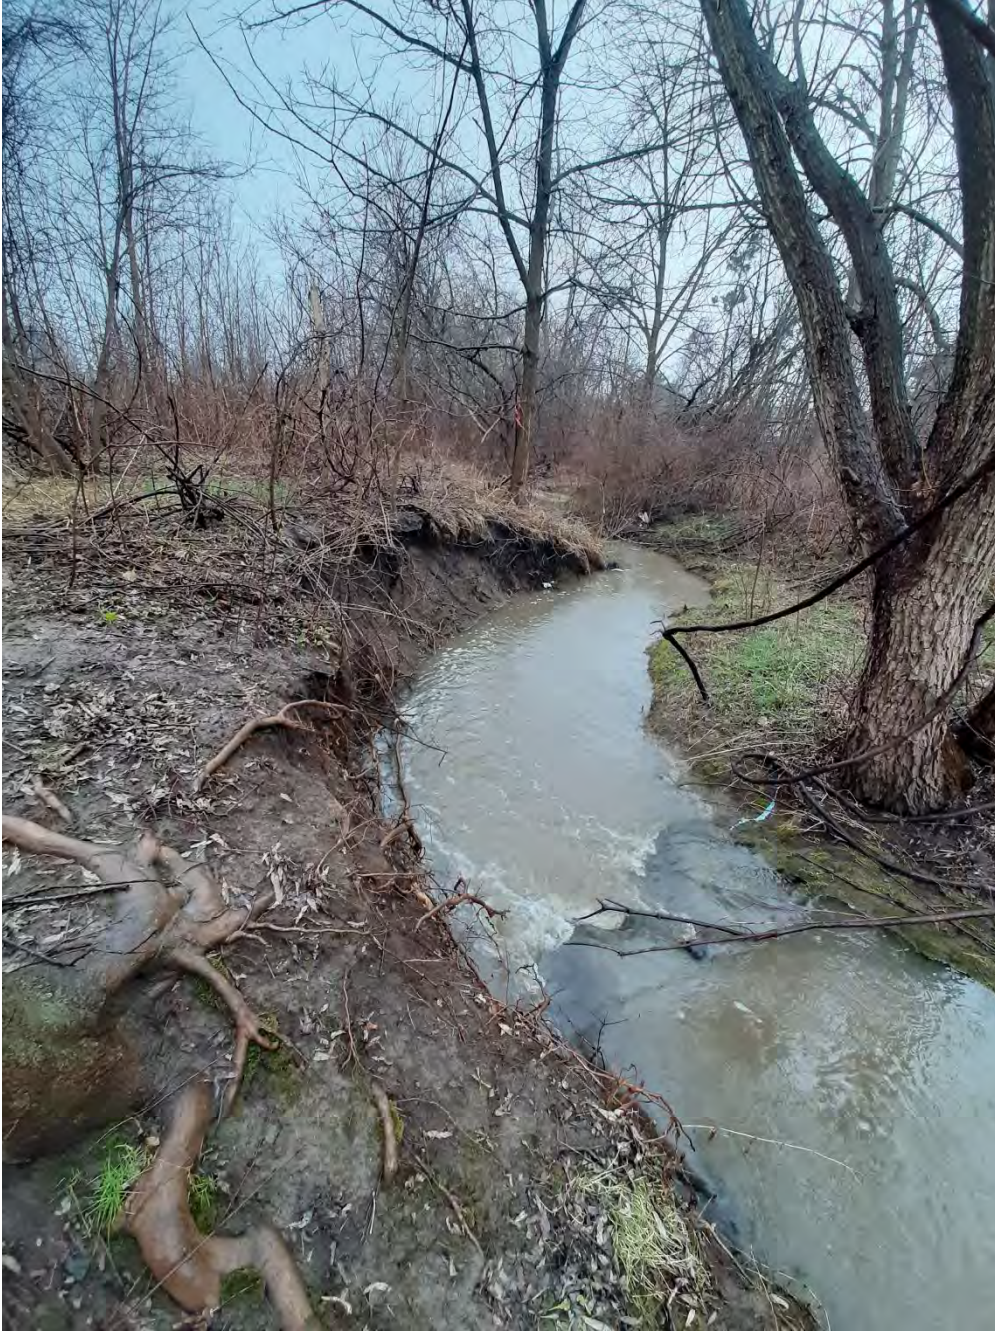
EES noted bank erosion on the right (south) bank of Shriner's Creek. This bank should be monitored to ensure stability and confirm there is no long-term risk of property damage. Potential source of erosion includes the unmitigated inputs from the Mount Carmel Park drainage feature approximately 10m upstream. The proposed development is not expected to contribute to increased erosion of the southern bank of Shriner's Creek because appropriate setbacks have been maintained and the proposed sheet overland flow will dissipate energy as water flows over the riparian zone into the creek.

*Figure 6: Photo of erosion on south bank of Shriners Creek.*

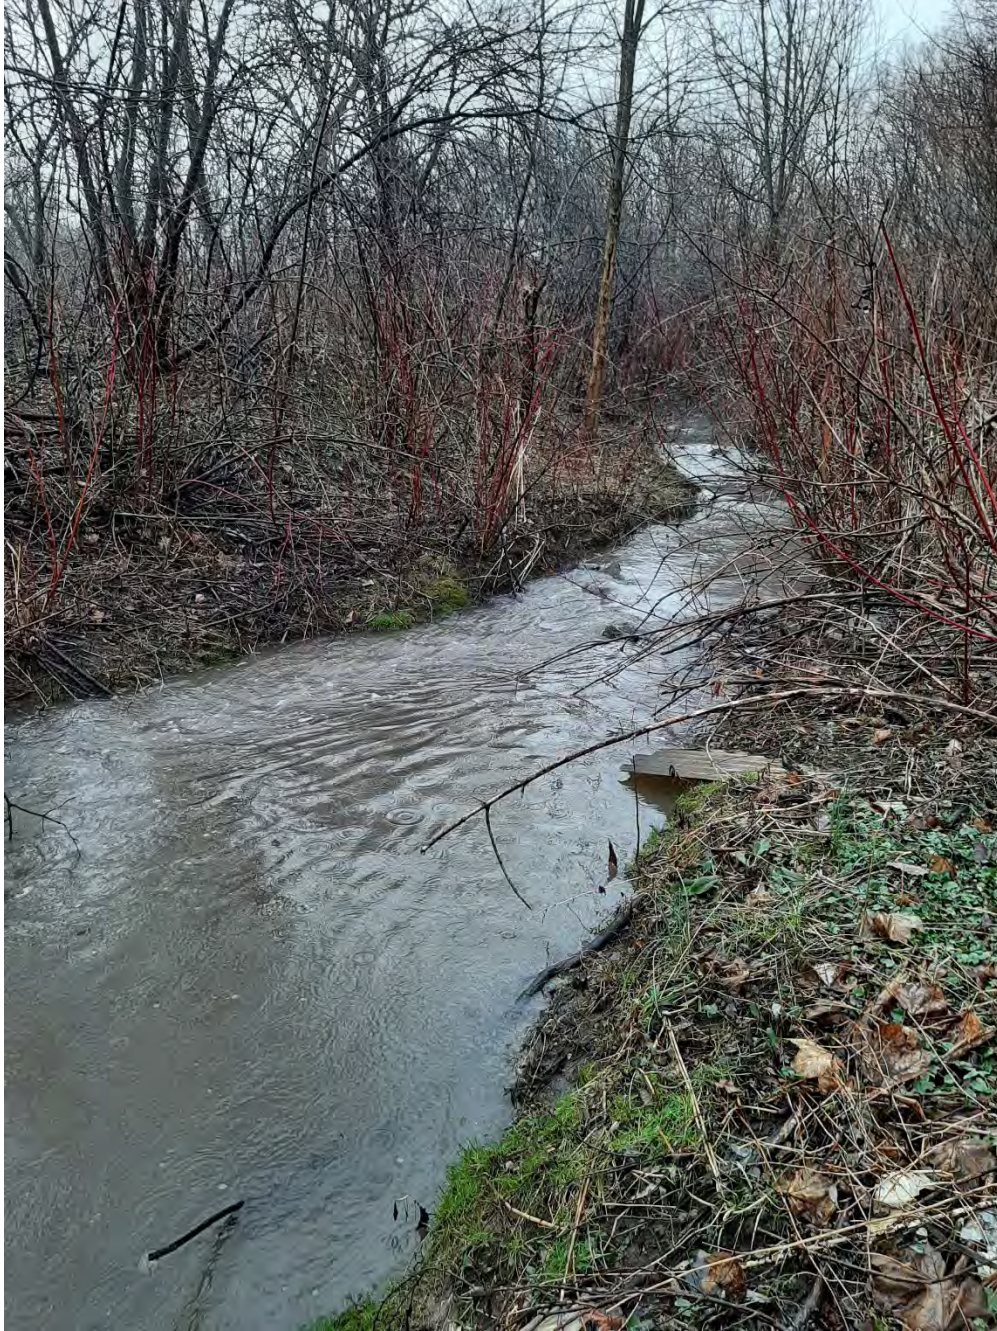
*Figure 7: Photo of Shriver's Creek looking upstream (east)*

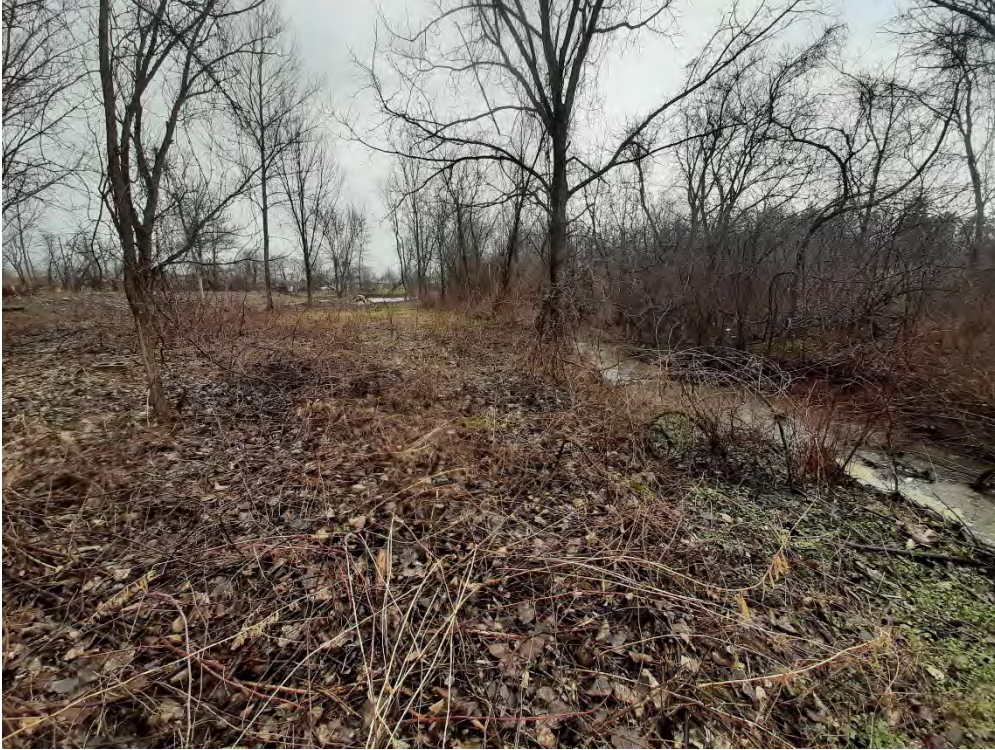
*Figure 8: Photo of proposed restoration area with sparse riparian vegetation.*
