**8885 – 8911 Lundy's Lane**  
**Phase One Environmental Site Assessment Update**

8885 – 8911 Lundy's Lane  
Niagara Falls, Ontario  
L2H 1H5

**Date:** June 10, 2022  
**NSSL File No.:** NS2255-01

## PHASE ONE LETTER UPDATE

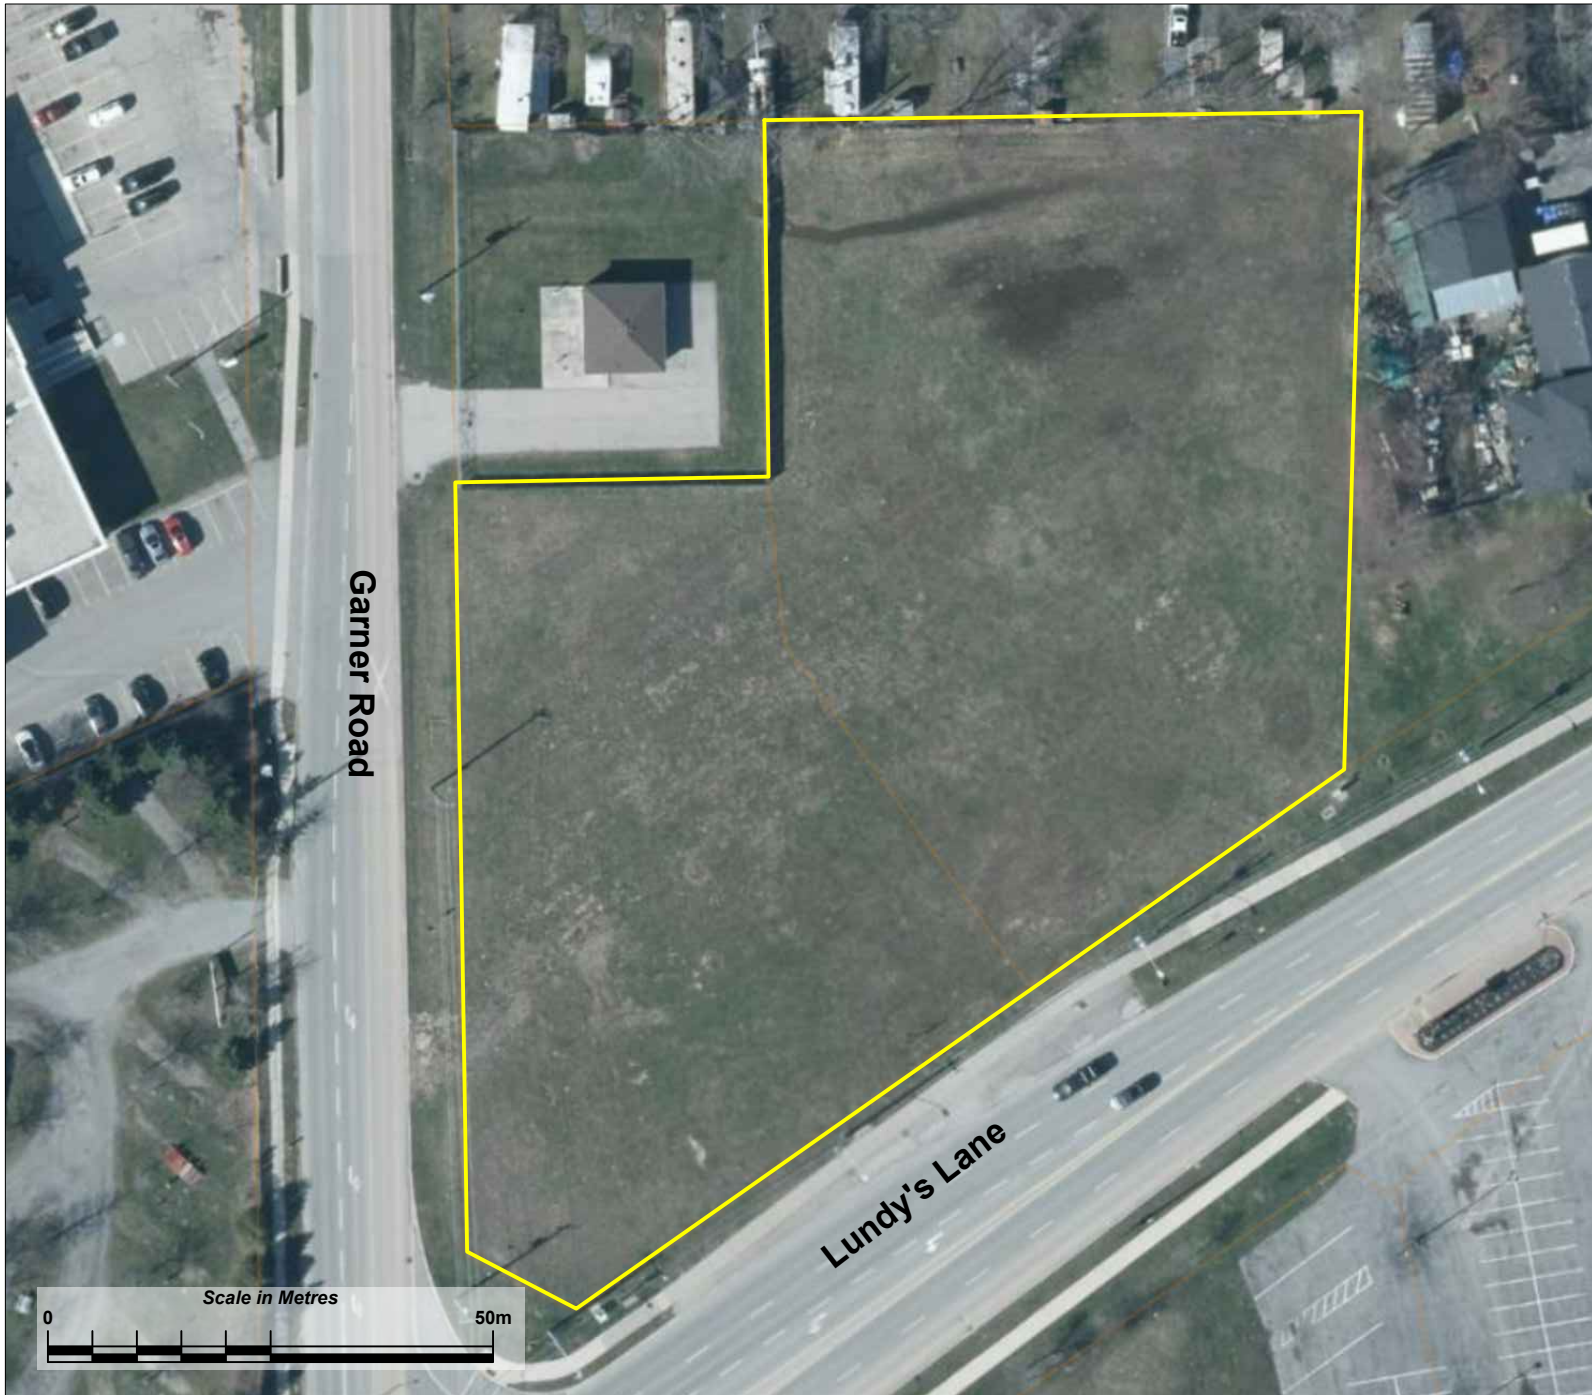
**Figure 2**

**SITE LAYOUT & FEATURES**

The size of the study site is approximately 0.92 hectares. The site is located northeast of the intersection at Lundy's Lane and Garner Road in the City of Niagara Falls. The property is vacant with no structures on-site and is currently covered with fill / granular material. Initial land use was noted as agricultural in 1934. The site was later redeveloped in 1954/55 for commercial and residential purposes including one [1] motel and one [1] dwelling located on the southwestern portion of the property. The motel was noted as having various owners throughout the decades including Chateau-Gay Motel from 1960 to 1975, the Anchor Motel in 1990, and the three Diamond Inn since 1995. The site also developed a "Diamond Pizza and Sub" Store at the beginning of 2009. All buildings on-site were demolished and removed in 2018 for potential land development purposes. The site has since remained vacant with no activities or operations noted. The site location and layout are illustrated in Figures 1 and 2.
