**PHASE TWO CONCEPTUAL SITE MODEL**  
**4078 VICTORIA AVENUE, NIAGARA FALLS, ON**

**Project Location:**  
4078 Victoria Avenue  
Niagara Falls, ON

**Prepared For:**  
Build Up Victoria Inc.

**NSSL File No.:** NS2241-04

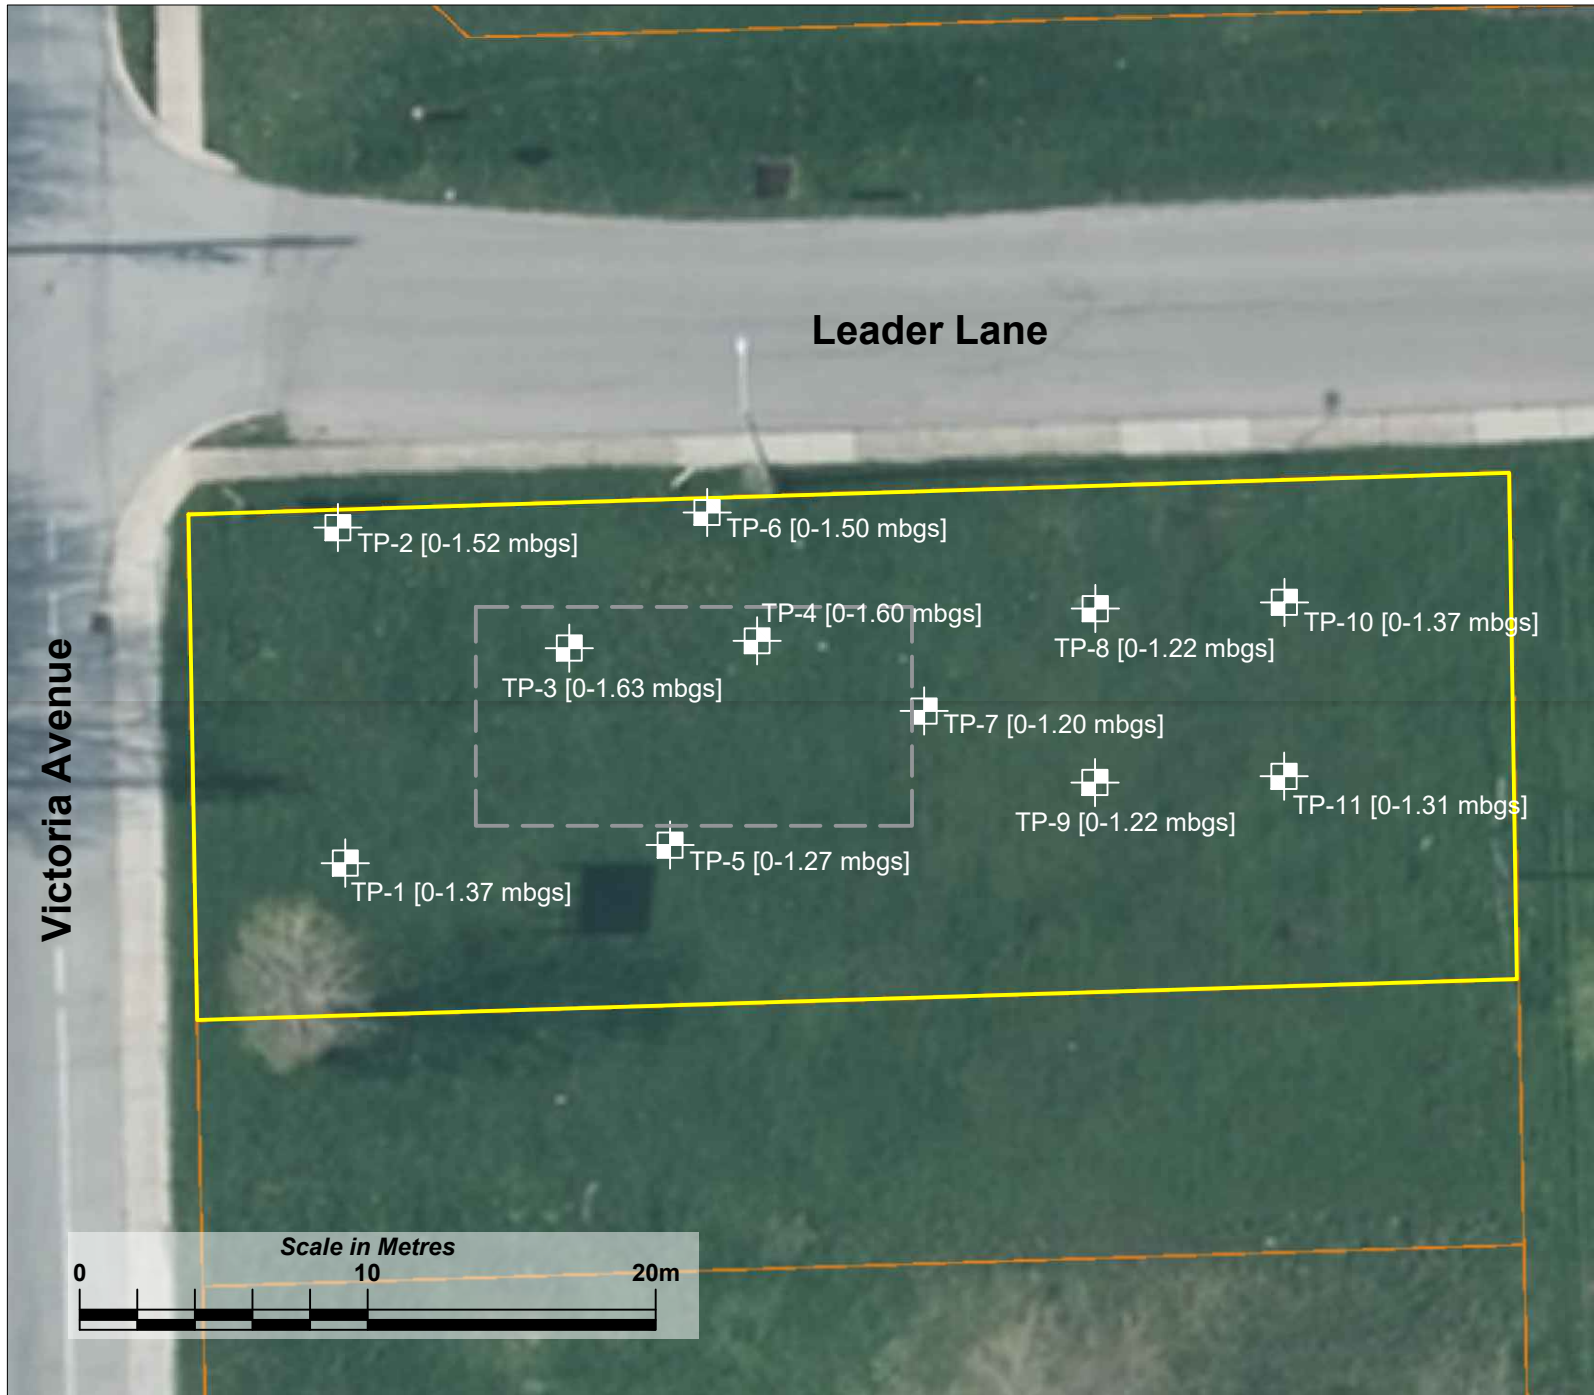
NO:  
**Figure 4**

A Phase Two ESA was completed by Hallex Environmental Ltd. in December 2021. Five test-pits TP1-TP5 were initially excavated within the APEC area identified above in section 2.0 to address potential on-site contamination within the soil medium. Sample results revealed exceedances to PHCs, Metals and PAHs in TP3 and TP4 within the location of the former residential structure as compared to Table 2 residential site condition standards. An additional six test pits TP6-TP11 were advanced for delineation purposes with test results confirming further impacted fill material in all additional test pits extending outwards from the original building footprint towards the eastern property boundary. Figures 4 and 4a to 4c depict the test results. The lateral and vertical distribution of contaminant concentrations in the soil at the Phase Two Property are shown on Figures 5a to 5h.

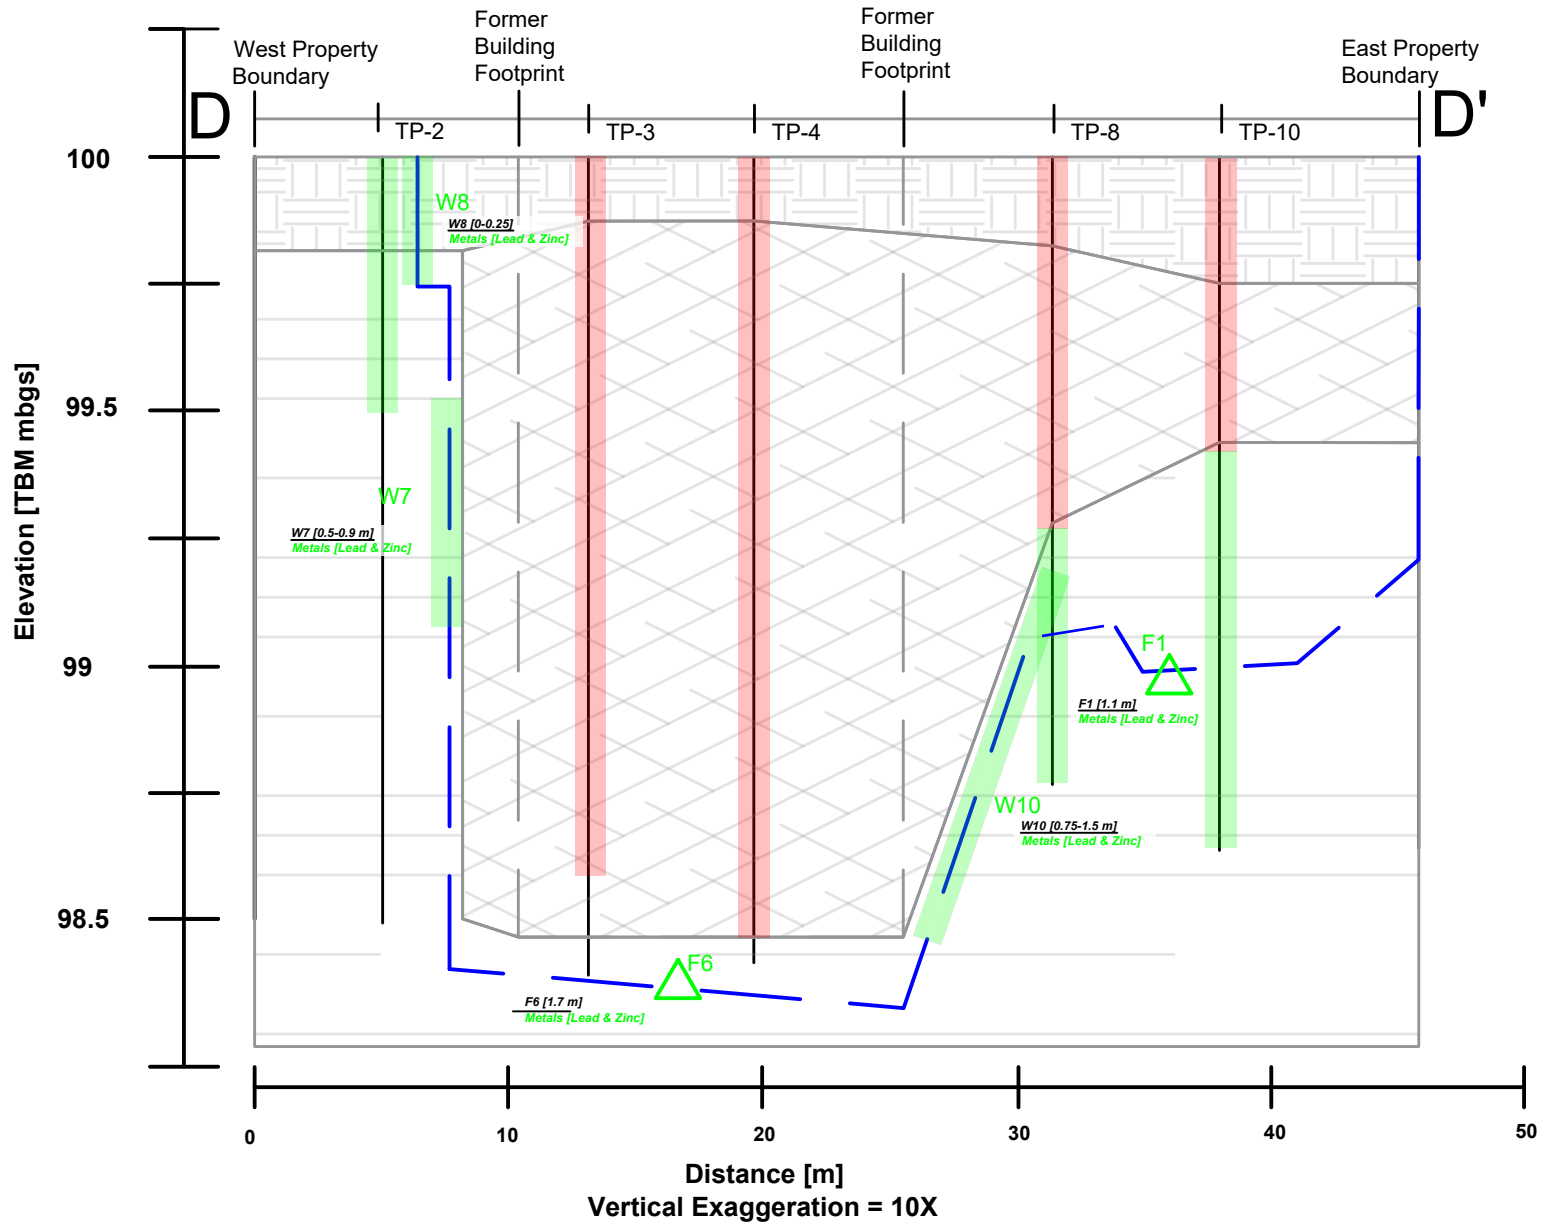
NO:  
**Figure 9A**

The test sample results were compared against Table 2 Residential criteria, fine soil texture. All test results met the applicable criteria except for sample W-3, located at the eastern limits of the Phase Two ESA property boundary. Although W-3 did not meet Table 2 Standards, contaminated soil was removed to the maximum extent on-site across the eastern property boundary [to the eastern property line]. See Figures 8 and 8a to 8c for Verification Results. Cross-sectional figures depicting the extent of the excavation and soil sample locations at the Phase Two Property following remediation are provided on Figures 9a to 9h.

NSSL was engaged to complete the remediation and verification work across the site and prepare the RSC package for submission to the Ministry. The impacted fill material across the property was identified within two distinct areas as identified within Hallex Environmental Ltd.'s Phase Two ESA report and NSSL's site reconnaissance. Area 1 was impacted with Metals [Lead and Zinc] and Area 2 was impacted with Metals [Lead and Zinc], PAHs, and PHCs [F3]. The impacted soil material was excavated by Cotton Inc. from the study site and disposed of at Walker's landfill. See Figure 6 for the excavation areas and verification sampling locations. As the excavation proceeded across the property miscellaneous debris such as bricks and asphaltic concrete rubble were also encountered within the soil medium. This material was also removed from site and disposed of at Walker's. The final excavation depths for the two areas were measured between about 0.25 and 1.1 m bgs for Area 1 and about 0.25 and 1.8 m bgs within Area 2, see Figure 7 for topographic contours across the site. Approximately 600 m<sup>3</sup> was excavated from Area 1 and 95 m<sup>3</sup> for Area 2 for a total of 1,114 metric tonnes removed from the study site [as indicated on the weigh tickets].
