**City of Niagara Falls  
2024 Asset Management Plan  
Non-Core Assets  
Current Levels of Service**

Prepared by  
SLBC Inc.  
May 2024  
Rev. 2

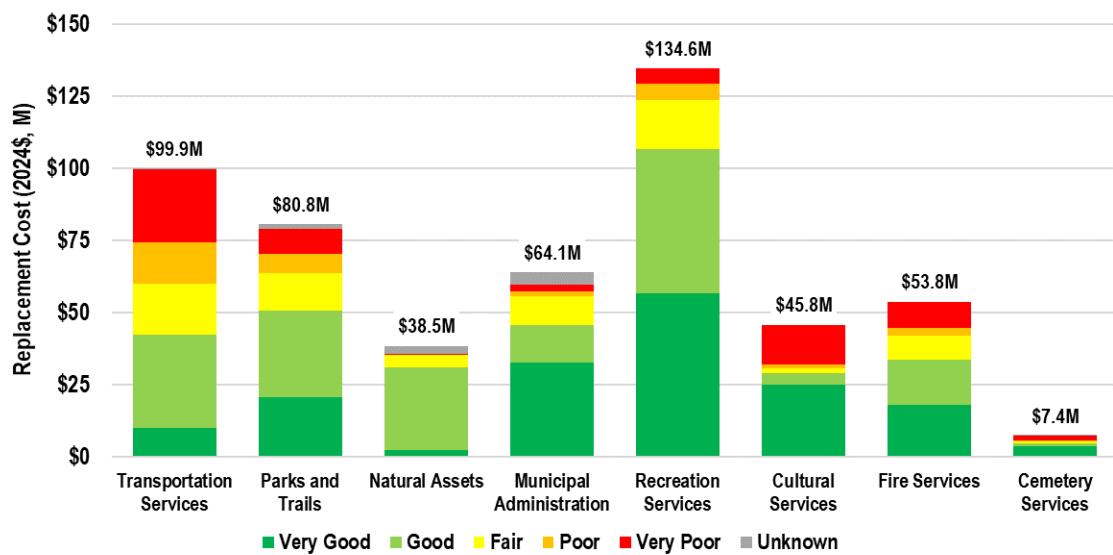
**Figure ES-1: Condition Distribution of the City's Non-Core Assets**

The current condition distribution of the City's non-core assets is shown in Figure ES-1 below, by Service Area. Overall, \$416 million (81%) of the City's non-core assets are in Fair condition or better, \$33 million (6%) are in Poor condition, which means they are nearing their end of life, and \$66 million (13%) are in Very Poor condition, which means that they are due or overdue for replacement.

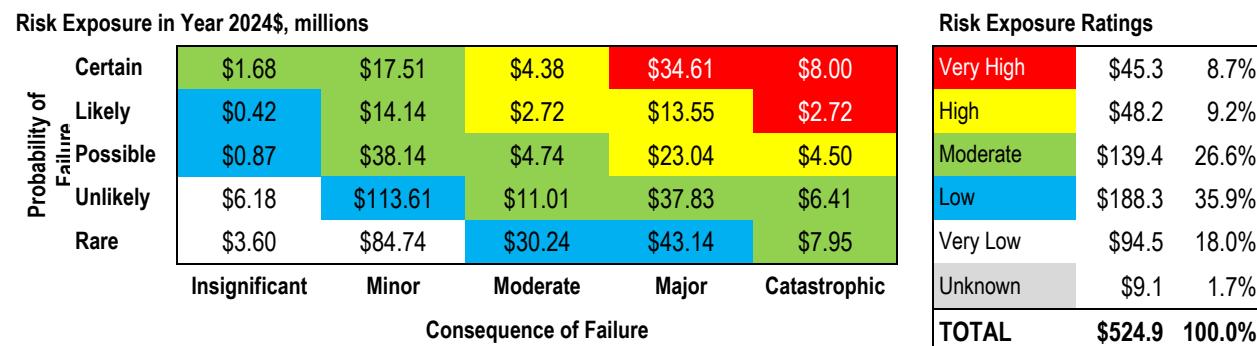
Figure ES-2: Risk Exposure of the City's Non-Core Assets

Based on those assets with known condition, Figure ES-2 shows that \$45.3 million or 8.7% of the City's non-core assets are in the Very High-risk exposure category related to provision of reliable services. The percentage excludes approximately \$9.1 million of assets with unknown condition (probability of failure). The City mitigates its exposure to these risks through the planned lifecycle strategies, such as renewal and maintenance.

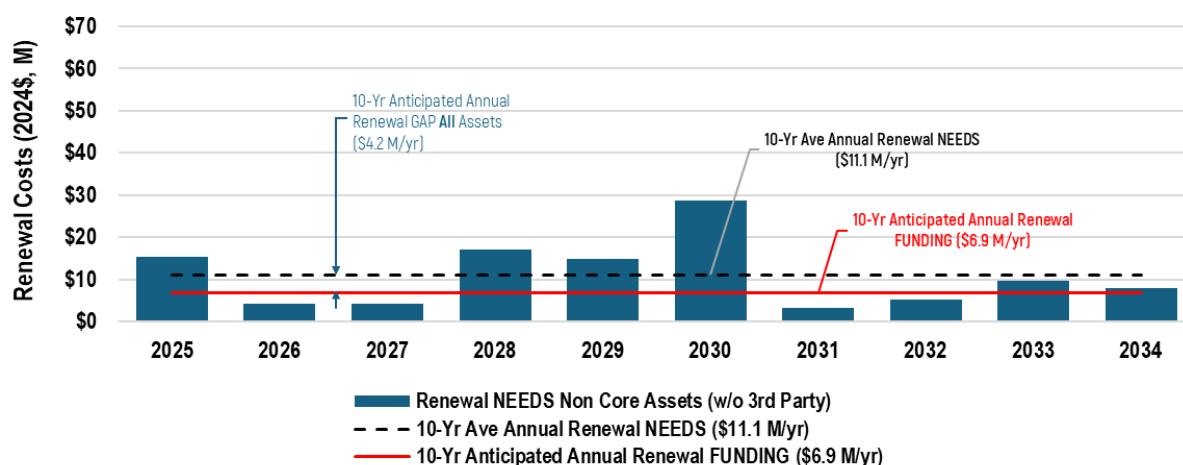
**Figure ES-3: Infrastructure Renewal Needs – Maintaining Current LOS Scenario**

This scenario shows the renewal activities that would be conducted if assets were renewed immediately upon reaching end of asset life. The unconstrained renewal funding scenario is aspirational since most municipalities do not have sufficient resources to support this level of service. In fact, this funding level would significantly improve the City's LOS performance for Asset Service Condition by eliminating the renewal backlog.

Figure ES-4 below shows the forecast condition distribution associated with funding the renewal needs, as shown by the dashed line in Figure ES-3 (Maintaining Current LOS Scenario). The plot shows that the City's current LOS is maintained over the next ten years with \$11.1M/year in funding. As the anticipated available funding of \$6.9M/year is not sufficient to maintain the current LOS, the City will see increasing quantities of very poor assets over time. If assets are not renewed when they reach end-of-life, their probability of failure increases. Depending on the asset type and failure context, an asset failure may result in various negative impacts, such as service disruptions, injuries to employees or the public, and reputational harm to the organization.

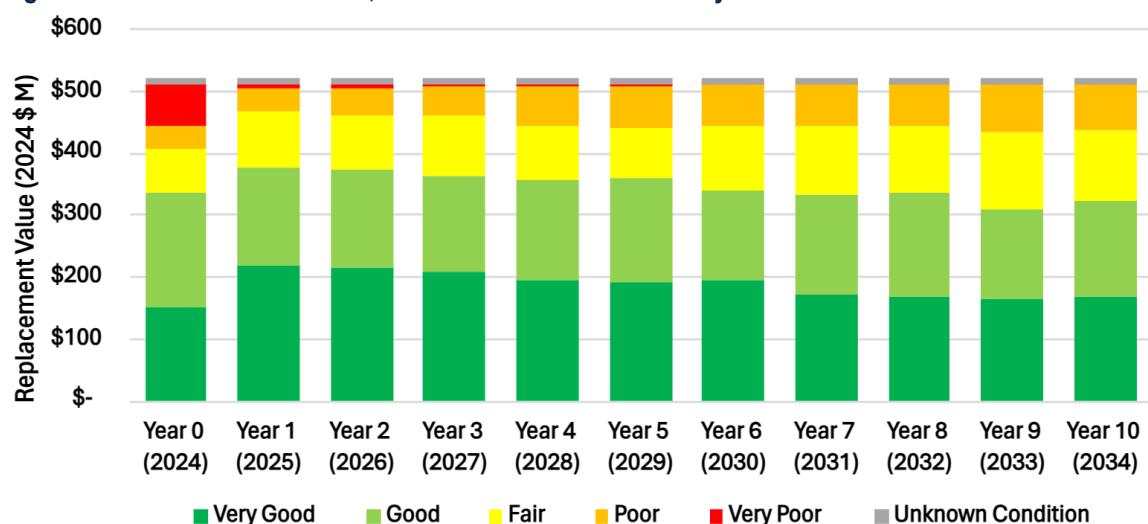
Figure ES-6: Condition Forecast, Unconstrained Planned Lifecycle Scenario

The resulting condition distribution over the next 10 years for this scenario is shown in Figure ES-6 as seen in the unconstrained scenario. Unlike the maintain LOS scenario, the City's backlog of assets is cleared immediately in the first year and not permitted to return.

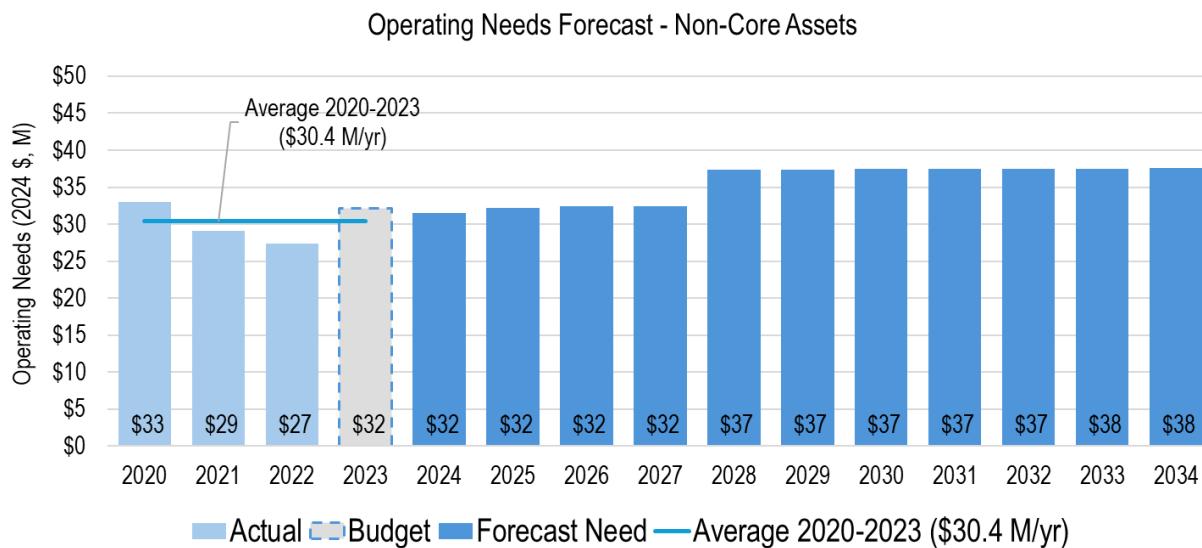
Figure ES-7: Operations and Needs Forecast

Forecast operations and maintenance costs are expected to vary in relation to the total value of the asset stock. If additional assets are acquired, the future operations and maintenance costs are expected to increase. Conversely, if assets are disposed of (without being replaced), the forecast operation and maintenance costs are expected to decrease. Figure ES-7 shows the forecast operations and maintenance costs for the next 10 years.

The figure shows that the estimated annual costs are expected to increase from a 2020-2023 average of \$30.4 million/year to \$38 million/year in 2034. All values are shown in 2024 \$. Forecast increases in operations and maintenance needs are due to estimated growth in the asset portfolio as indicated in the **City's Capital Projects List**, including planned opening of the **new parking garage** and the **new operations centre**. Operational needs associated with the planned expansion of **cemeteries** are not included in Figure ES-7, because the design of the future cemeteries is not yet known.

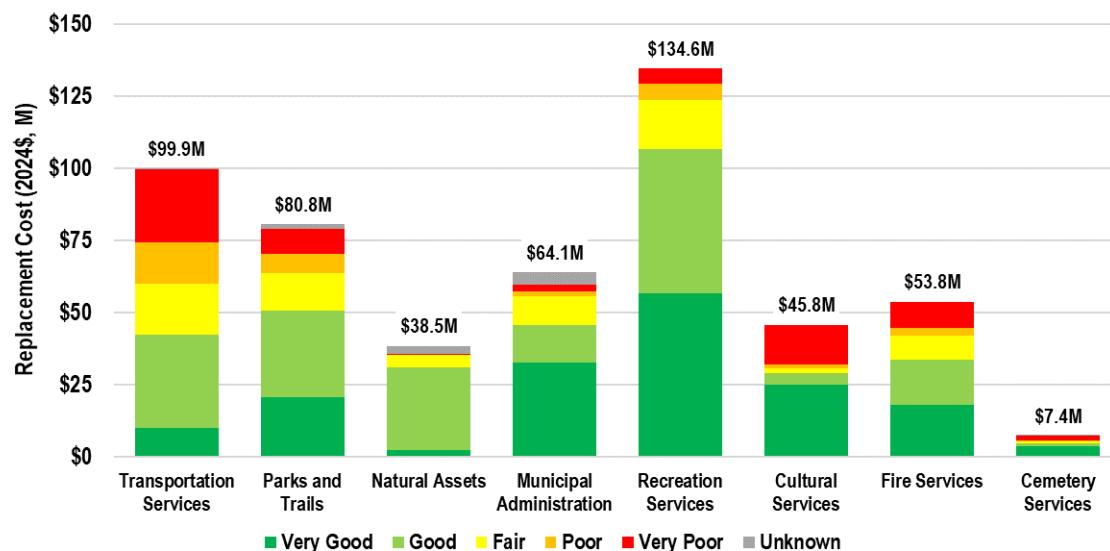
**Figure 2-1: Condition Distribution of the City's Non-Core Assets**

Overall, 81% or \$416 million of the City's non-core assets are in Fair condition or better, 6% or \$33 million are in Poor condition and 13% or \$66 million are in Very Poor condition. This excludes approximately \$9.1 million of assets with unknown condition either because the install date is not known, or a condition assessment has not yet been undertaken. Knowing the condition of assets is important to understanding the risks and costs of meeting stated service delivery objectives. Most of the assets of unknown condition include facilities without BCAs, natural assets and parks.

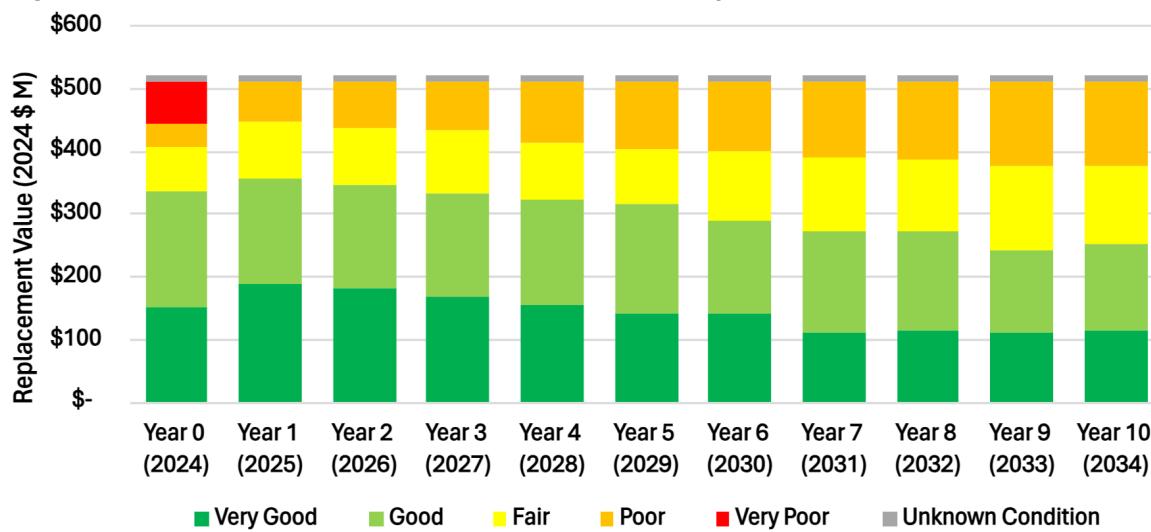
**Figure 2-10: Condition Forecast, Unconstrained Planned Lifecycle Scenario**

The resulting condition distribution over the next 10 years for this scenario is shown in the following figure. As seen in the unconstrained scenario, different from the maintain LOS scenario, the City's backlog of assets is cleared immediately in the first year.

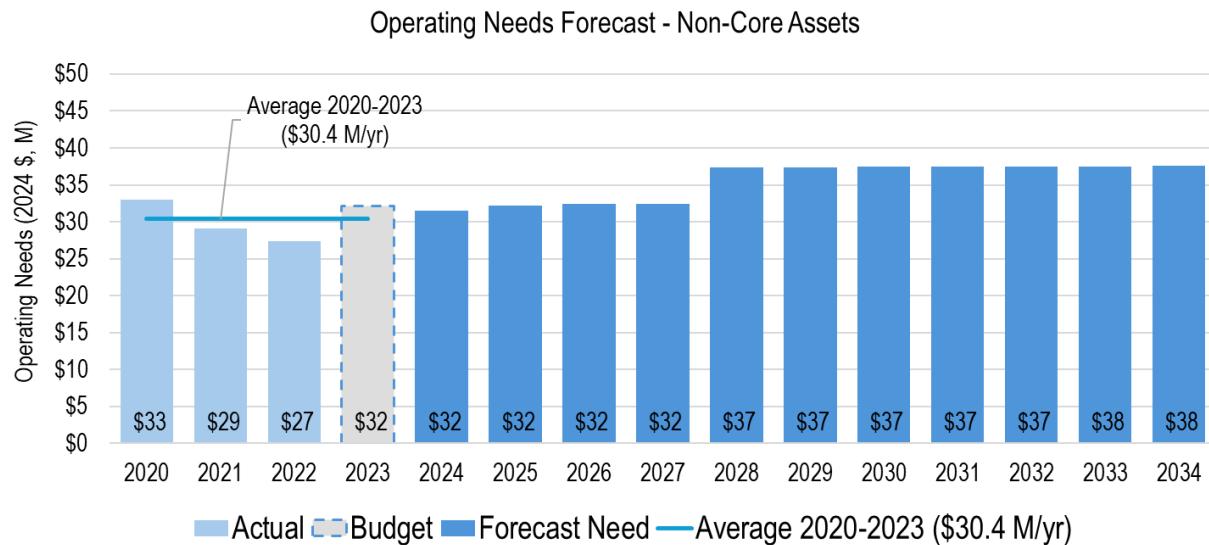
Figure 2-11: Operations and Needs Forecast

The figure shows that the estimated annual costs are expected to increase from a 2020-2023 average of \$30.4 million/year to \$38 million/year in 2034. All values are shown in 2024 \$. **Forecast increases in operations and maintenance needs are due to estimated growth in the asset portfolio as indicated in the City's Capital Projects List**, which include the **planned opening of the new parking garage and the new operations centre**. Operational needs associated with the planned expansion of cemeteries are not included in Figure 2-13, because the design of the future cemeteries is not yet known.

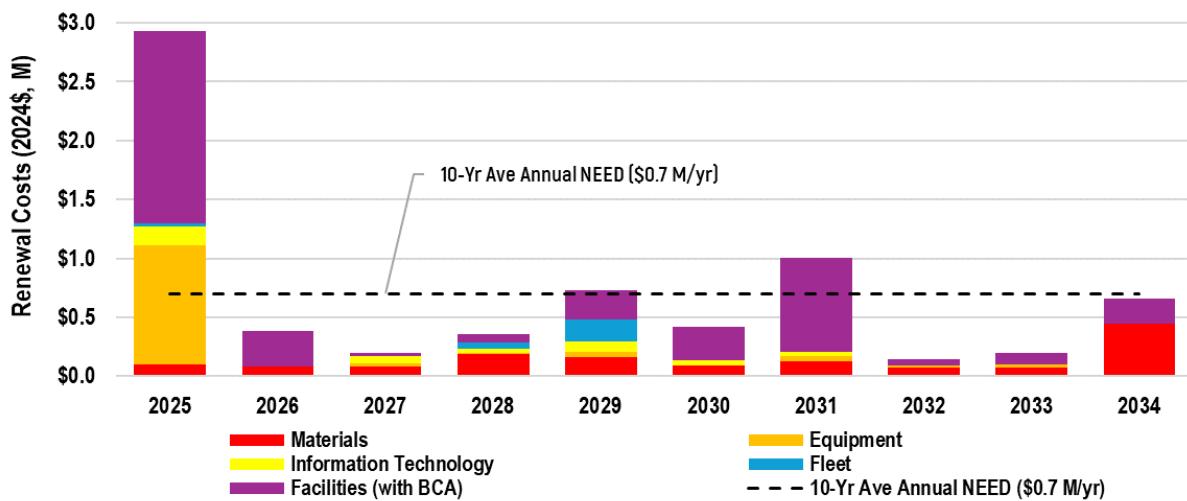
**Figure A-3: Forecasted Renewal Needs, Library Services**

Library facilities and other Library assets are generally renewed by the Library through the City's capital funding, and various other sources as part of the Niagara Falls Public Library's overall budget. As such, the average annual renewal needs to be covered by NFPL's budget are estimated at \$0.3 million/year. In comparison, the annual funding for renewals is \$0.2 million/year, based on NFPL's 2024 transfer to reserve. This leaves a gap of \$0.1 million/year.

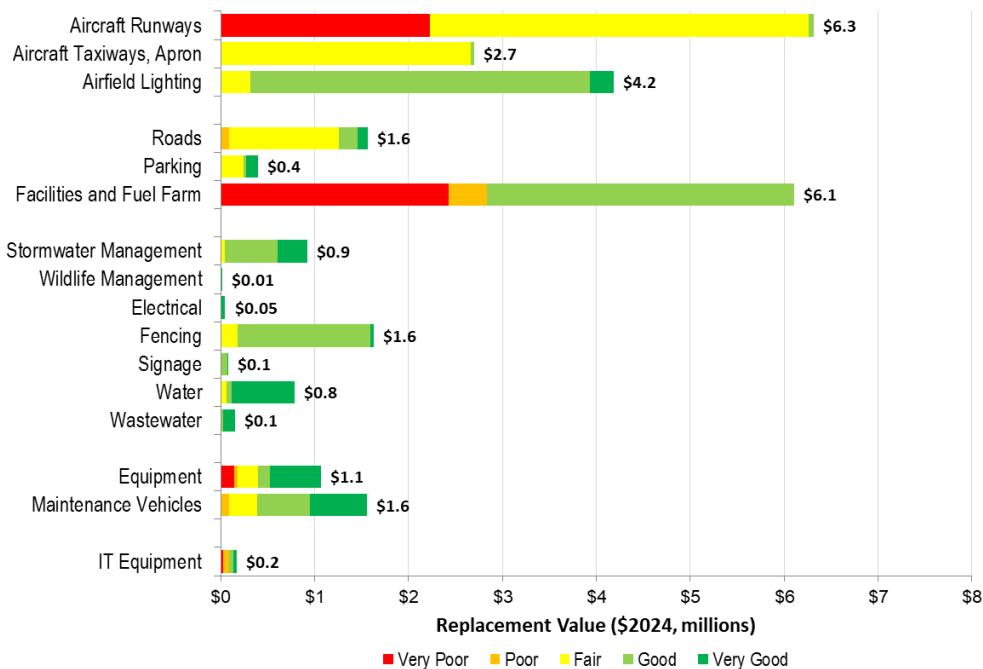
**Figure ES-1: Condition Distribution of Airport Assets**

Eighty percent (80.1% or \$22.2 million) of the Airport's assets are in Fair condition or better. Two and a half percent (2.5% or \$0.7 million) are in Poor condition, which indicates that they are nearing the end of their service life. Seventeen and a half percent (17.5% or \$4.8 million) are in Very Poor condition, which means they are due or overdue for replacement. Assets in Very Poor condition consist of Runway 11-29, Hangar 11, a front-end loader, a snowblower, handheld radios and various IT devices. Runway 11-29 has an estimated replacement value of \$2.2 million and is currently closed. Hangar 11 has an estimated replacement value of \$2.4 million and is nearing the end of its lease period to Genaire Limited.

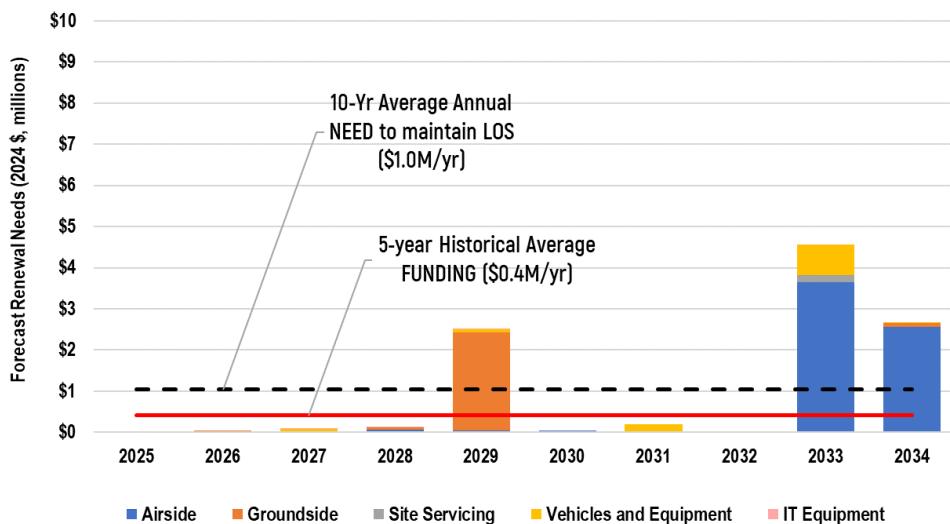
**Figure ES-2 Renewal Needs and Funding – Maintain Current LOS Scenario**

For reference, Figure ES-2 shows that the average capital renewal funding over the past 5 years (2020-2024) was \$0.4 million/year, which is \$0.6 million/year less than the amount required to maintain the current LOS. As such, continuing to fund at an average of \$0.4 million/year would

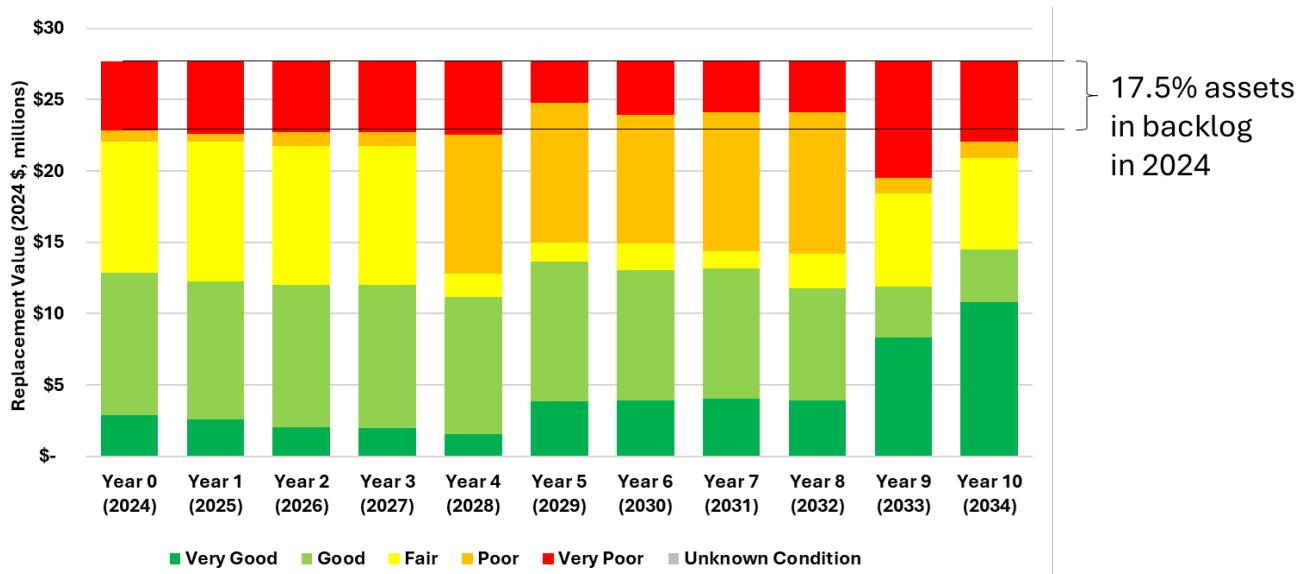
**Figure ES-3 Condition Forecast – Maintain Current LOS Scenario**

Figure ES-3 shows the forecast condition distribution associated with the funding scenario depicted in Figure ES-2. This scenario was designed to maintain the current LOS, i.e. the renewal backlog. In 2024 the renewal backlog was 17.5%. The backlog grows to 20.3% by 2034; however, through the period 2025-2034; the annual renewal backlog averages 17.3%.

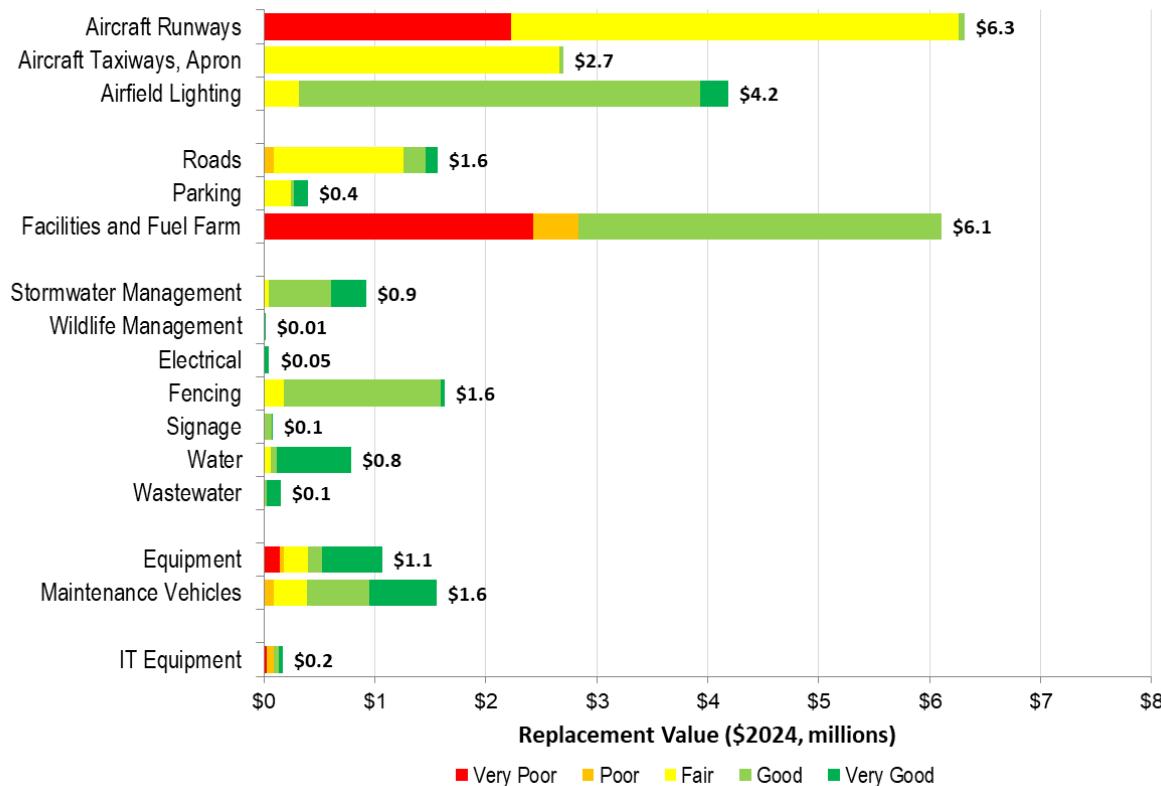
**Figure 2-2 Asset Condition Grade Profile**

To adequately meet service levels and manage risk while minimizing lifecycle costs, most assets should generally be preserved in fair or better condition. The above figure shows that the majority of the Airport's assets – in fact **80.1%** – are in fair or better condition. A total of **2.5%** of assets are in poor condition and **17.5%** of assets are in very poor condition. Assets in poor or very poor condition require increased attention and renewal investment (i.e., funding and staff resources) to avoid increased maintenance costs and/or unexpected failure. The majority of assets that are currently in very poor condition are aircraft runway 11-29 which is closed to traffic and the Hangar 11 facility which is under review as it is in very poor condition and not functional as a hanger as it does not have airside access. Assets in poor and very poor condition would typically be included in 10-year capital renewal program and budget forecast.

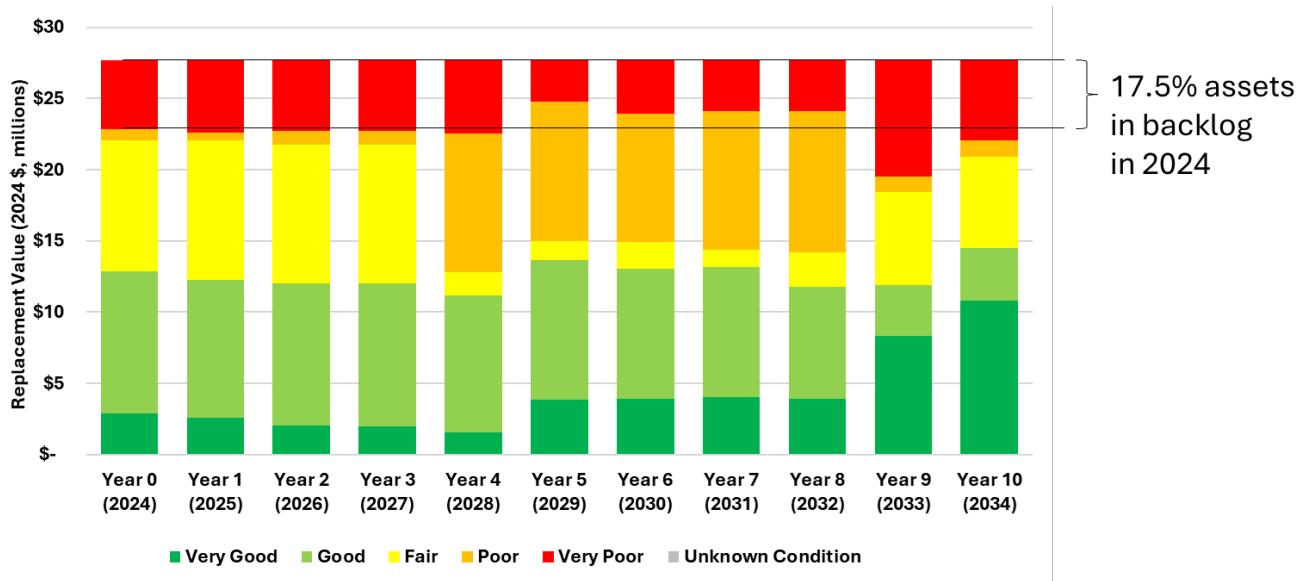
**Figure 5-2 Condition Forecast – Maintain Current LOS Scenario**

Figure 5-2 shows the forecast condition distribution associated with the funding scenario depicted in Figure 5-1. This scenario was designed to maintain the current LOS, i.e. the renewal backlog. In 2024 the renewal backlog was 17.5%. The backlog grows to 20.3% by 2034; however, through the period 2025-2034; the annual renewal backlog averages 17.3%.

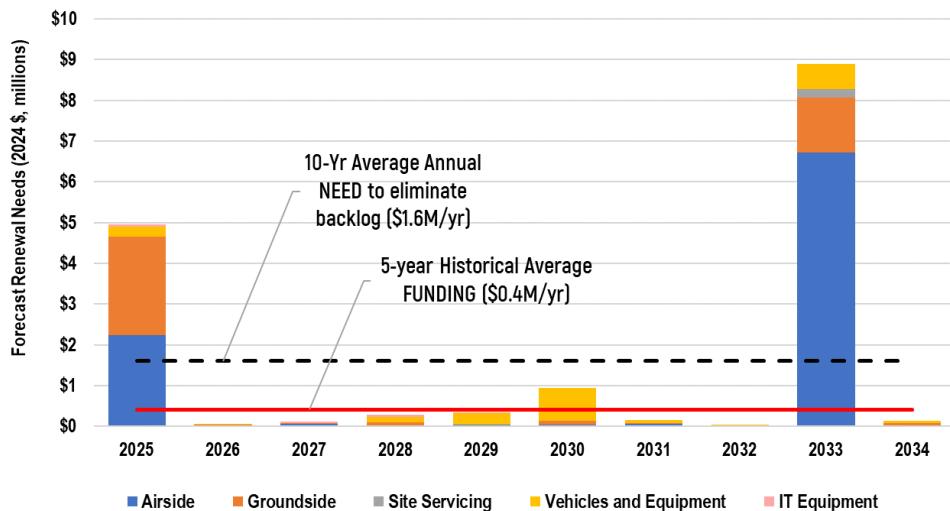
**Figure 5-3 Renewal Needs and Funding – Eliminate Backlog**

Figure 5-3 shows the capital renewal needs forecast to address all outstanding needs for each of the next 10 years (coloured bars), the average for the next 10 years (dashed black line), and the average historical renewal funding of \$0.4 million/year (solid red line). The Figure shows that \$1.6

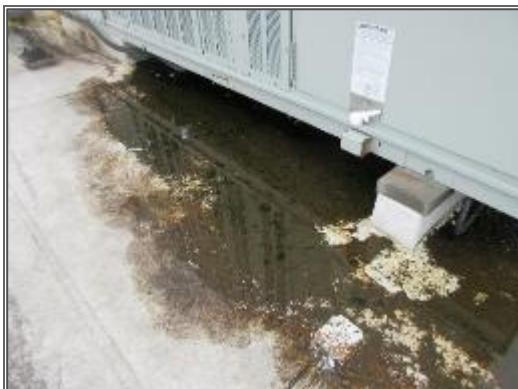
View of water ponding atop the roof system.

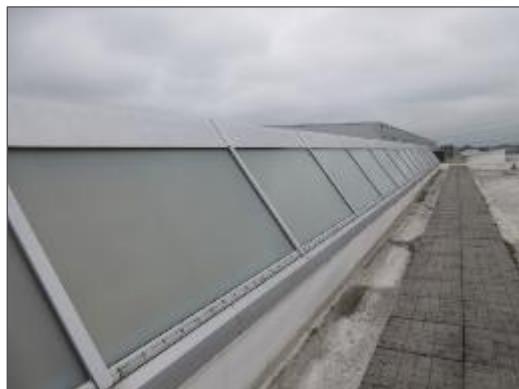
View of a typical skylight noted atop the north portion of the main roof system.

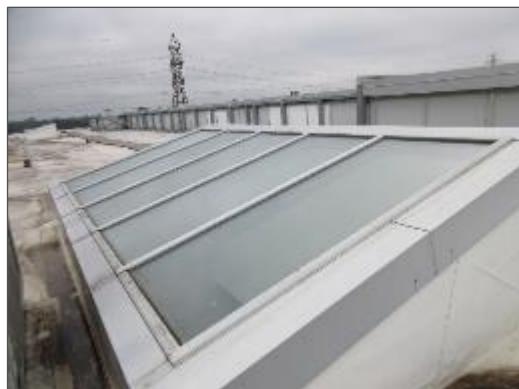
View of a typical skylight noted atop the north portion of the main roof system.

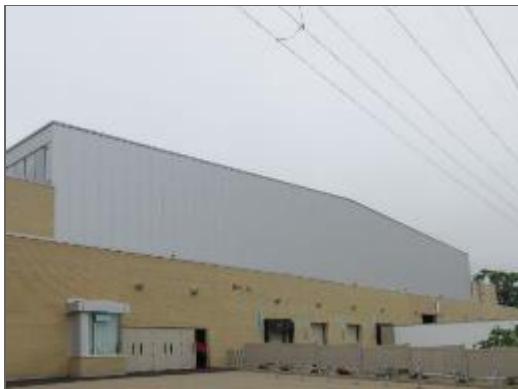
View of the metal wall panels noted on the west elevation of Site Building.

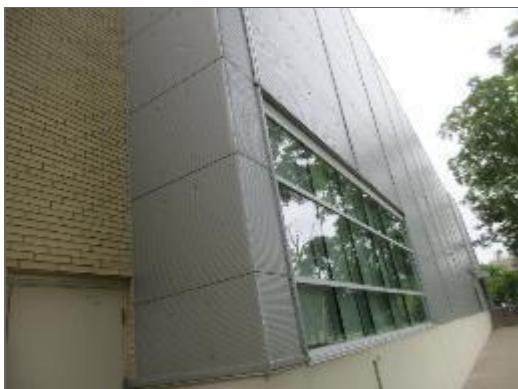
View of the metal wall panels noted on the east elevation of Site Building.

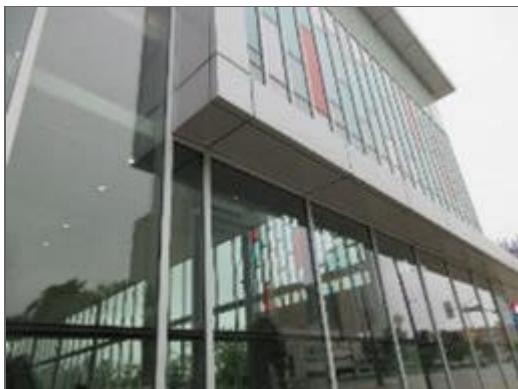
View of the metal wall panels noted on the north elevation of Site Building.

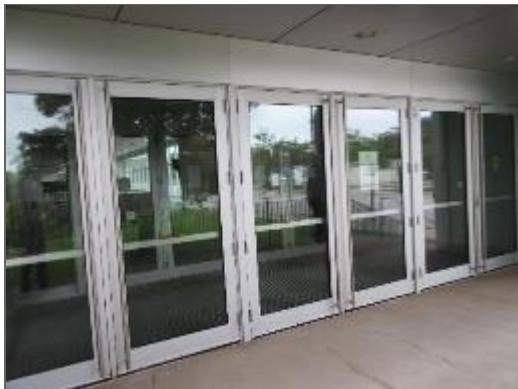
General view of the main entrance doors on the south elevation of the Site Building.

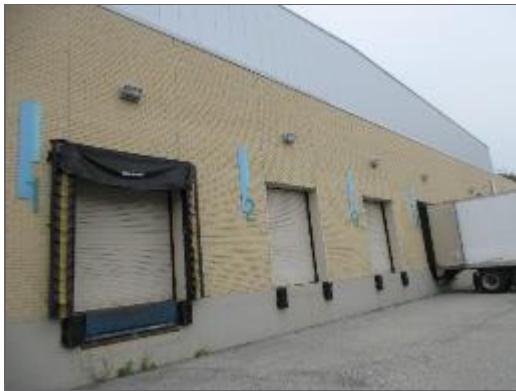
General view of the metal overhead rollup doors noted on the west elevation of Site Building.

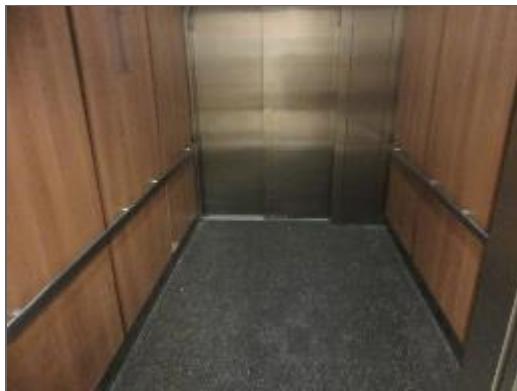
General view of a typical elevator cab.

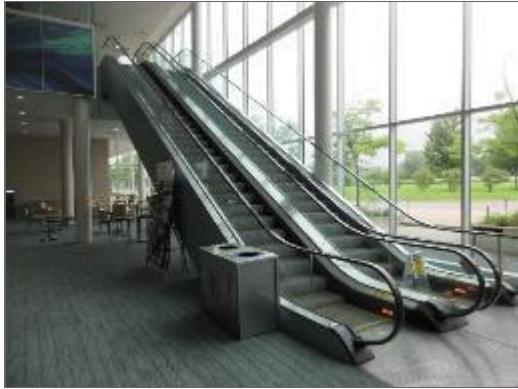
View of the escalators.

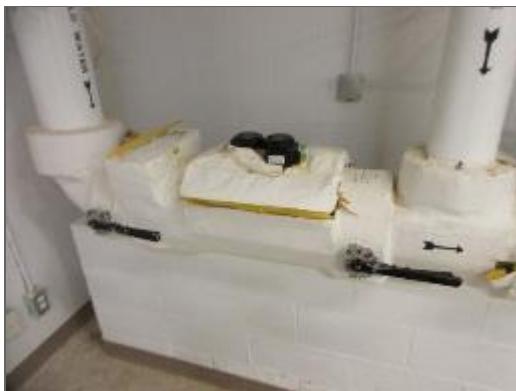
View of the main water line within the fire sprinkler room of the Site Building.

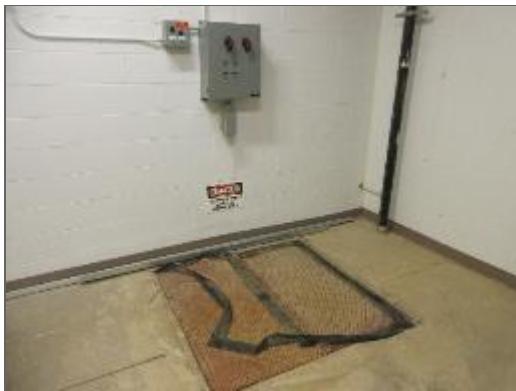
General view of the sump pump within the basement level of Site Building.

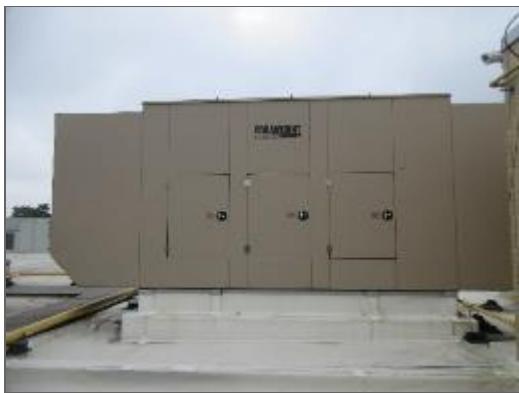
View of emergency generator of the Site Building.
